**Report on Storm
16 February 2026
in
Pinehaven and Silverstream
Upper Hutt**

Executive Summary

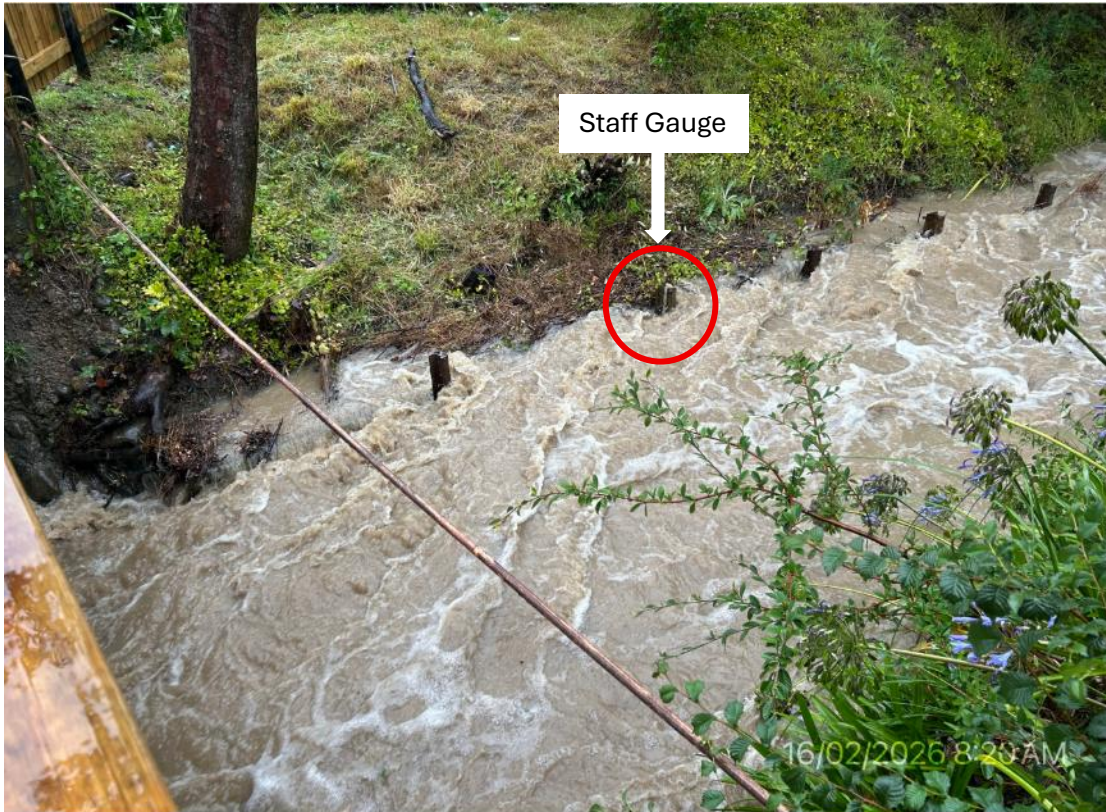
Figure 11 Staff gauge (above and below right), peak flow 1.41m, 8:20am Monday 16 Feb 2026

The peak water level at the staff gauge on 16 February 2026 was about 1.41m at around 8:20am. Using the rating curve by R J Hall & Associates Ltd, at 1.41m depth the flow is about 10.1m³/s. On R J Hall & Associates' Flood Frequency Curve, a flow of 10.1m³/s is about a 1-in-15 year flood.

The top of the timber retaining wall at the staff gauge is 1.31m. The peak water level on 16-2-2026 (above right) is about 25mm above the timber retaining wall on the upstream side of the railway iron, which is 75mm higher than the retaining wall on the downstream side. We estimate that the peak water level is about 1.31 plus 75mm plus 25mm = 1.41m peak water level.

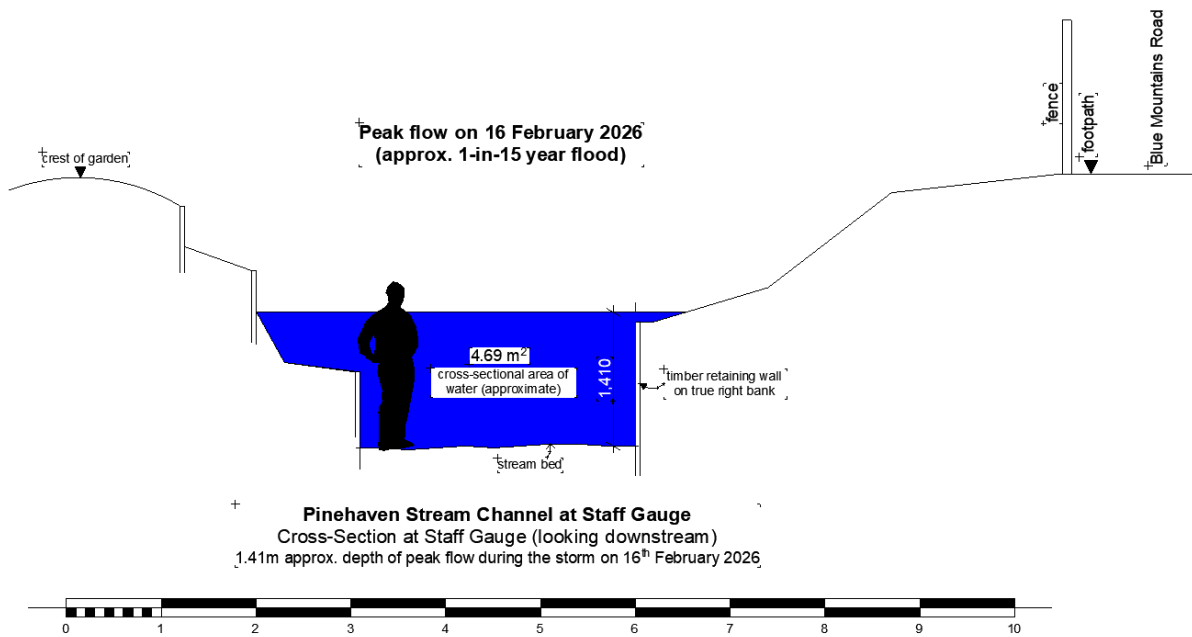
Figure 13 Surveyed cross-section of Pinehaven Stream channel at staff gauge

The cross-sectional area of water at 1.41m depth is about 4.69m² (Figure 13 above).

Dividing the flow by the cross-sectional area of water suggests that the velocity of the flow is $10.1 / 4.69 = 2.15$ m/s, which seems reasonable compared with independent velocity estimates by R J Hall & Associates and G. Horrell for the Dec 2019 flood event.

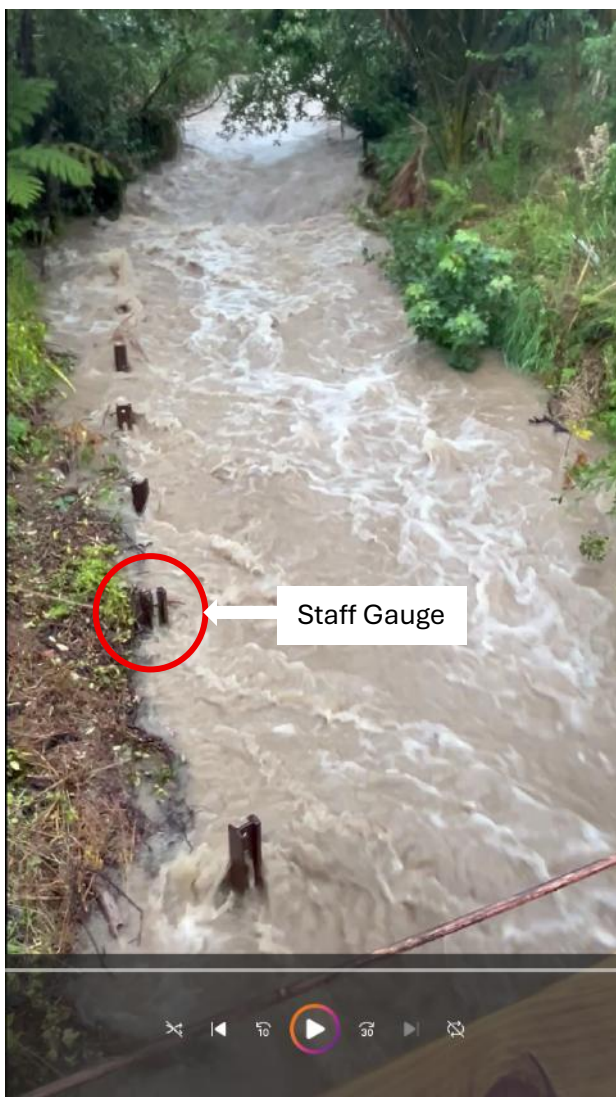
Figure 14 Peak flow 8:20am, staff gauge site 16-2-2026

In the video of peak flow (left), the staff gauge is at the second railway iron from the front. There is a weir under the footbridge the author is standing on.

There is another weir about 15m upstream of the footbridge, and water spilling over this weir is visible at the top of the image (left). See below (Figure 15) for a plan view of the staff gauge site.

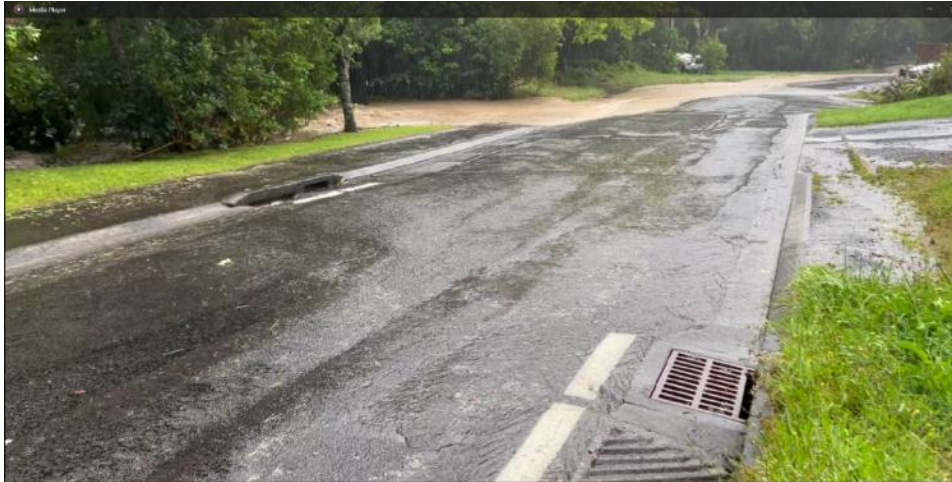
Road sumps contribute to overtopping of culvert at 122 Pinehaven Road

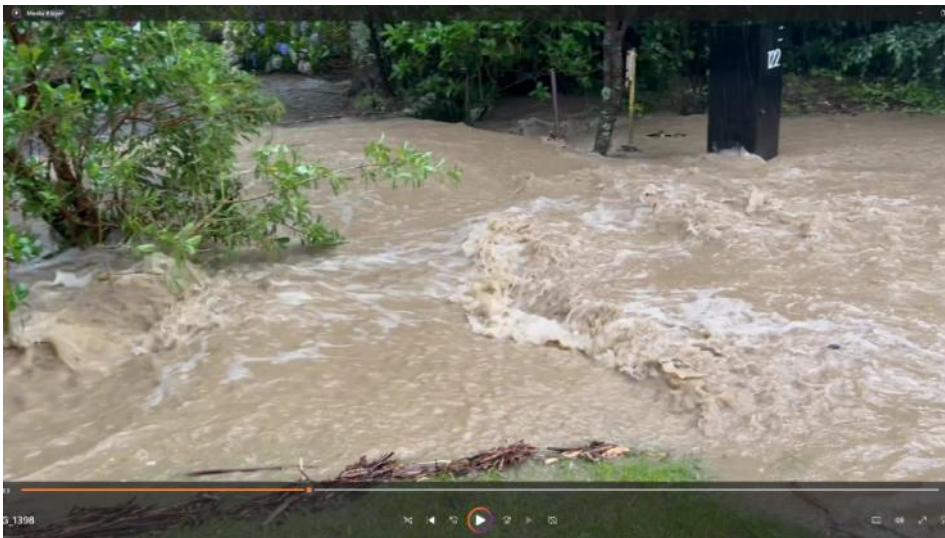
122 Pinehaven Road - overtopped driveway culvert (not being fixed in \$60M streamworks)

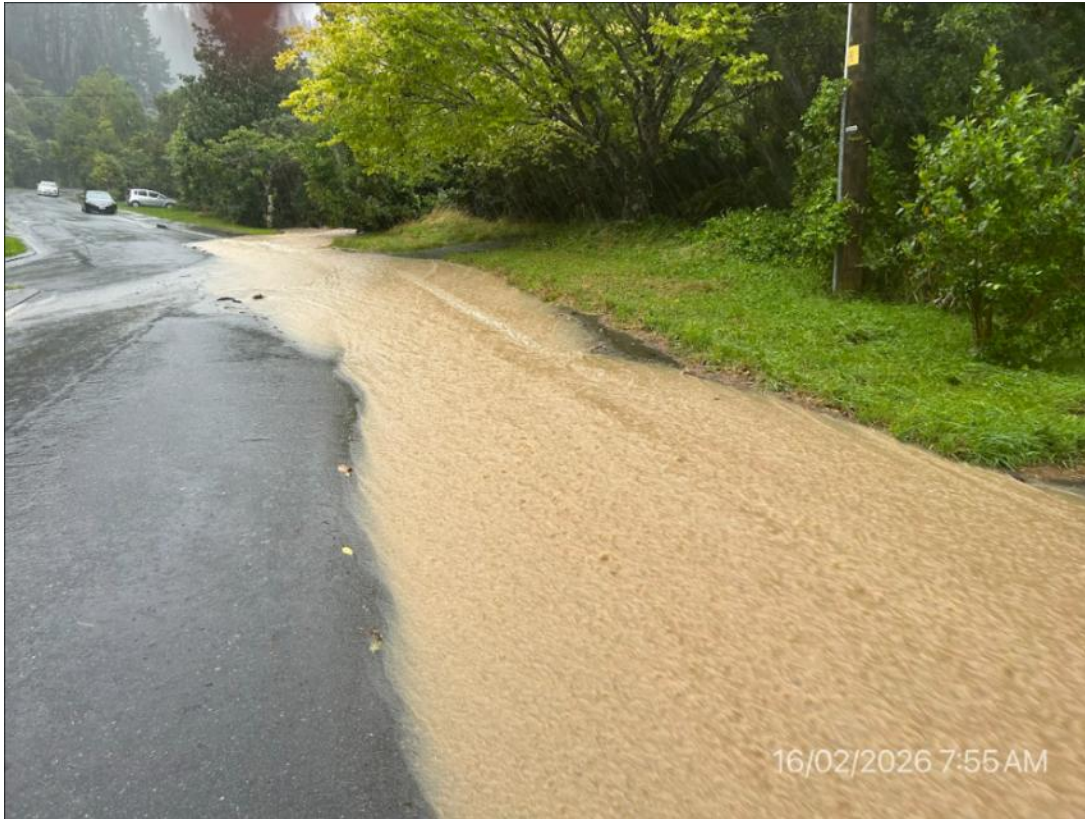
Looking south up to 122 Pinehaven Road where water overtops the driveway culvert

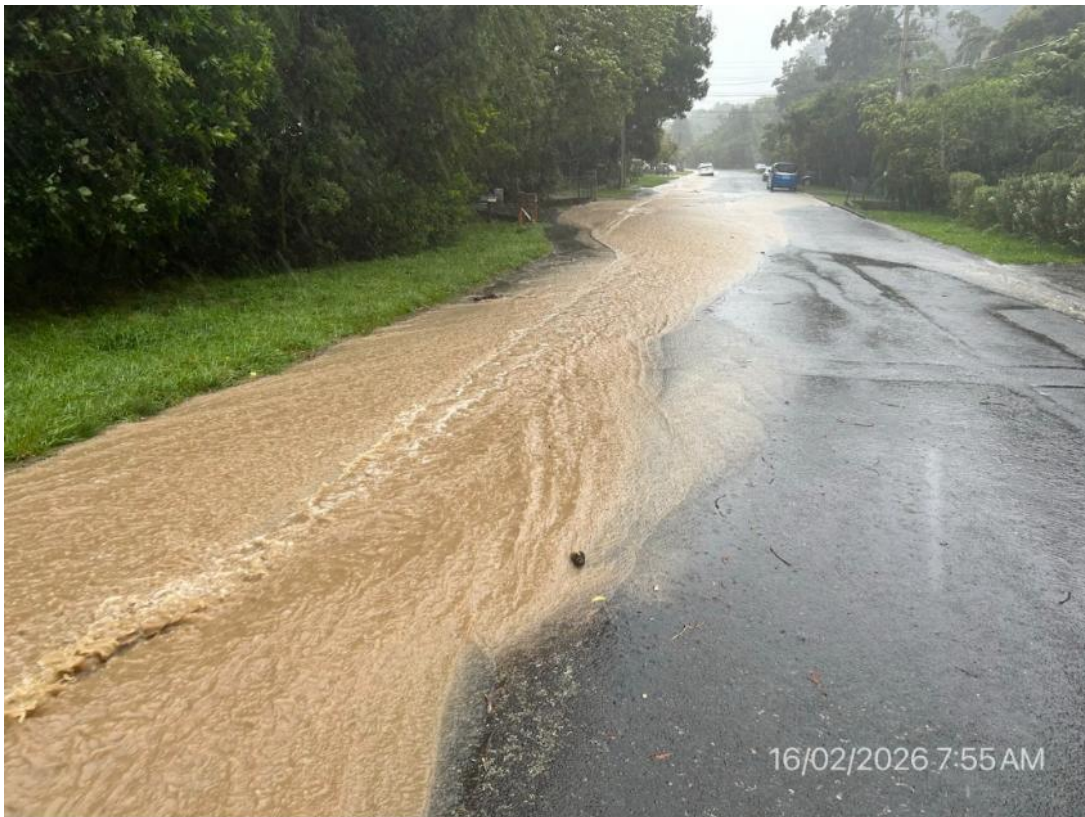
Looking north down Pinehaven Road from near 122 Pinehaven Road at 7:55am.

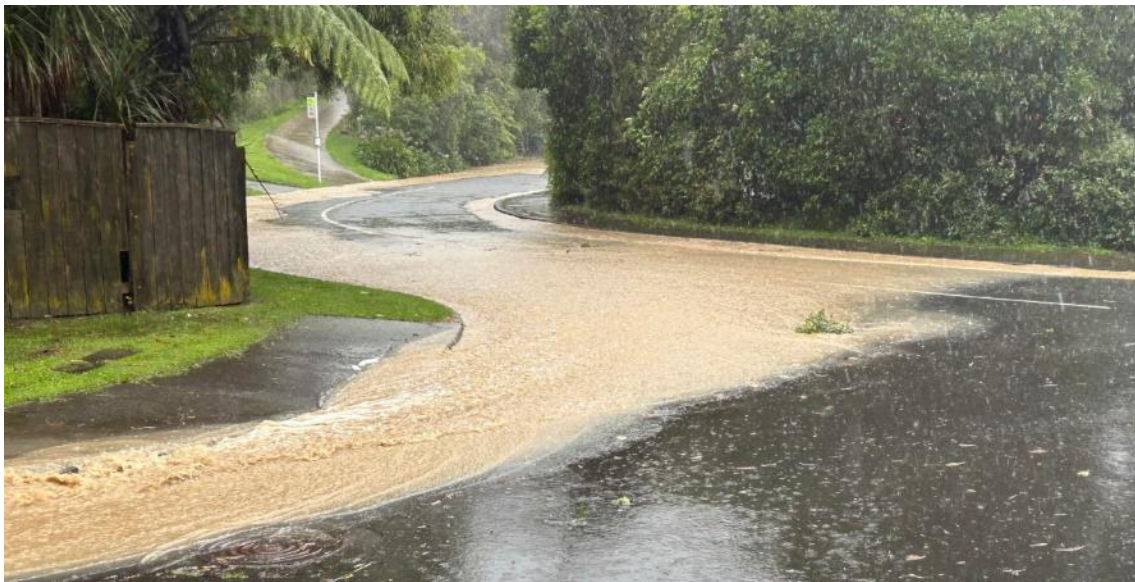
Most of the flow from 122 Pinehaven Road turned into Jocelyn Crescent

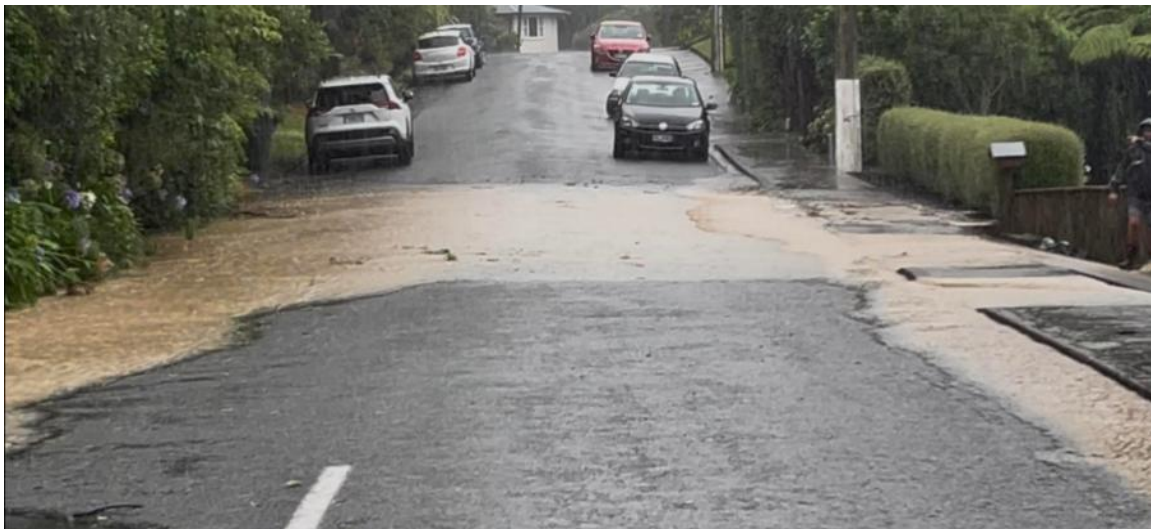
8:00am - water flowing into Jocelyn Crescent ran into 39 Jocelyn Crescent (right) - find out from local residents how this water finds its way back into the stream further down Pinehaven Road.

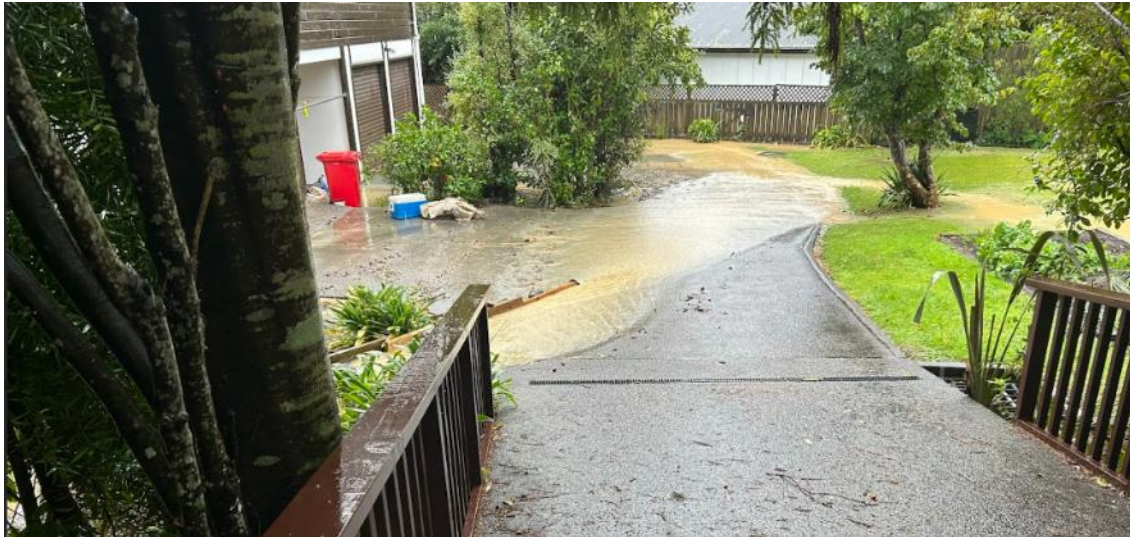
A pipe from under the road discharged stormwater into 37 Jocelyn Crescent ...

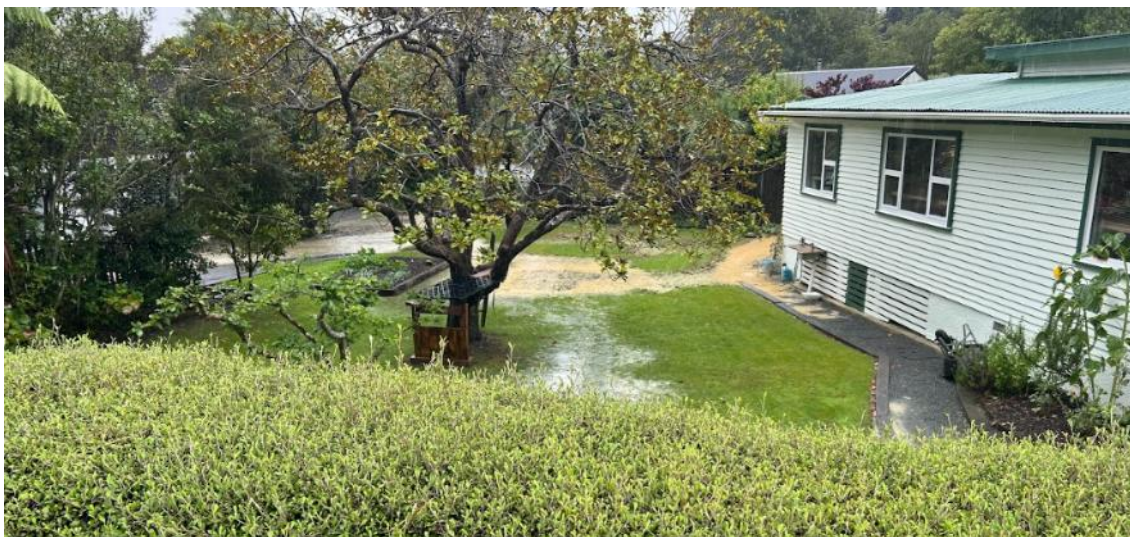
... which spilt over into neighbouring properties, in this photo above into 39 Jocelyn Crescent.

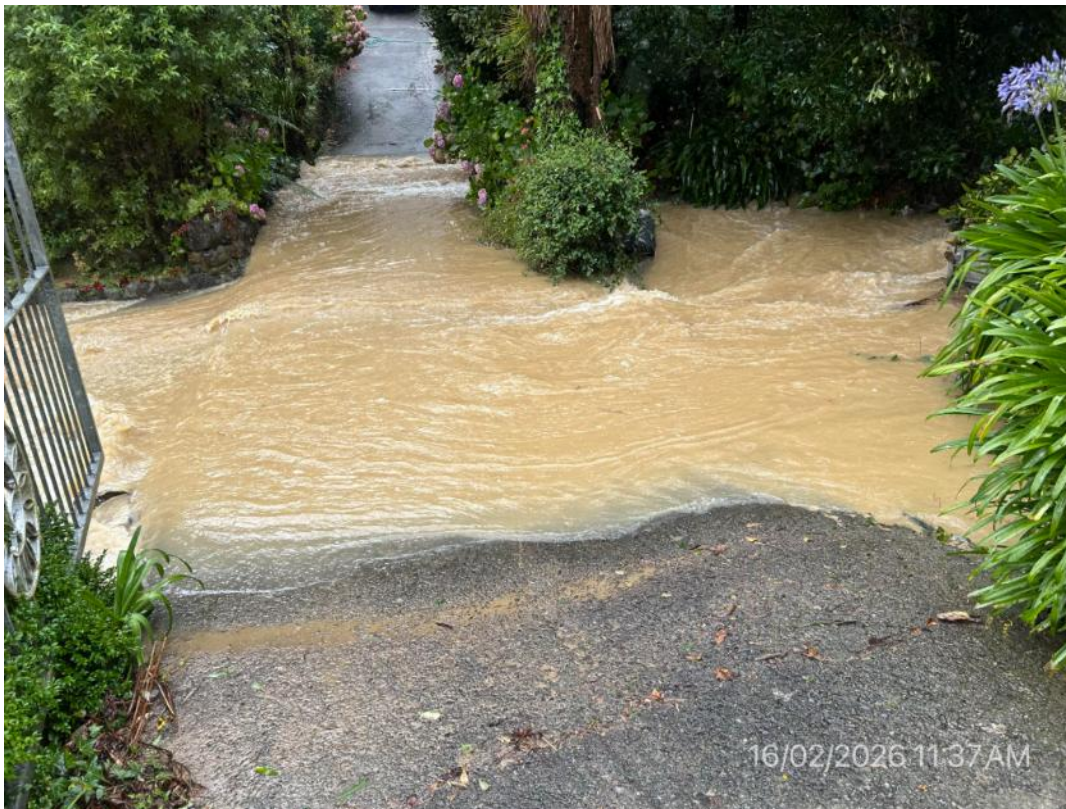
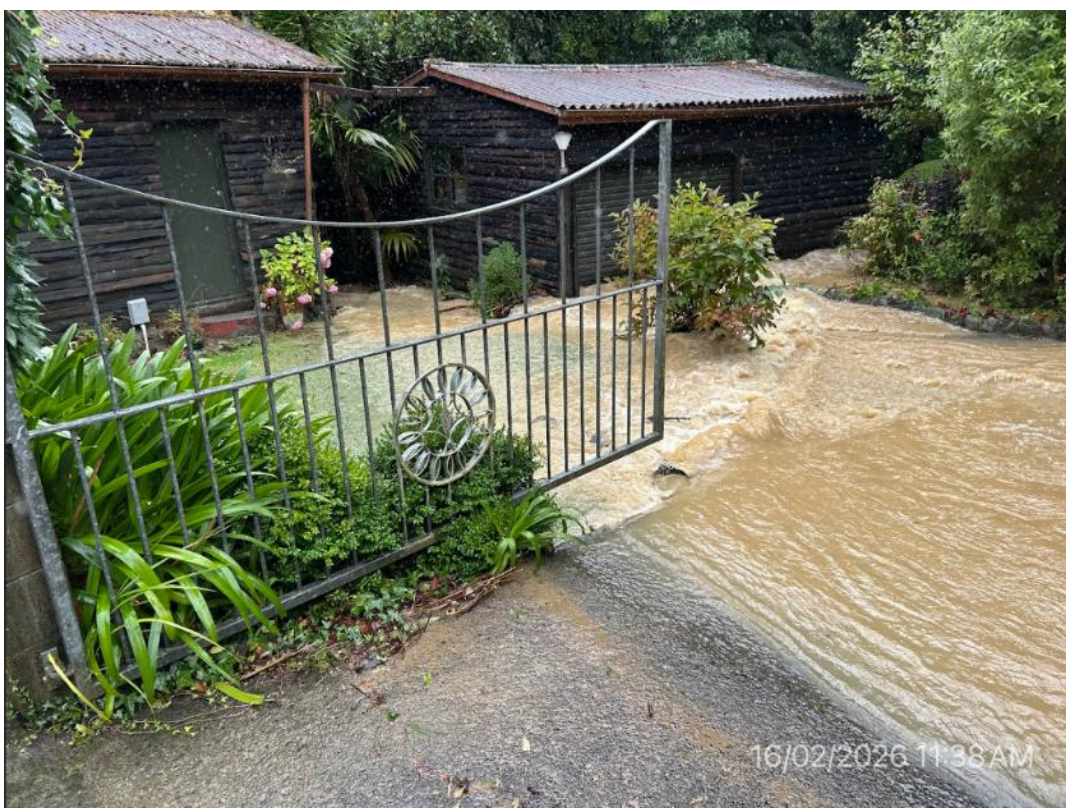
Figure 18 Flooding of driveway at 125 Pinehaven Road, 11:37am

Ask local residents about this flooding. NB: it isn't being fixed in the \$60M streamworks

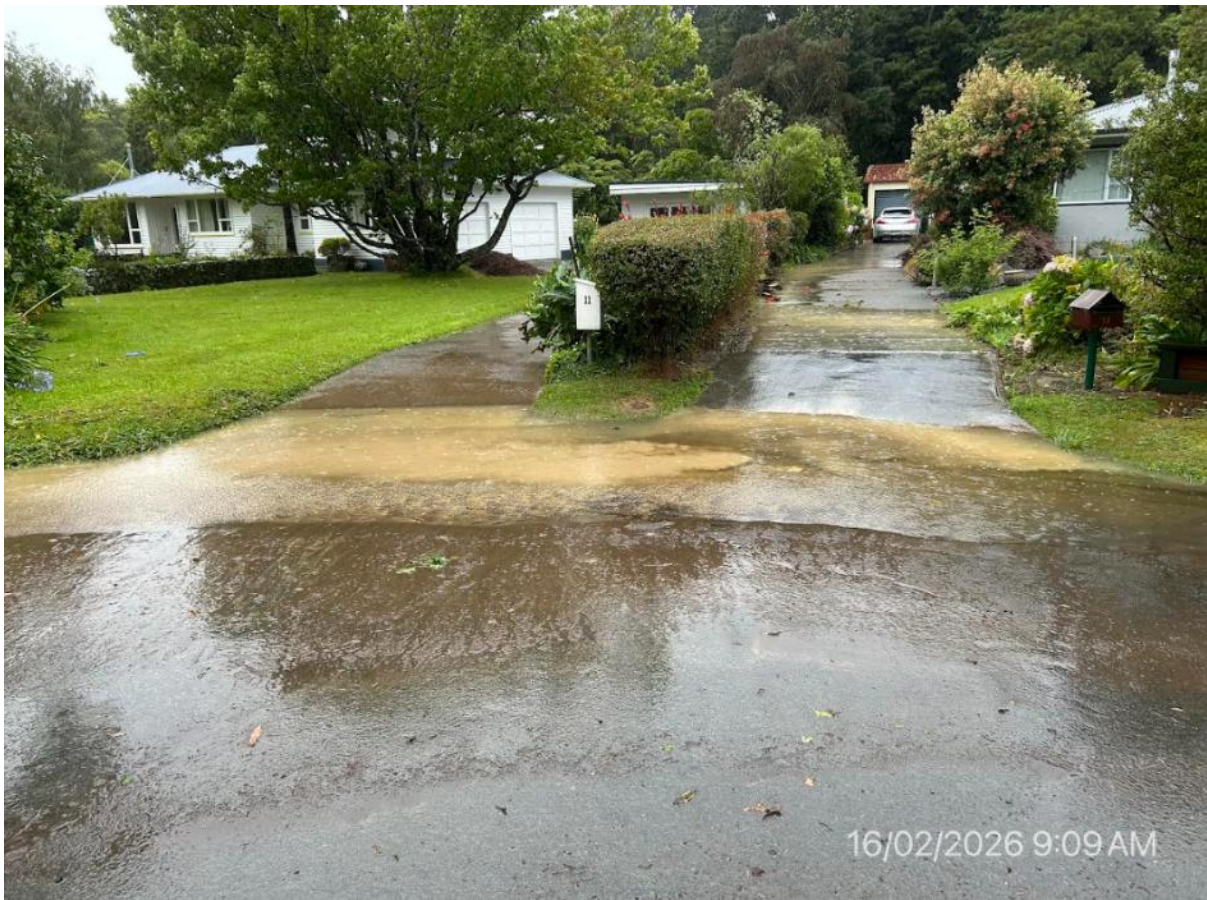
Figure 19 Minor flooding in Birch Grove cul-de-sac, 9:09am just after peak flow

The ponding in Birch Grove was minor compared to flooding that occurred here in December 2019 when the whole cul-de-sac was flooded. On Monday 16 February 2026, there was evidence of water starting to break out of the stream channel behind the house at 12 Birch Grove and running down the driveway into the cul-de-sac. There it mixes with surface water flowing down the Birch Grove road channels and ponding in the cul-de-sac. The ponding seems to be due to the drainpipes from the road sumps (under water in the top photo above) being unable to discharge properly into the stream channel because they are below the surface of the swollen water level. The pipes may also be receiving backflow from the flooded stream channel.

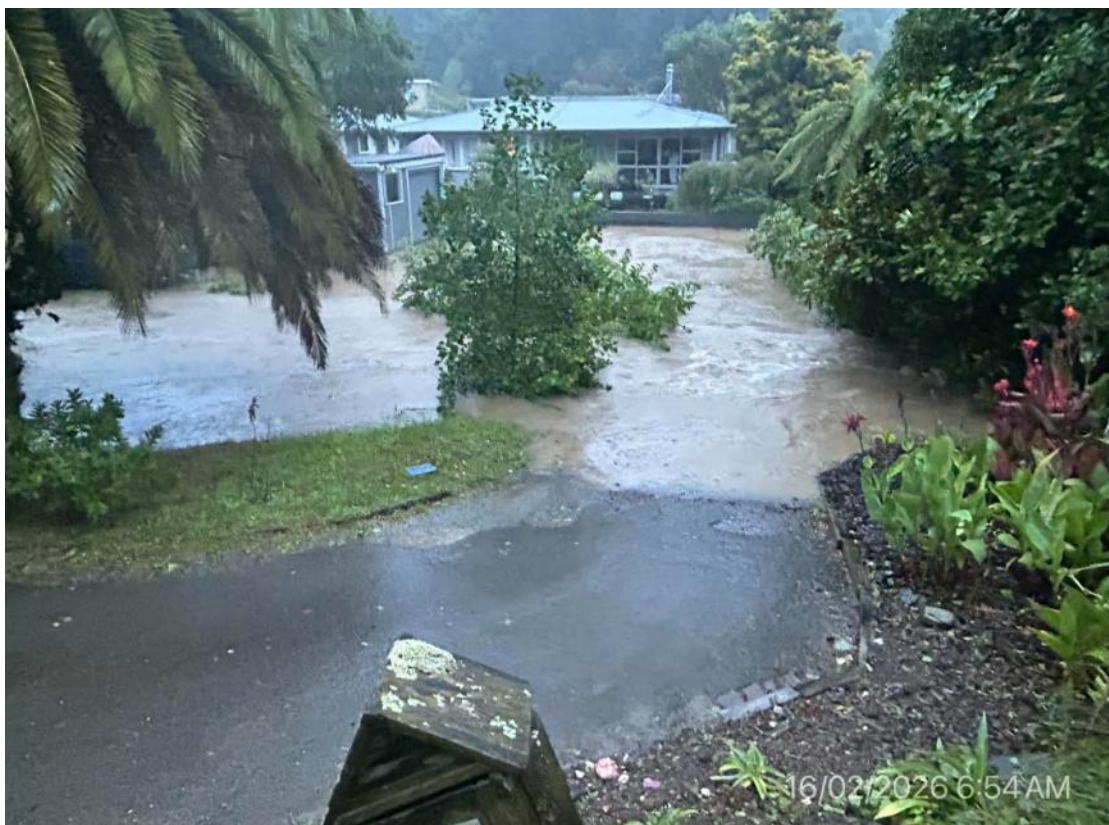
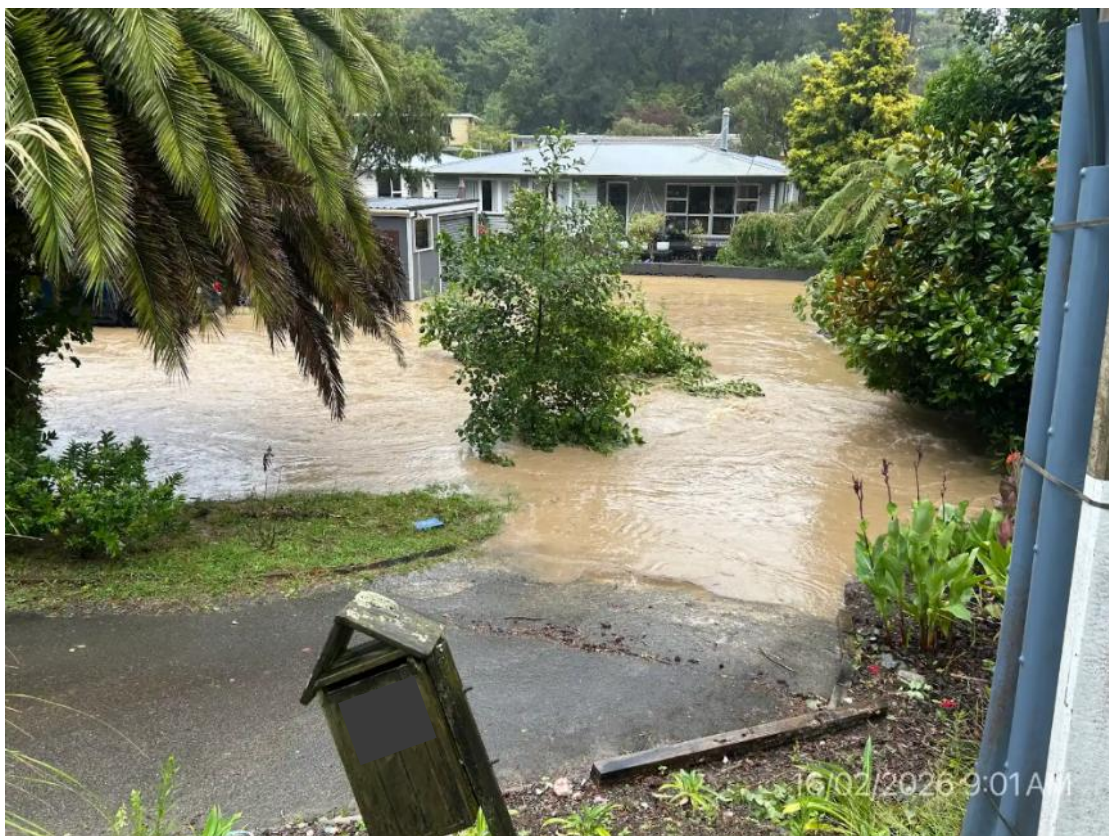
36 Blue Mountains Road, 6:54am (above) and 9:01am just after peak flow (below)

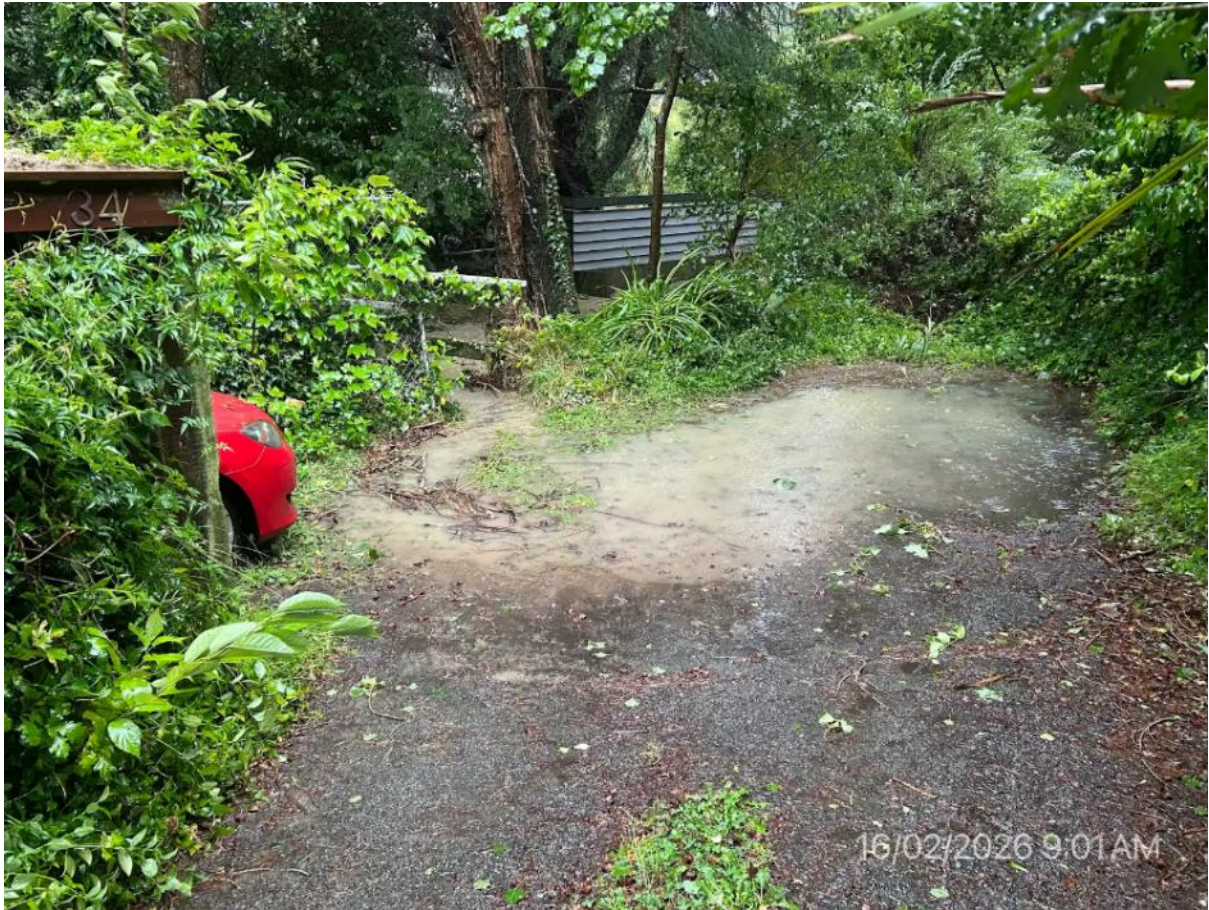
34 Blue Mountains Road, 9:01am just after peak flow

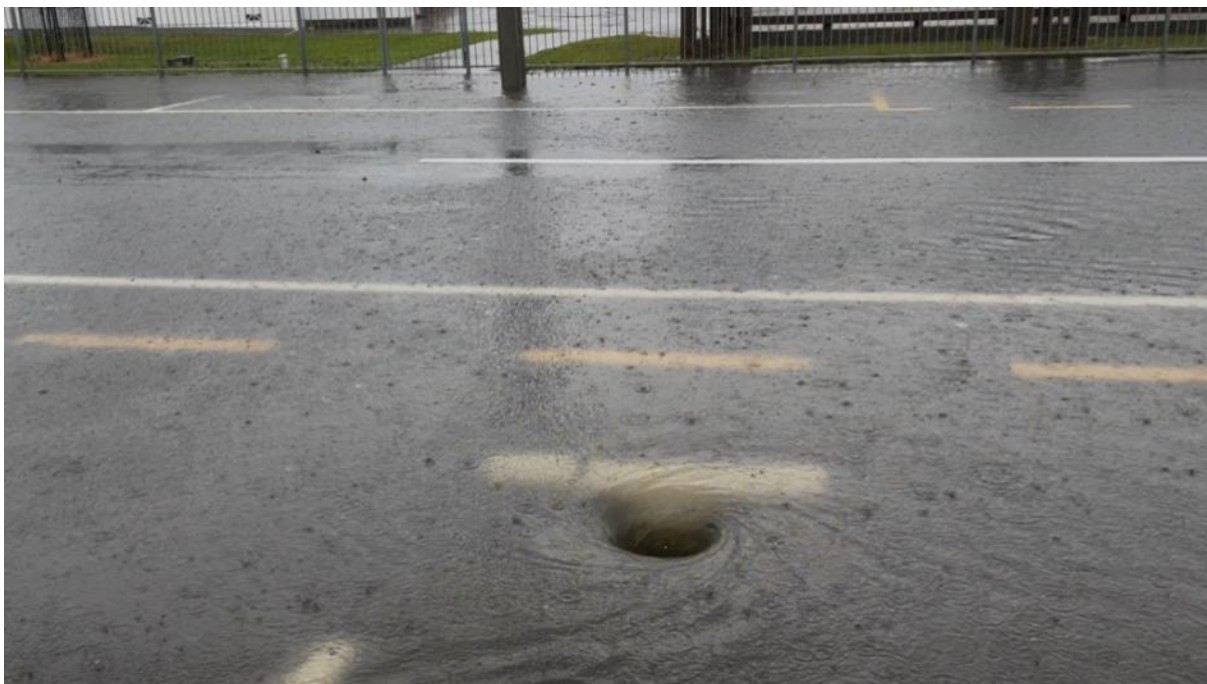
Figure 21 Ponding in Gard Street due to blocked road sumps

After clearing leaves and twigs at around 8:30am from the blocked road sumps, the ponding drained away within about 20 minutes.

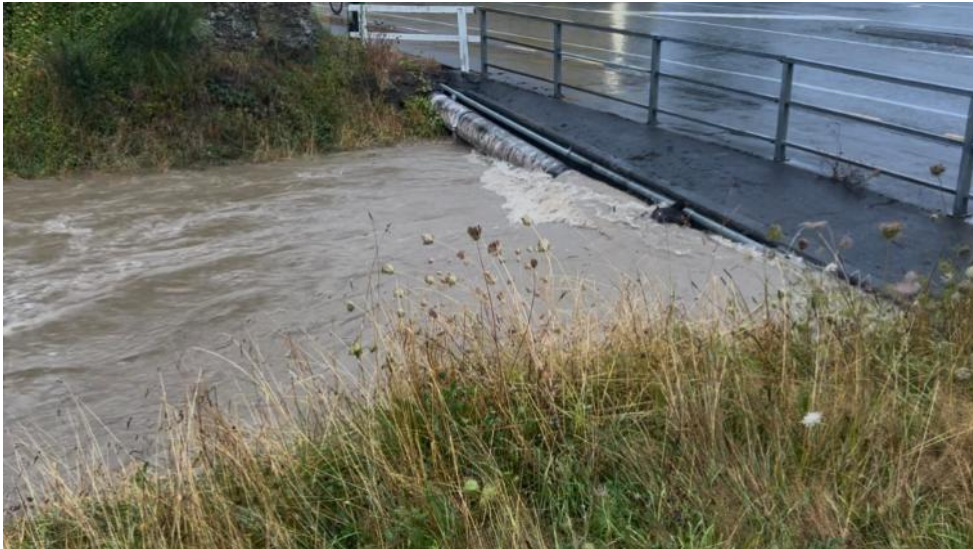
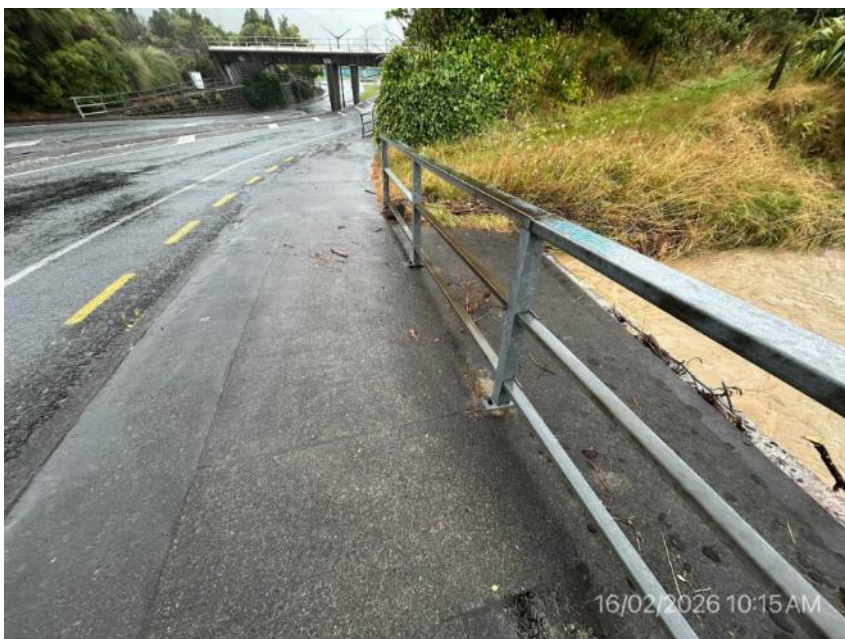
Figure 22 The Field Street road culvert reached full capacity

Field Street road culvert (upstream side) at 7:27am

The debris lines in these two photos (left) indicate that the road culvert overtopped a little at the peak of the flood almost two hours earlier.

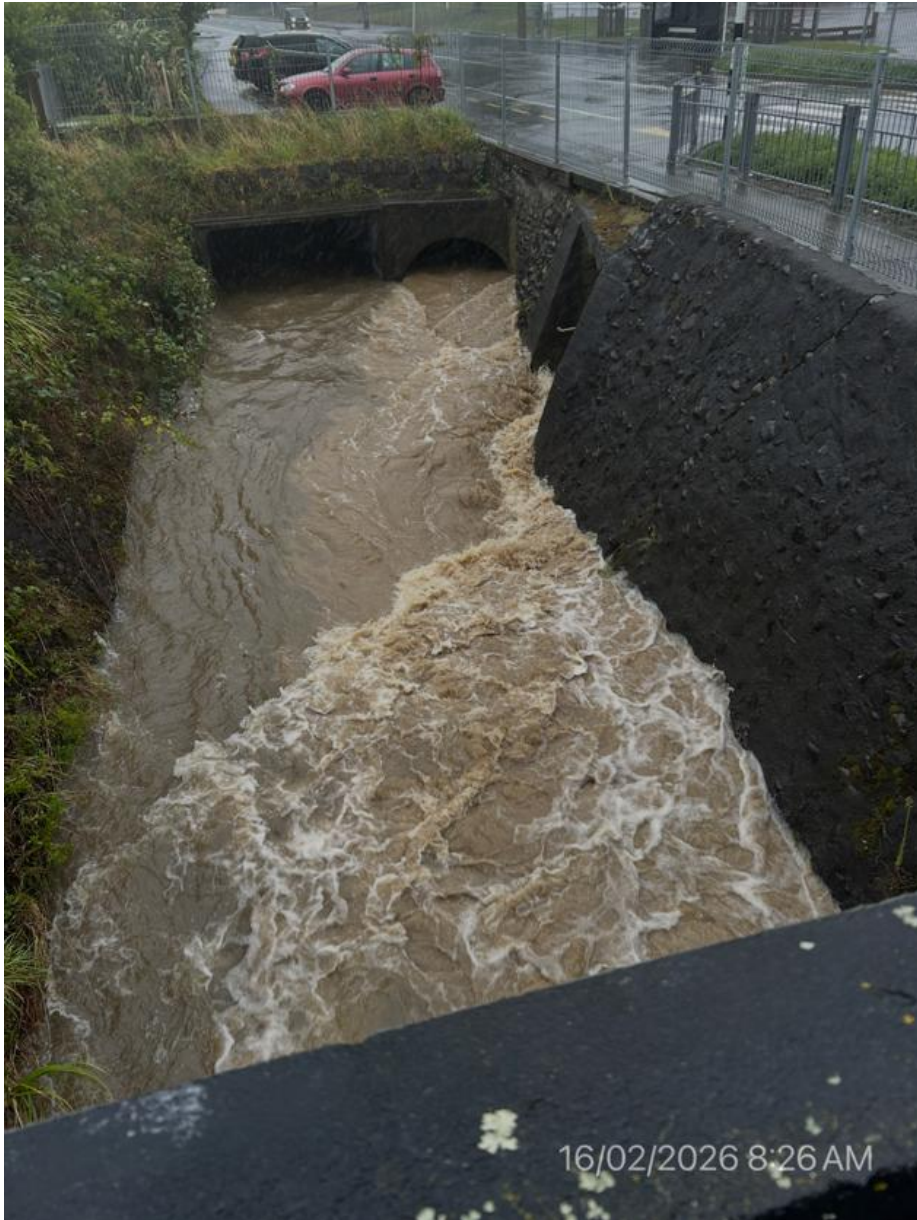
This photo (left) at 8:26am shows Hulls Creek at the time (approximately) of the peak flow of the Pinehaven Stream and Whitemans Road Bypass pipes

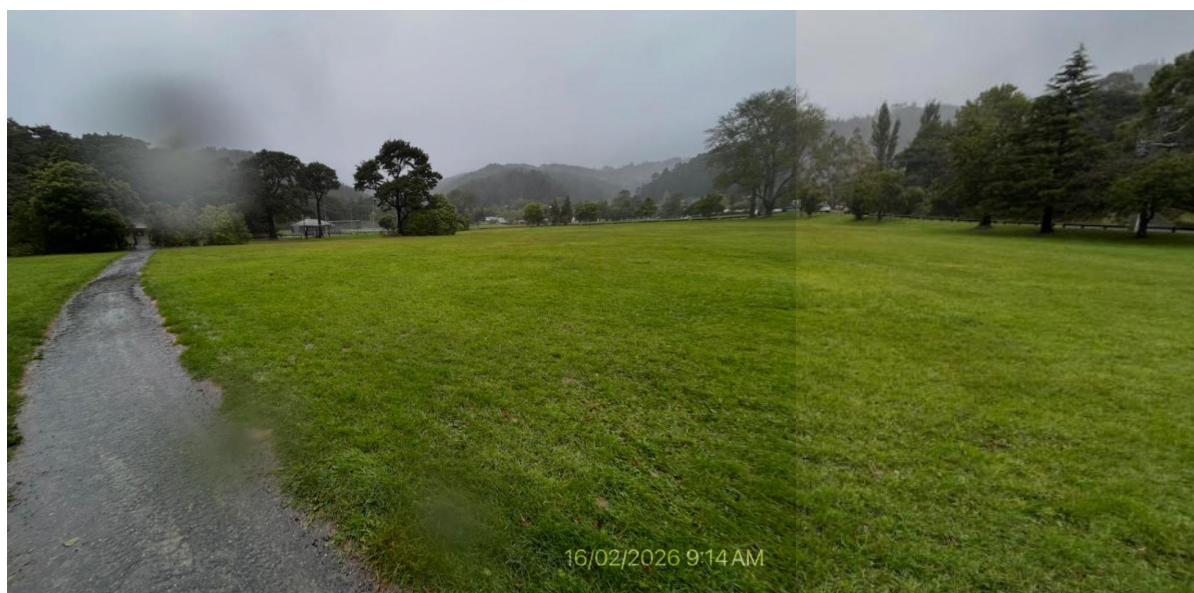
Figure 24 Pinehaven Reserve was not inundated in 15-year flood on 16 February 2026

We estimate that the storm on 16 February 2026 was about a 1-in-20 year rainfall event and about a 1-in-15 year flood event in Pinehaven. GWRC's 1-in-10 year flood map (above) shows Pinehaven Reserve inundated, but that did not happen on 16 February 2026. GWRC's flood map grossly overstates flooding, not only of Pinehaven Reserve but also many homes in Pinehaven are falsely shown inundated in GWRC's inflated and unreliable flood maps.

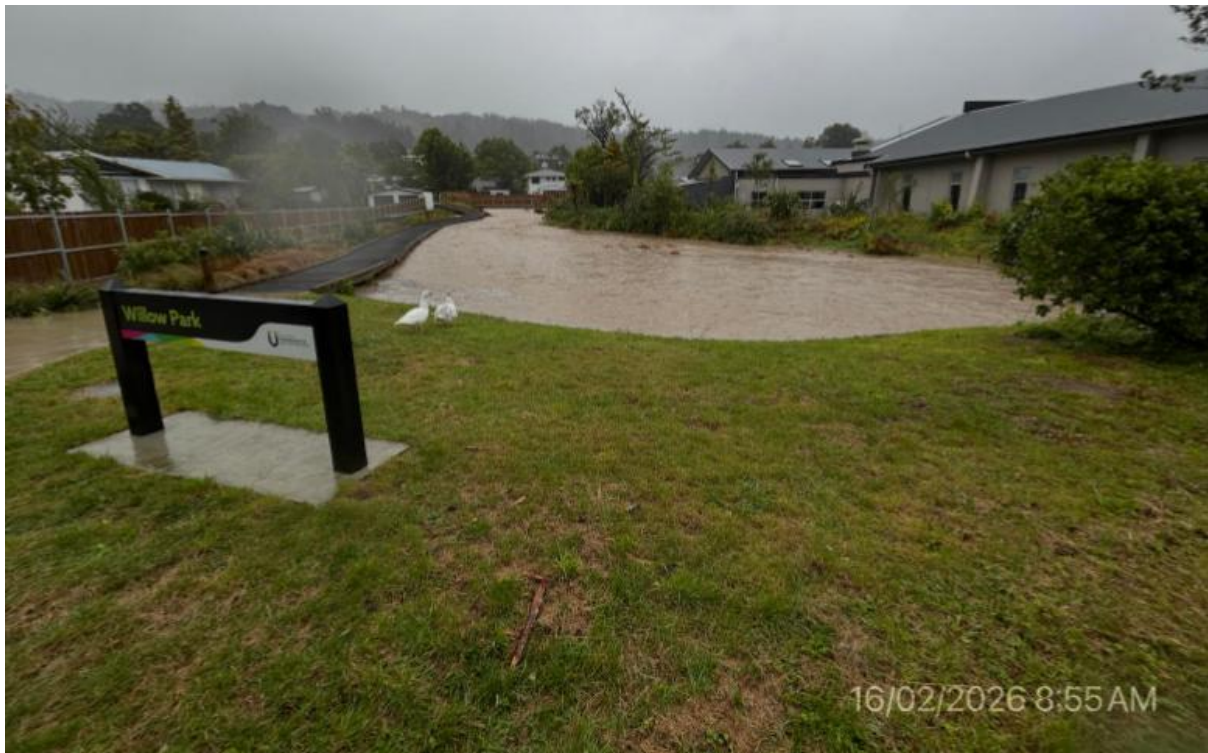
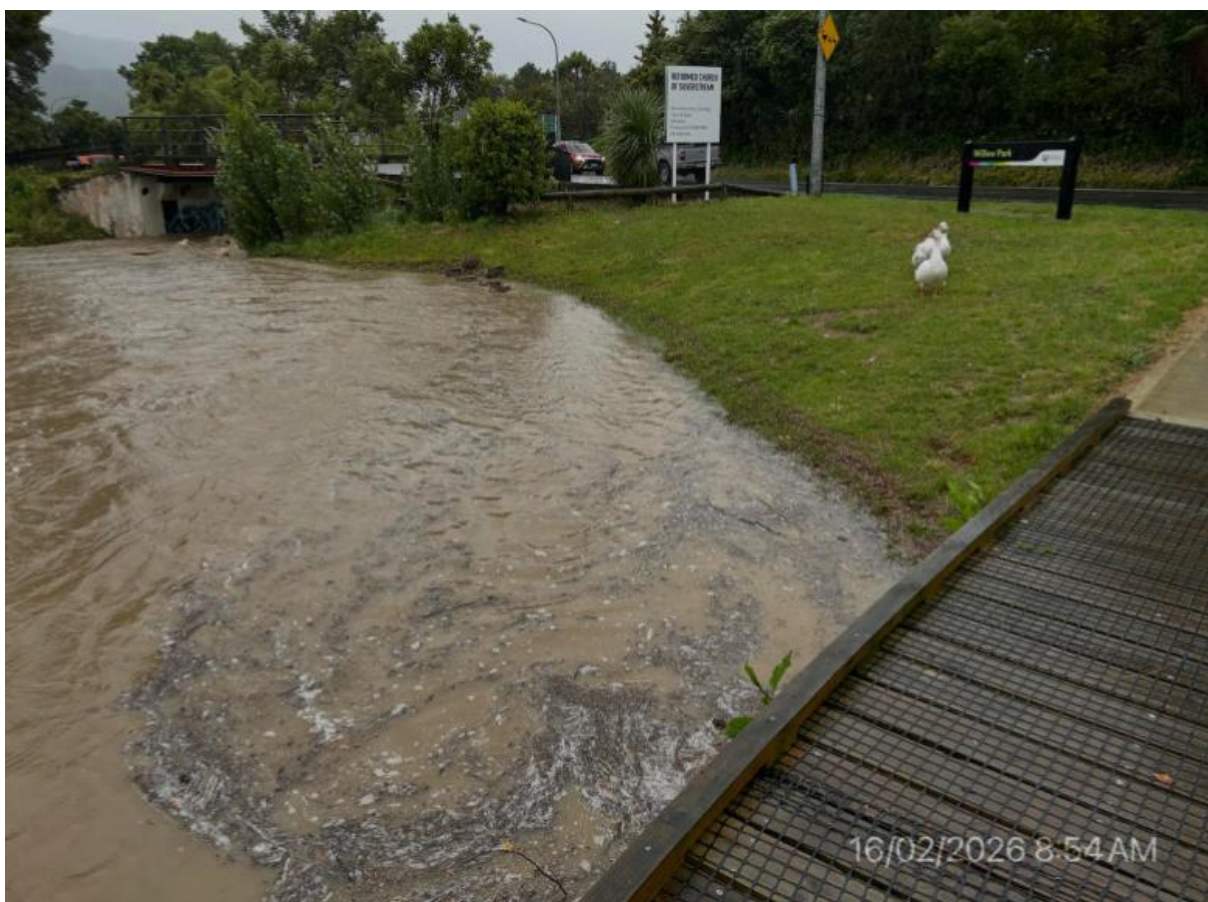
Figure 26 Willow Park, 8:55am, about half an hour after peak flow, the flood water is receding

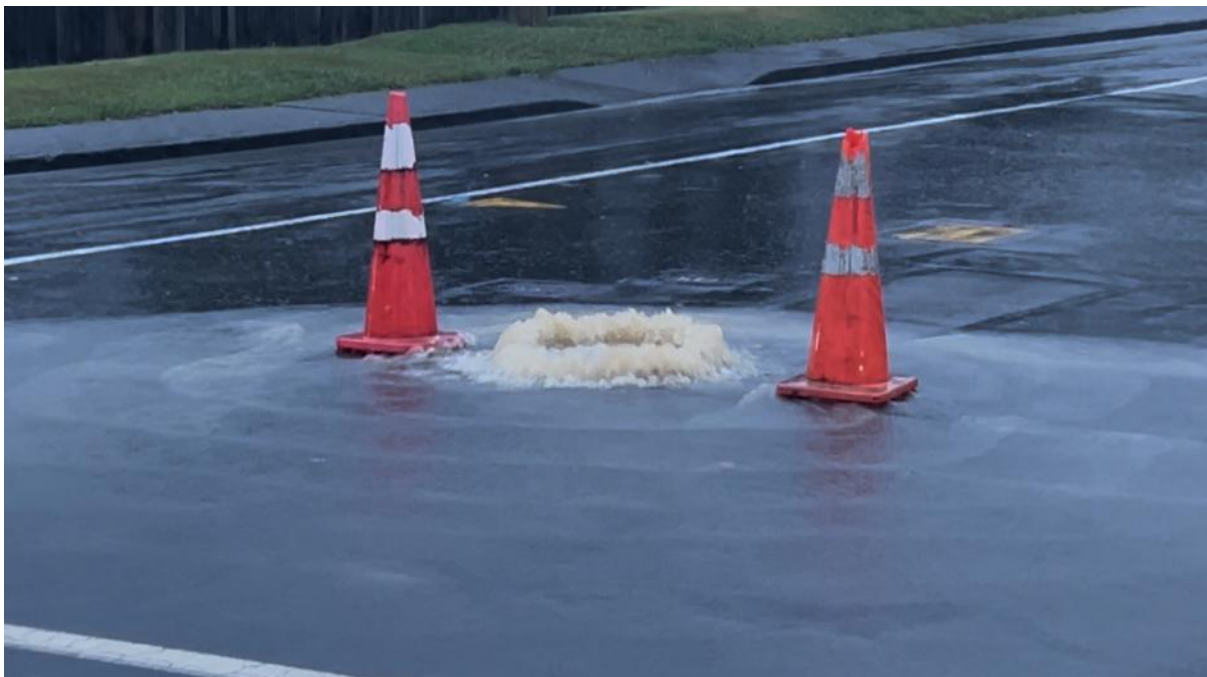
Figure 30 Popped manhole cover at intersection of Pinehaven Rd and Jocelyn Cres (by Library)

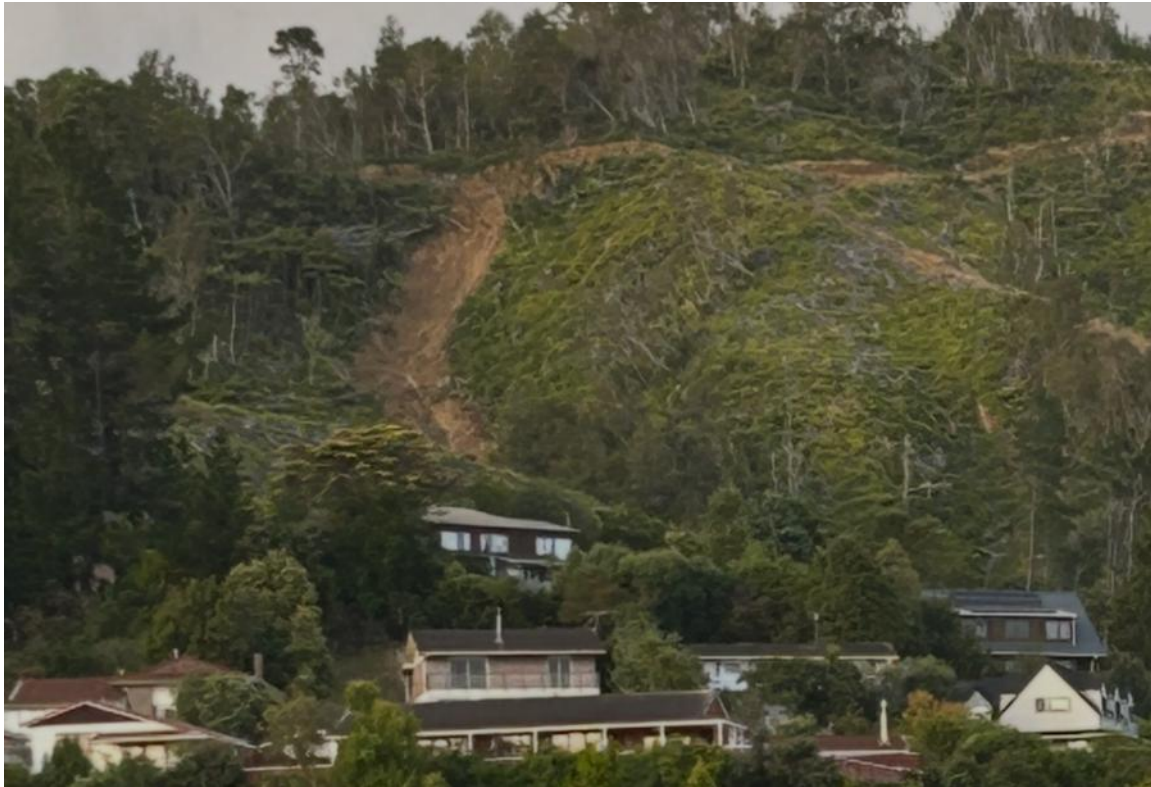
The slip occurred during the storm on Monday 16 February 2026 on steep land on which pine forest was recently harvested (see photo above).
