**Report on Storm
16 February 2026
in
Pinehaven and Silverstream
Upper Hutt**

Executive Summary

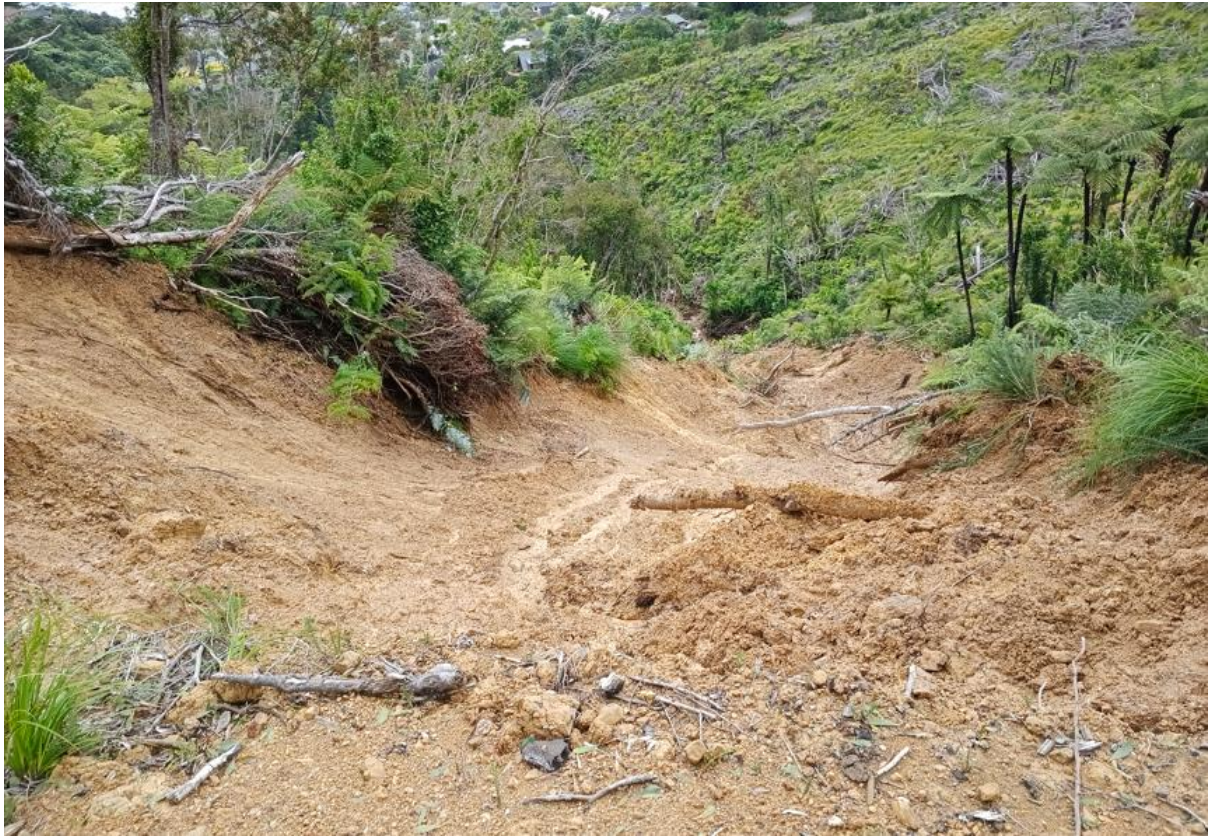
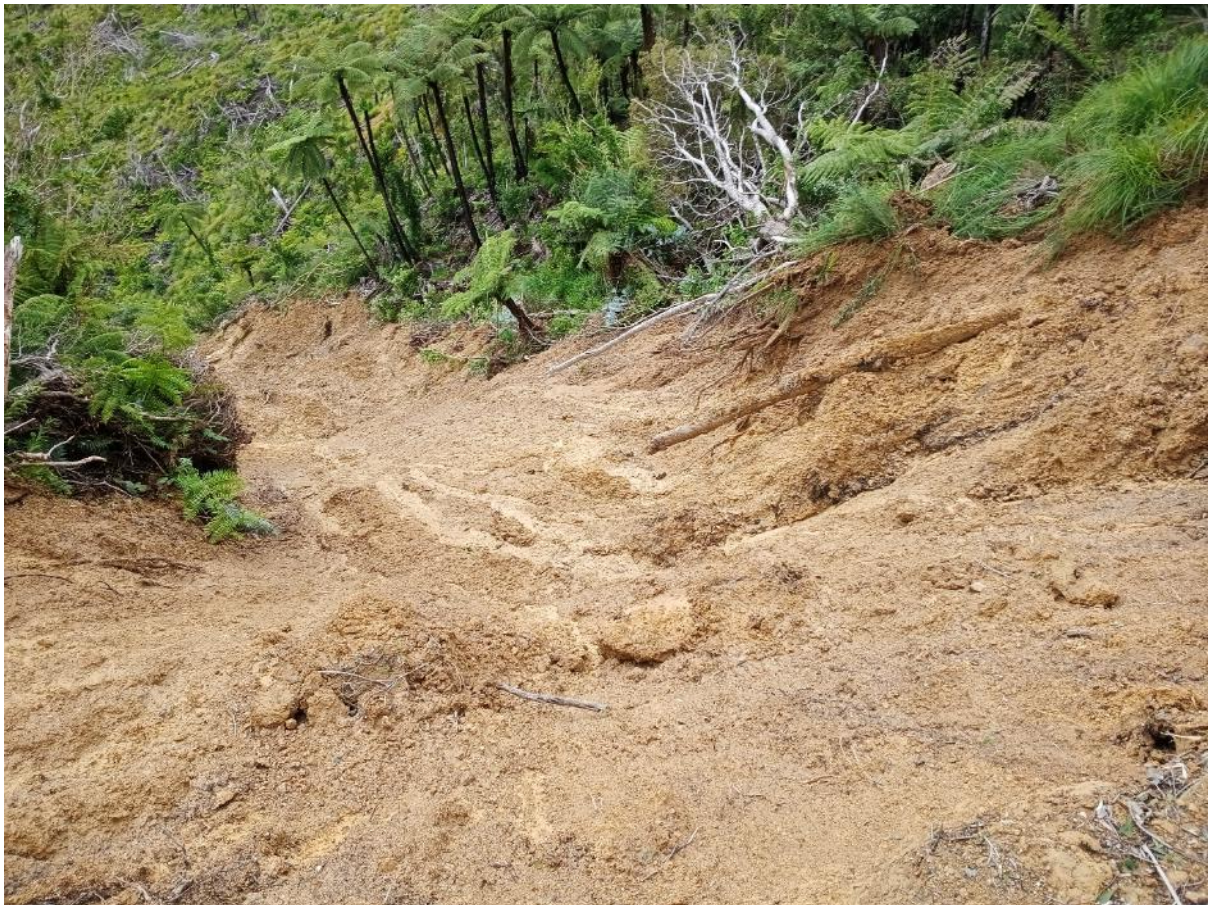
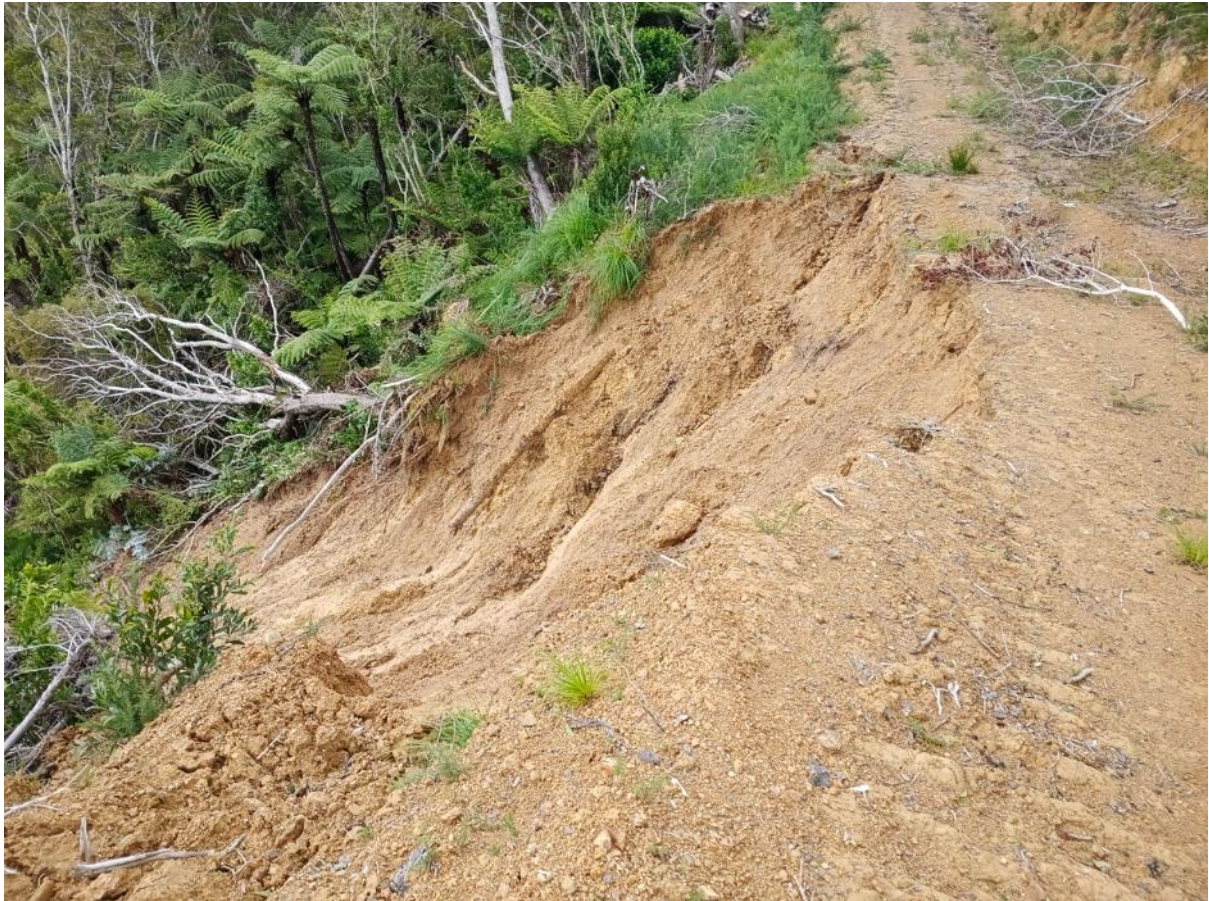
Figure 32 Landslide on steep hills above housing in Silverstream (Photos: Dennis Clark)

The Google map above shows pine forest that was at the landslide location before it was harvested. The slip occurred on the edge of a forestry road cutting, as seen in the photos below.

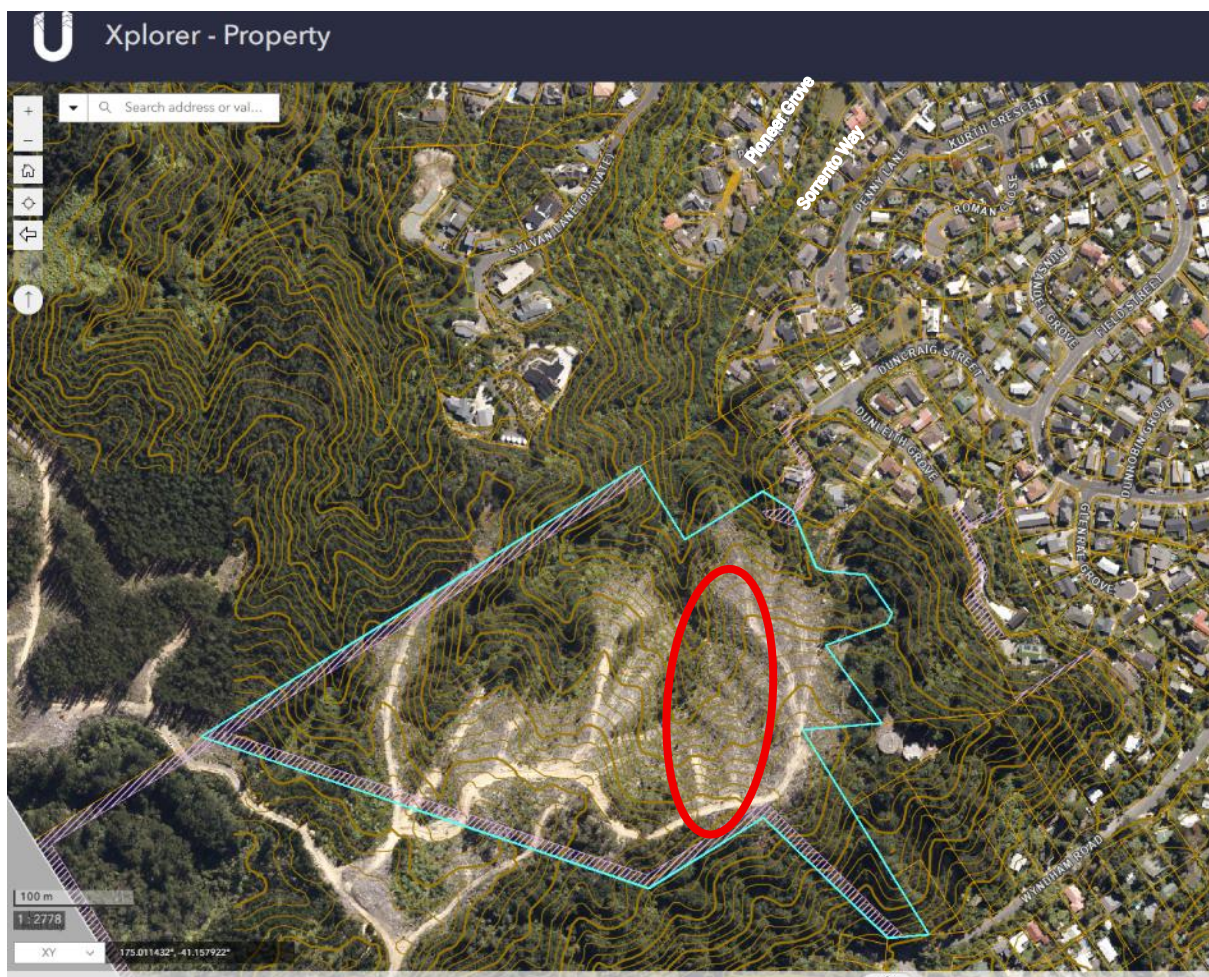
Figure 34 Approximate location (red ellipse) of landslide on Monday 16-2-2026

As mentioned earlier, and shown on Figure 34 above, the landslide on Monday 16 February occurred on the edge of a logging road in a gully that drains down to the stormwater intake in the small public reserve between Pioneer Grove and Sorrento Way in Silverstream. The pine forest in this area was recently harvested by The Guildford Timber Company (GTC), who own the site on which the landslide occurred (Figure 35 below).
