Warning Signs from the Hills

Forestry Runoff, Debris and Flood- Modelling Risk in Pinehaven and Silverstream

Report on the 18 April 2026 Storm

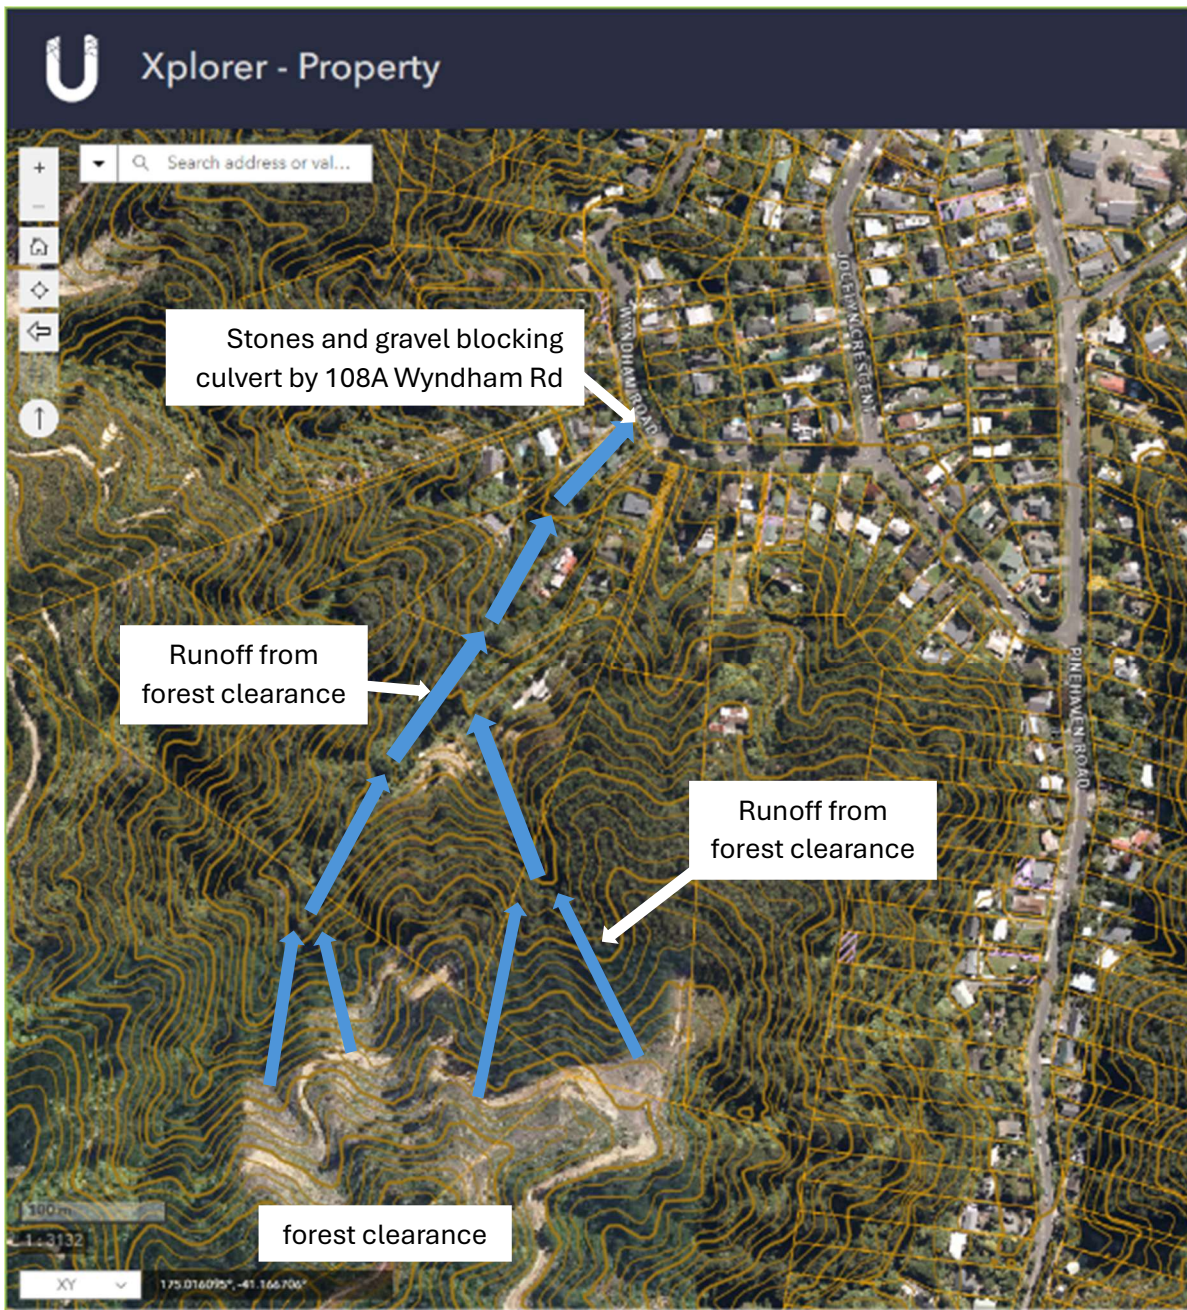
Figure 6 Gravel, rocks cleared from culvert

The culvert near 108A Wyndham Road was blocked by gravel, rocks, wood, debris and sediment. This does not prove that the recently cleared hillside was the only source of the blockage. However, the location of the forest clearance, the downhill runoff pathways, and the type of material found at the culvert are consistent with that explanation.

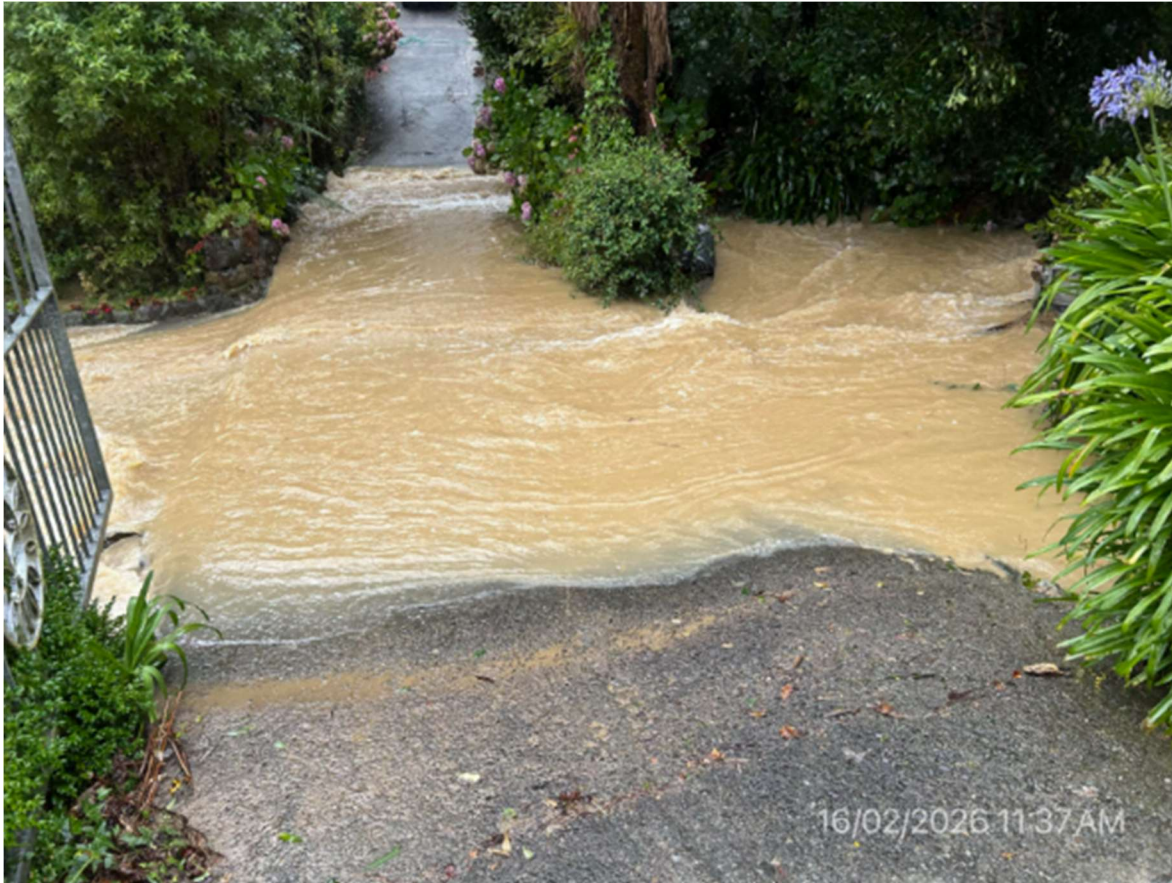
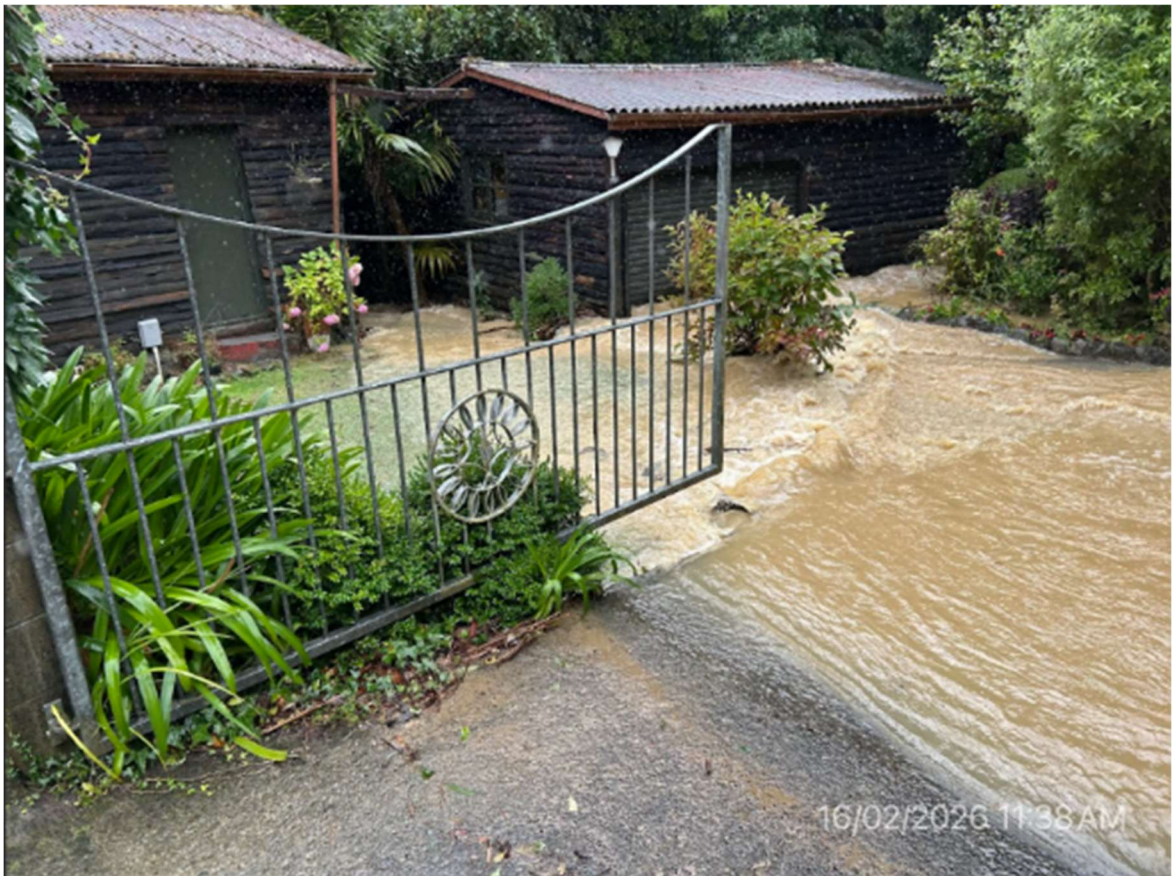
Figure 8 Blocked driveway culvert at 125 Pinehaven Road, 18 April 2026, 10:05am

Figure 9 Flooding of driveway at 125 Pinehaven Road, 16 February 2026, 11:37am

The clogged channel on 16 February diverted a torrent of water over the driveway and through the garage (Figure 9). The owner said the water reached 18 inches / 450mm deep in the garage. The floodwater damaged the car, which was written off and covered by insurance. Some tools and other equipment were also damaged.

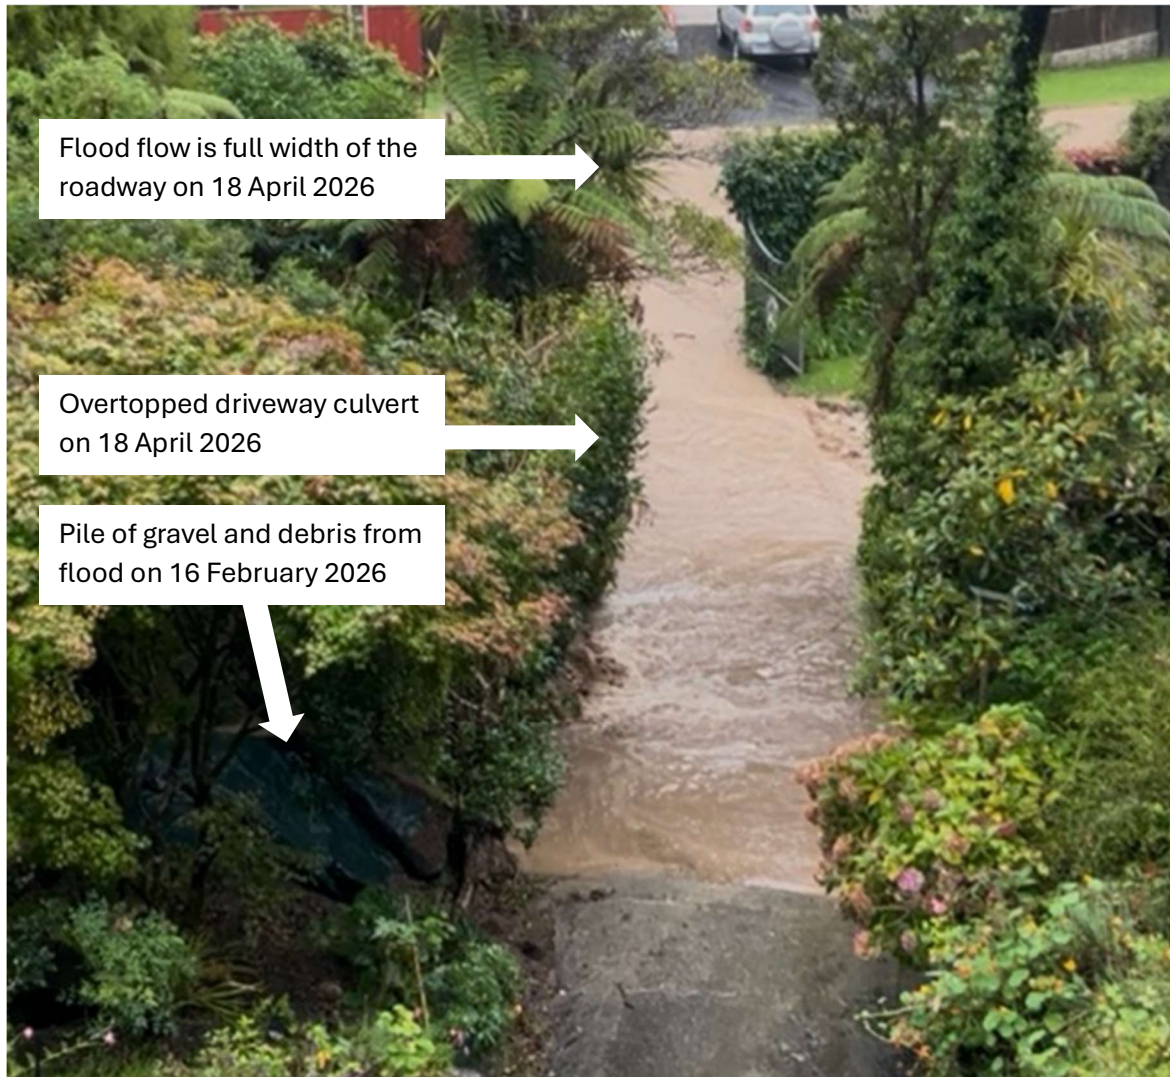
Figure 10 shows peak flow at 125 Pinehaven Road on 18 April 2026. At that time, floodwater was flowing across the full width of Pinehaven Road. The driveway culvert overtopped.

Figure 10 Flooding fully across roadway and in driveway at 125 Pinehaven Road on 18 April 2026

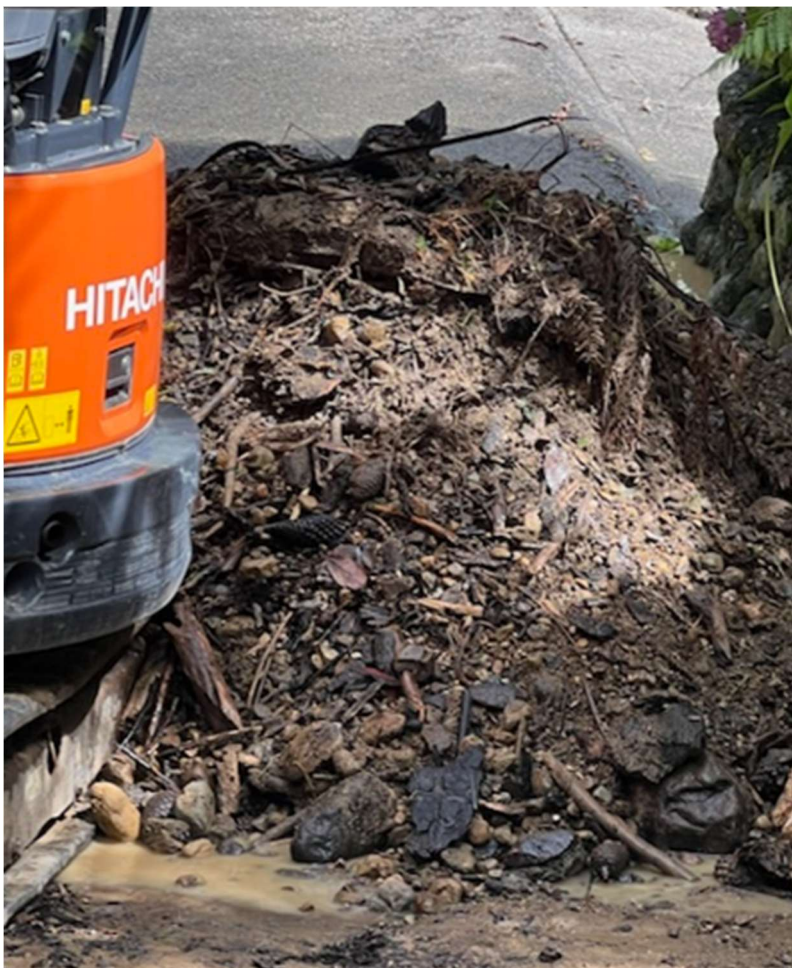
Figure 13 Some of the gravel, rocks and debris removed from the stream channel at 125 Pinehaven Road

The owners suspect the sudden appearance of large volumes of gravel, rocks and debris may be related to forestry clearance on the hills upstream. This warrants investigation because of the potential connection between hillside disturbance, sediment/debris mobilisation, blocked channels and increased flood damage downstream.

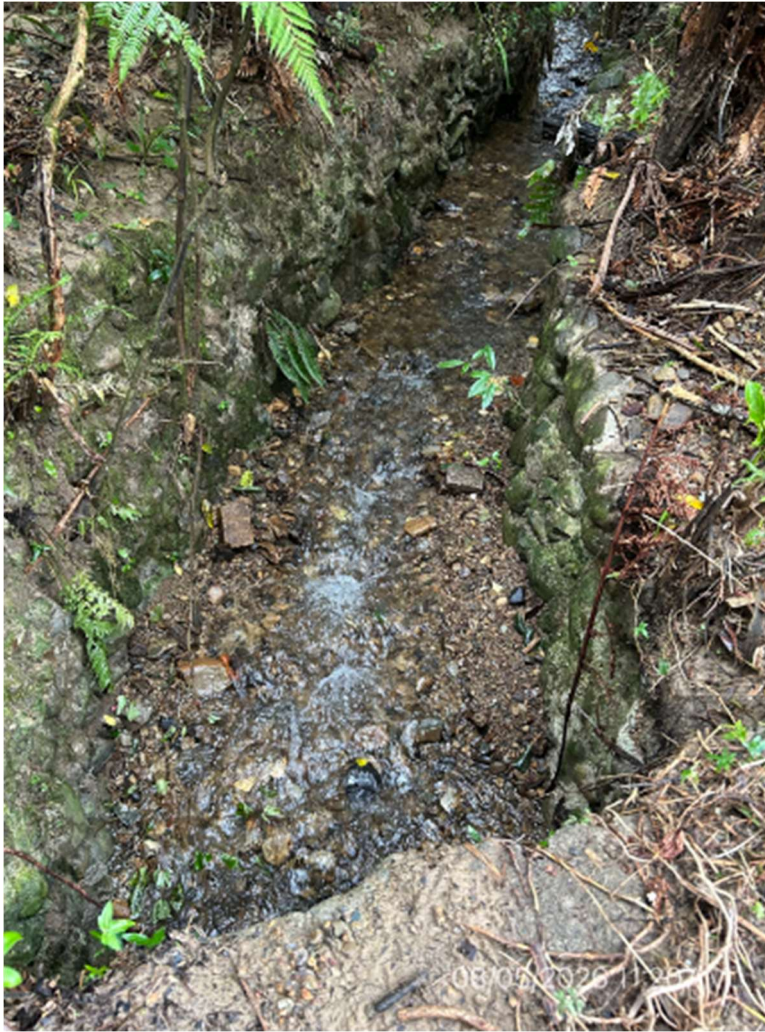
Figure 14 Photograph looking upstream at driveway culvert intake, 125 Pinehaven Road (Photo: 8 May 2026)

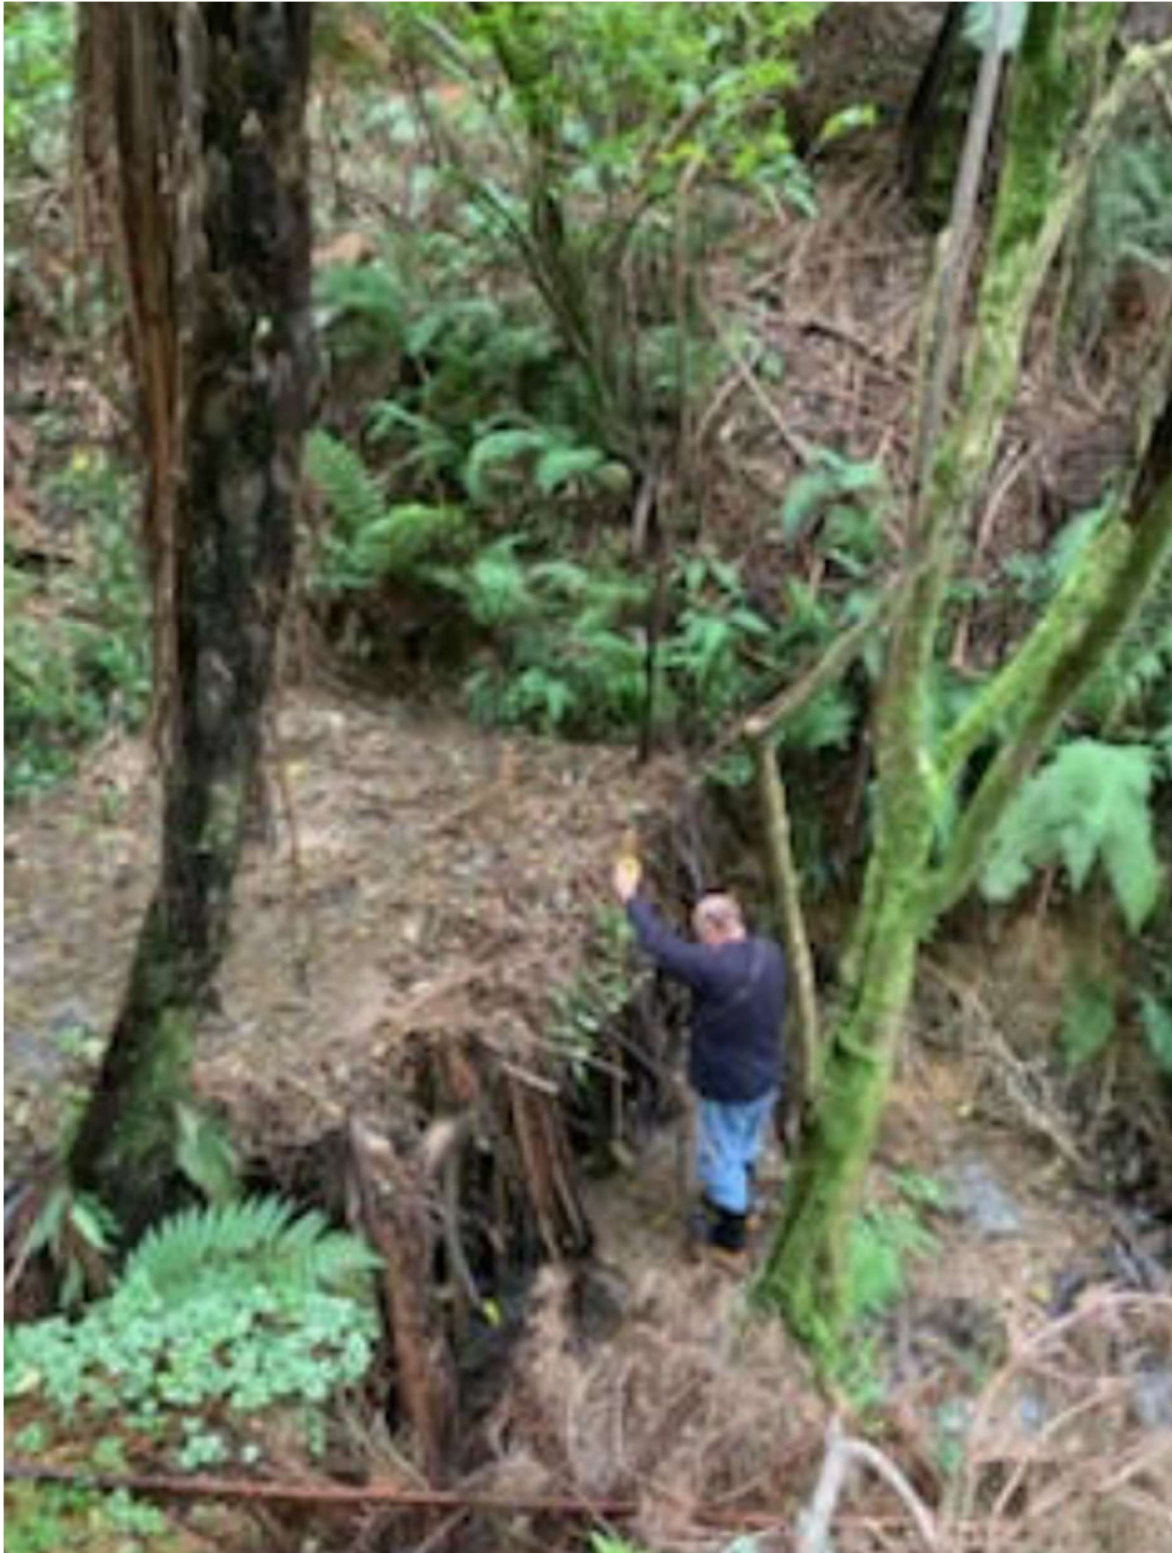
Figure 22 A debris dam 18 April 2026 raised the stream bed 1.6m. Photo: Flooding Us NZ Ltd

The debris traps and pipe were already under pressure during the 16 February 2026 storm. The larger debris trap appears to have trapped some material during that event. However, the more serious debris dam formed, or was substantially enlarged, during the 18 April 2026 storm, when gravel, rocks, sediment and debris filled the stream channel upstream of the larger trap.

The response must be urgent and independent. The debris dam in the upper Pinehaven Stream valley must be properly removed and the affected pipe intake and debris-trap structures assessed. Known local drainage failures, including the 108A Wyndham Road culvert, the 122 Pinehaven Road culvert and the isolated Jocelyn Crescent road sumps, need practical attention. GTC must be required to manage runoff, sediment, slash and debris from recently harvested land. Most importantly, the Pinehaven hydrology and hydraulic model must be independently reviewed, recalibrated against the 2019, February 2026 and April 2026 flood observations, and rebuilt with a correct existing baseline before any reliance is placed on it for GTC's fast-track development, future streamworks, LIM information or planning decisions.

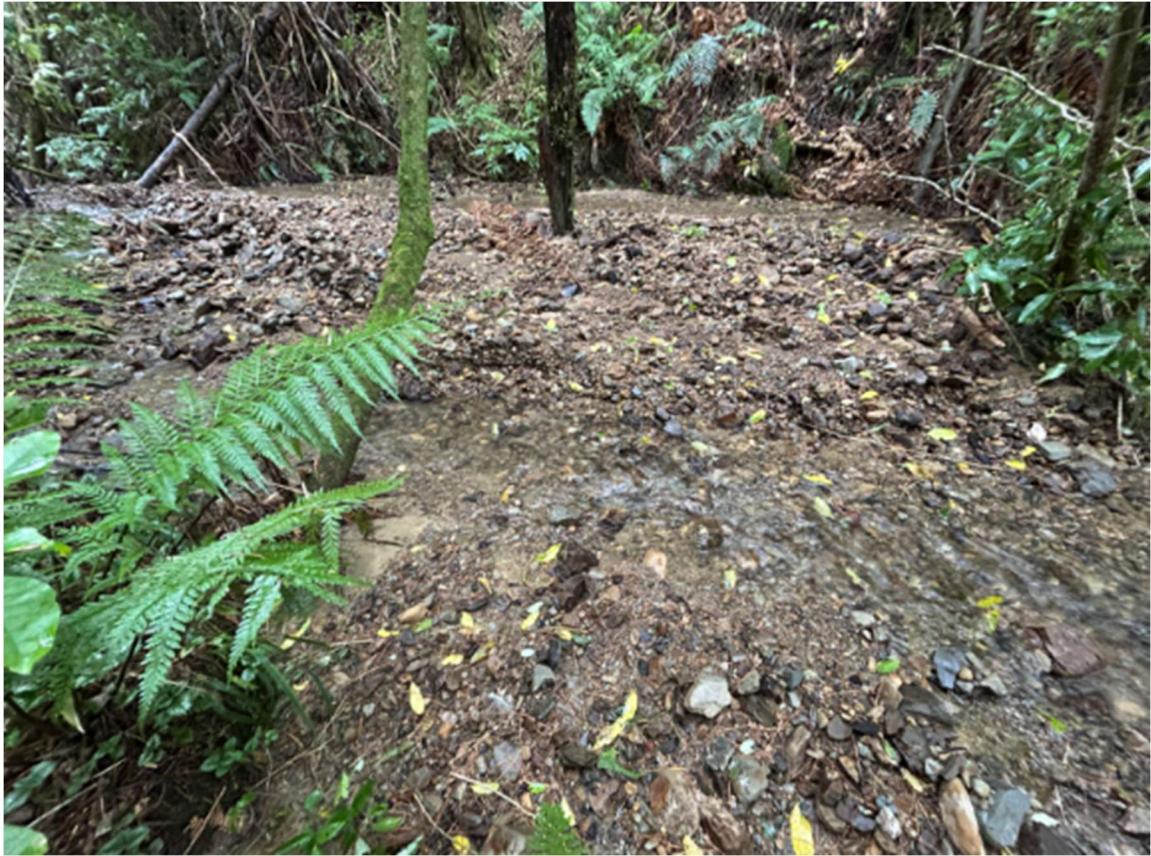
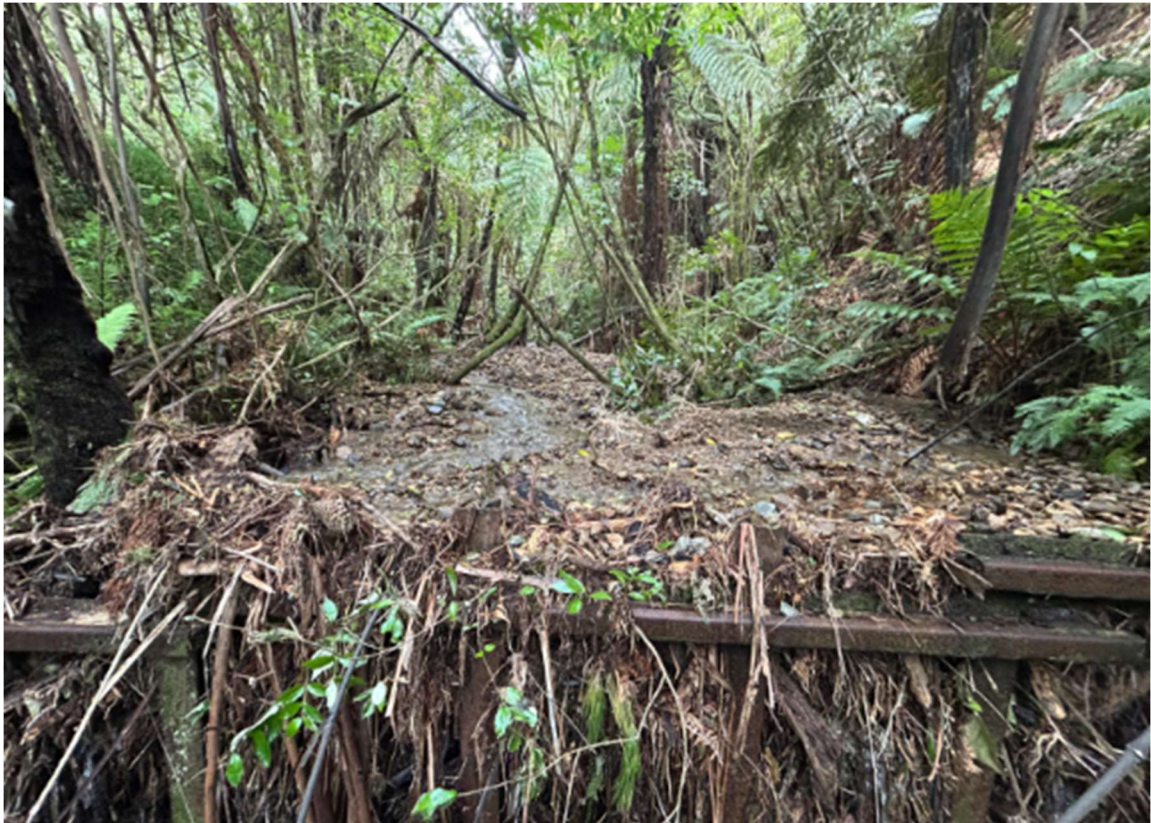
Figure 23 The debris dam - many tonnes of sediment, gravel, rocks and debris

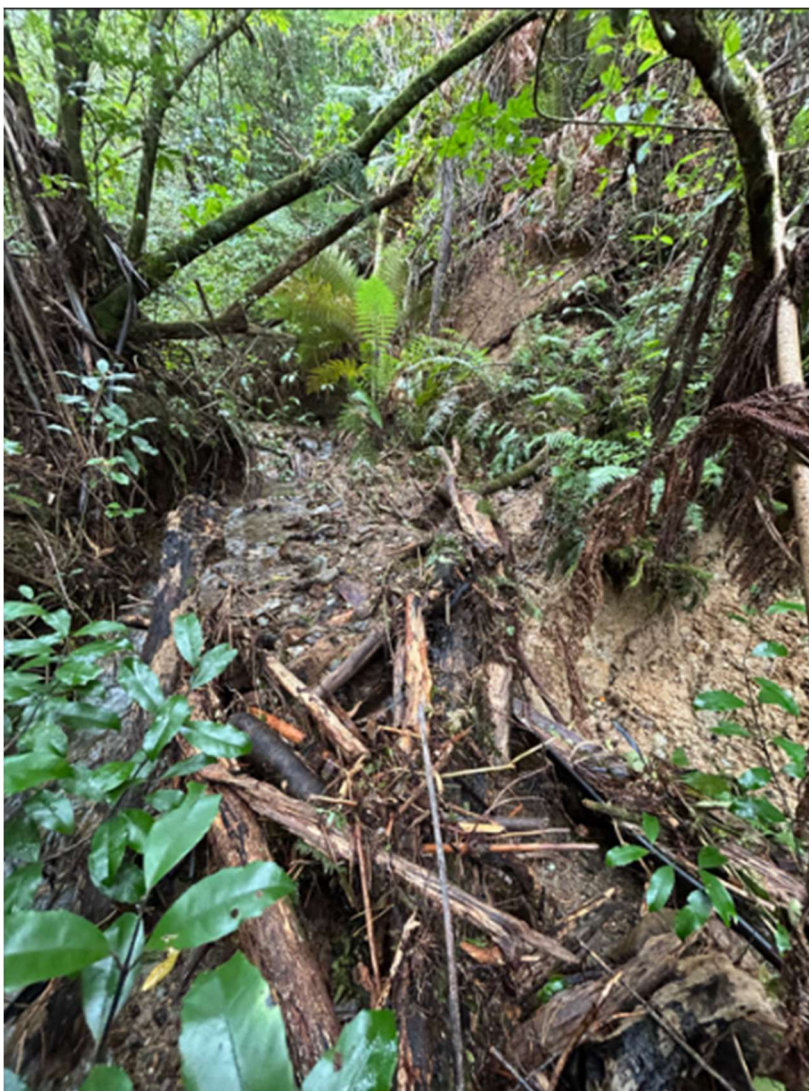
Figure 25 Stream bank erosion and debris

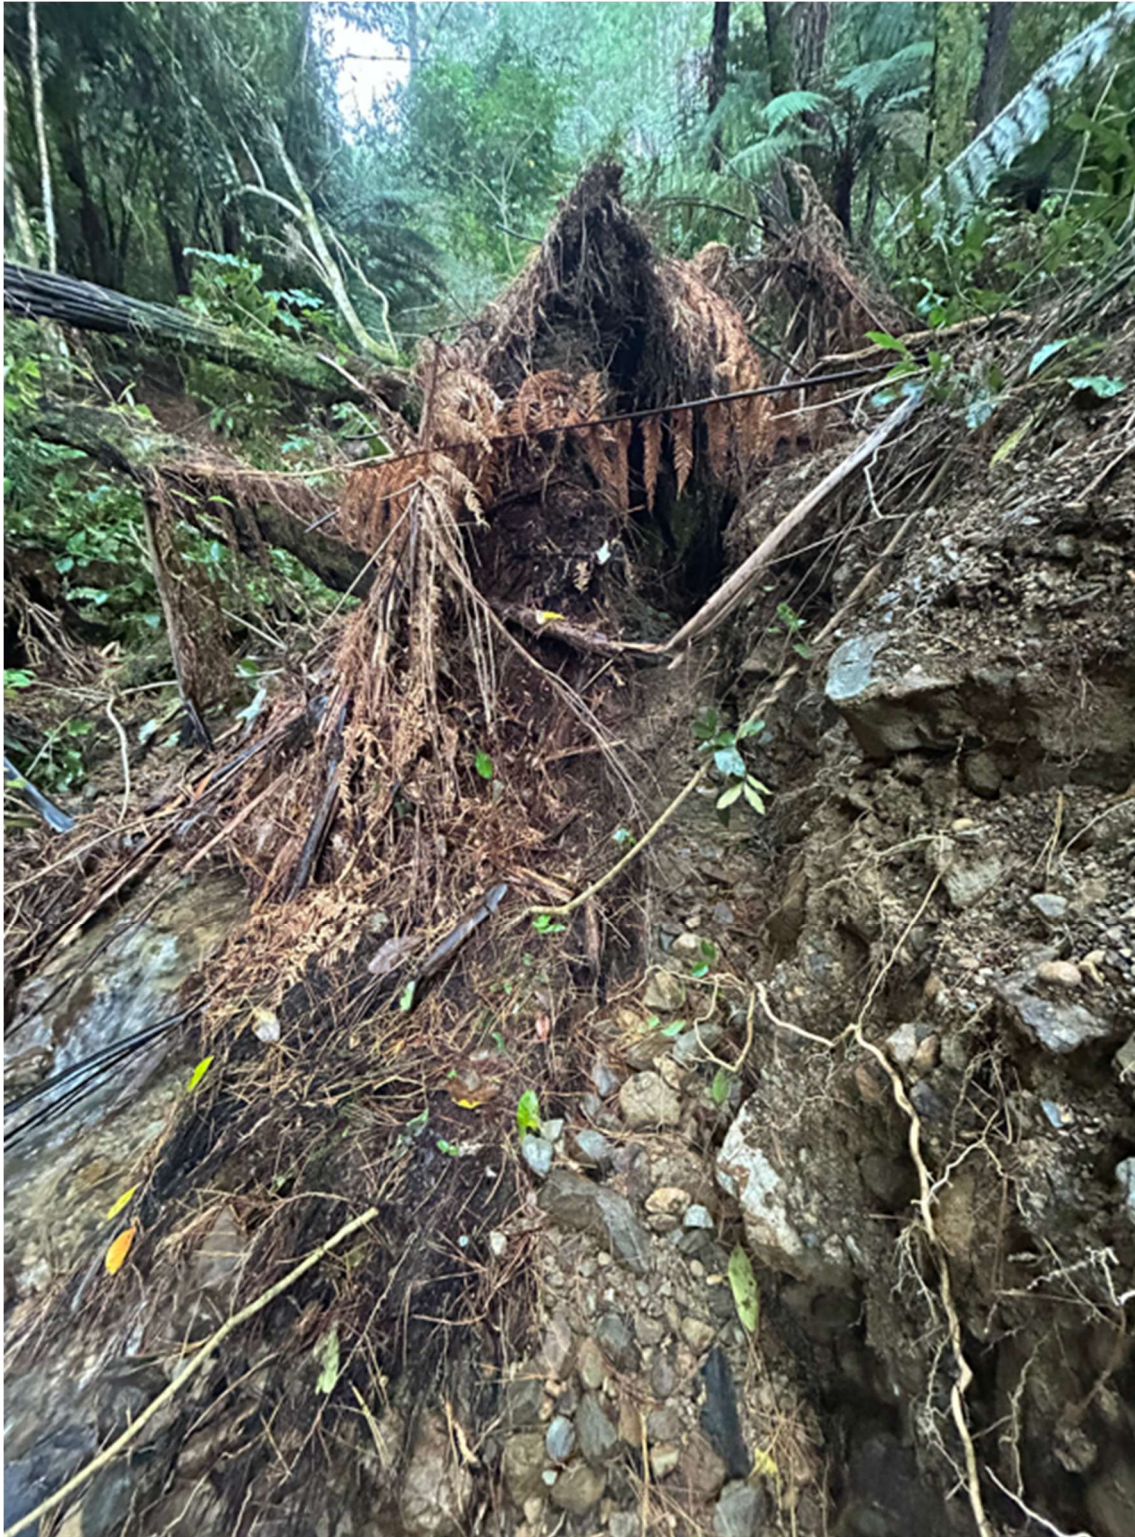
Figure 27 Another example of severe bank erosion

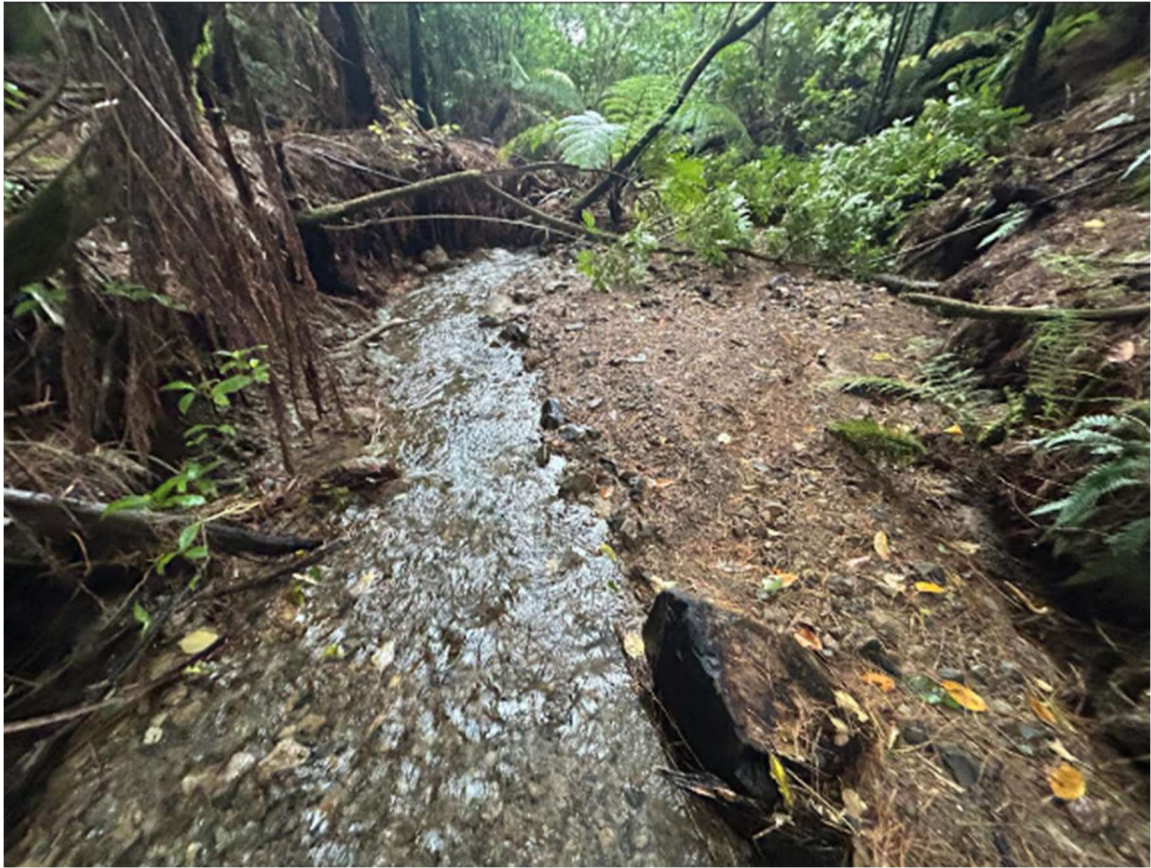
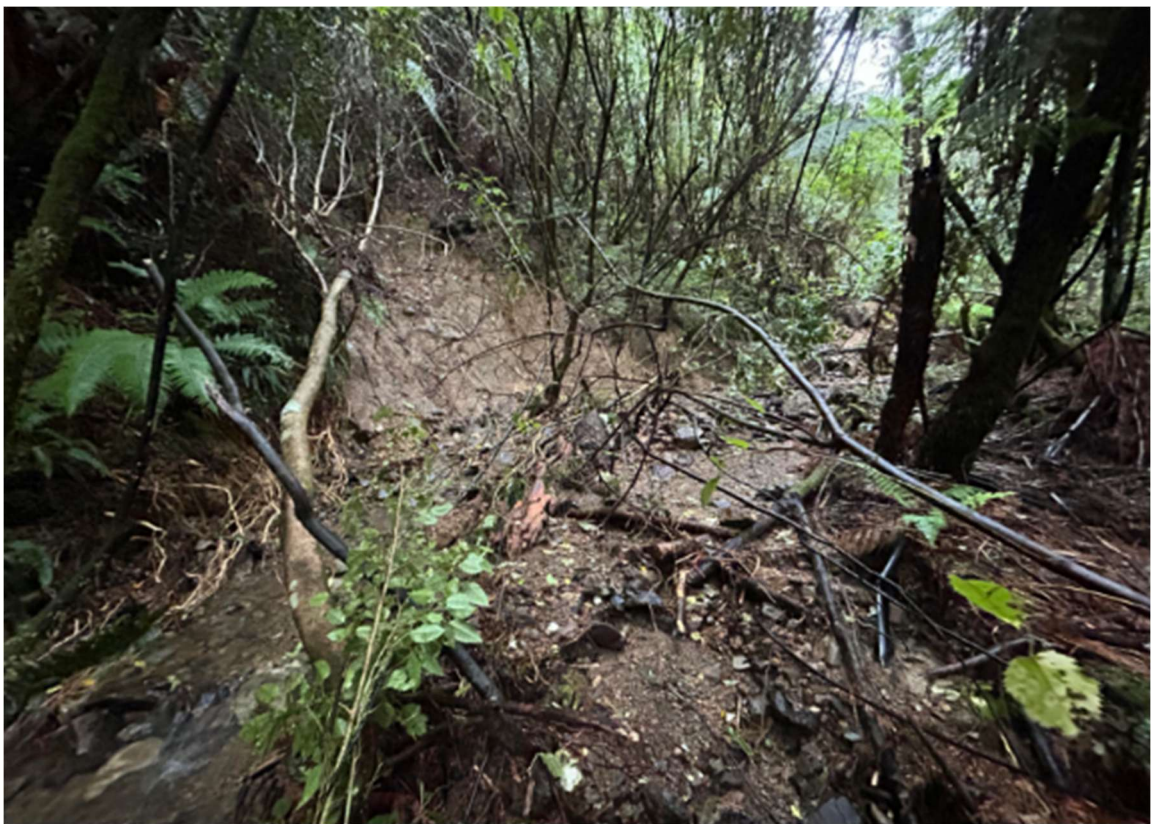
“the streambed had some changes higher up after 16 Feb, with gravel filling one of the deep holes and a few changes in the meandering - but we noticed after 18 April that much more change had occurred, especially in the lower reaches near our house - the streambed is higher and wider, corners have been carved off, lots of gravel and debris, trees are down and fallen into the stream. My concern is that this progressive loss of complexity in the streambed has turned it into a chute, delivering water and debris faster downhill into Pinehaven during high rainfall ... it's sad to see this happen to Pinehaven Stream.”

Figure 29 Much loose material in the stream bed, from scouring and erosion?

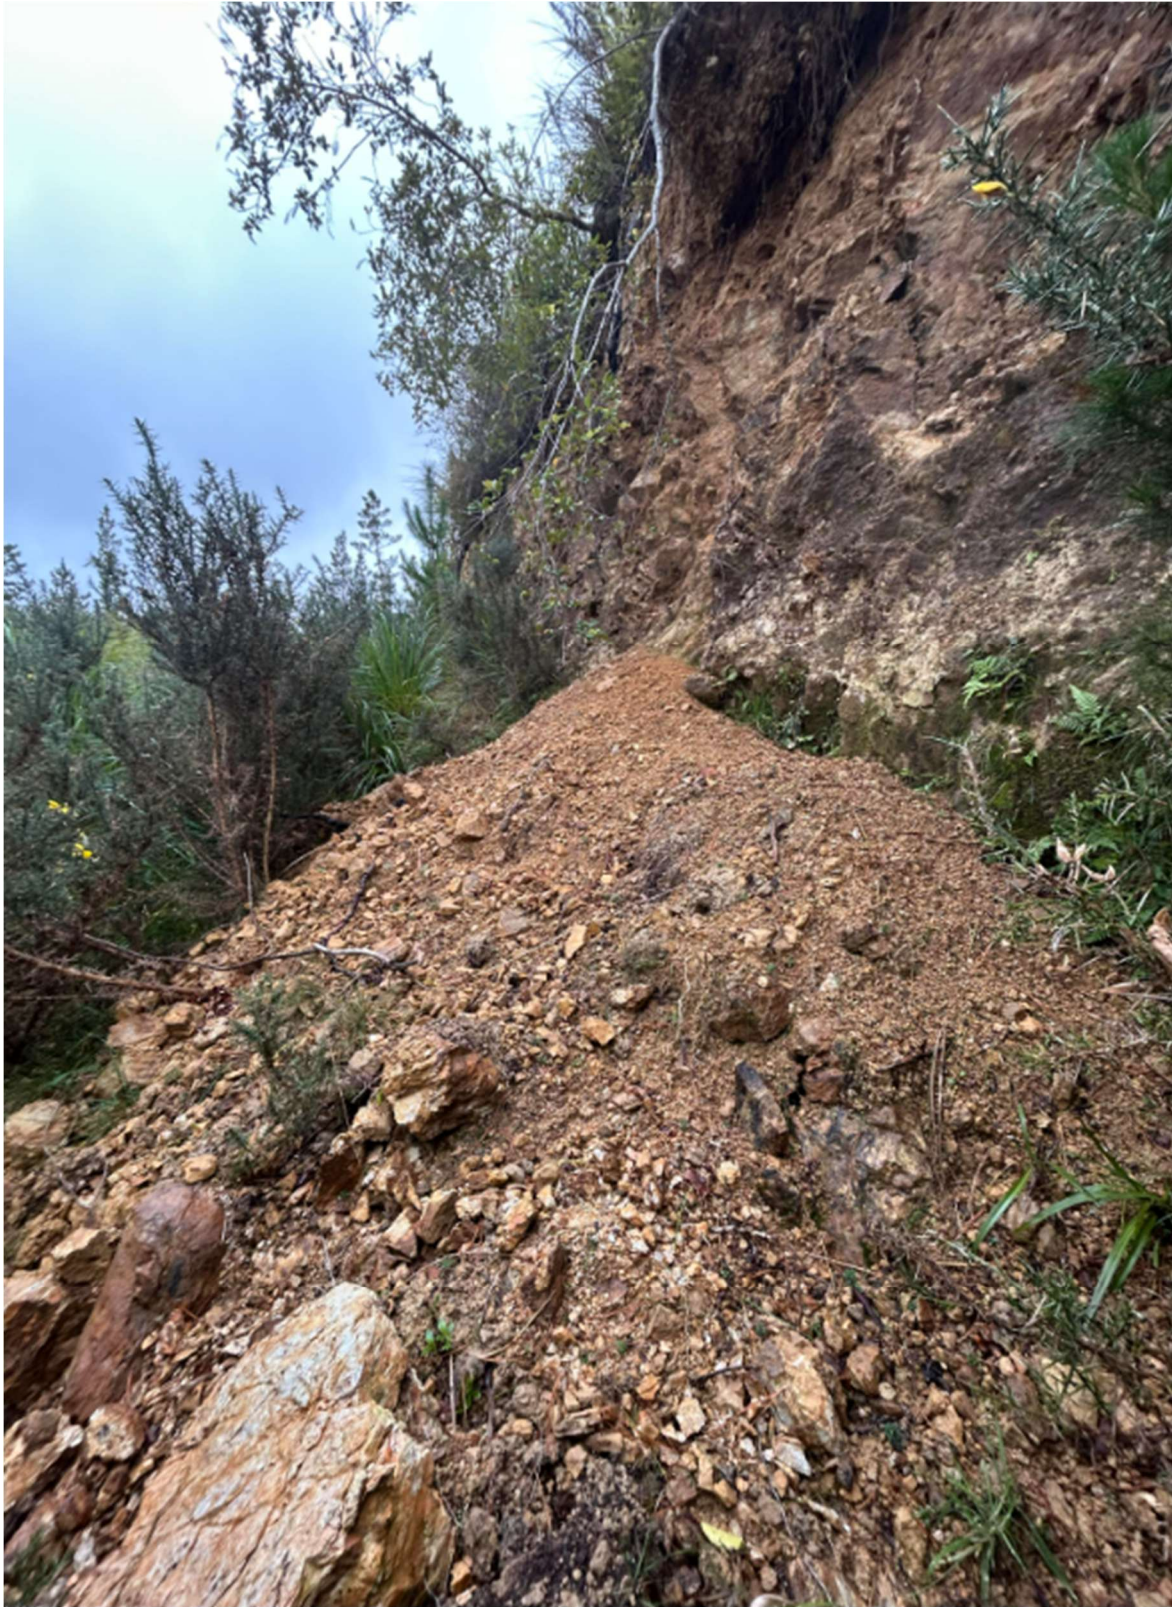
Figure 30 An example of eroded logging cuttings on the GTC hillside

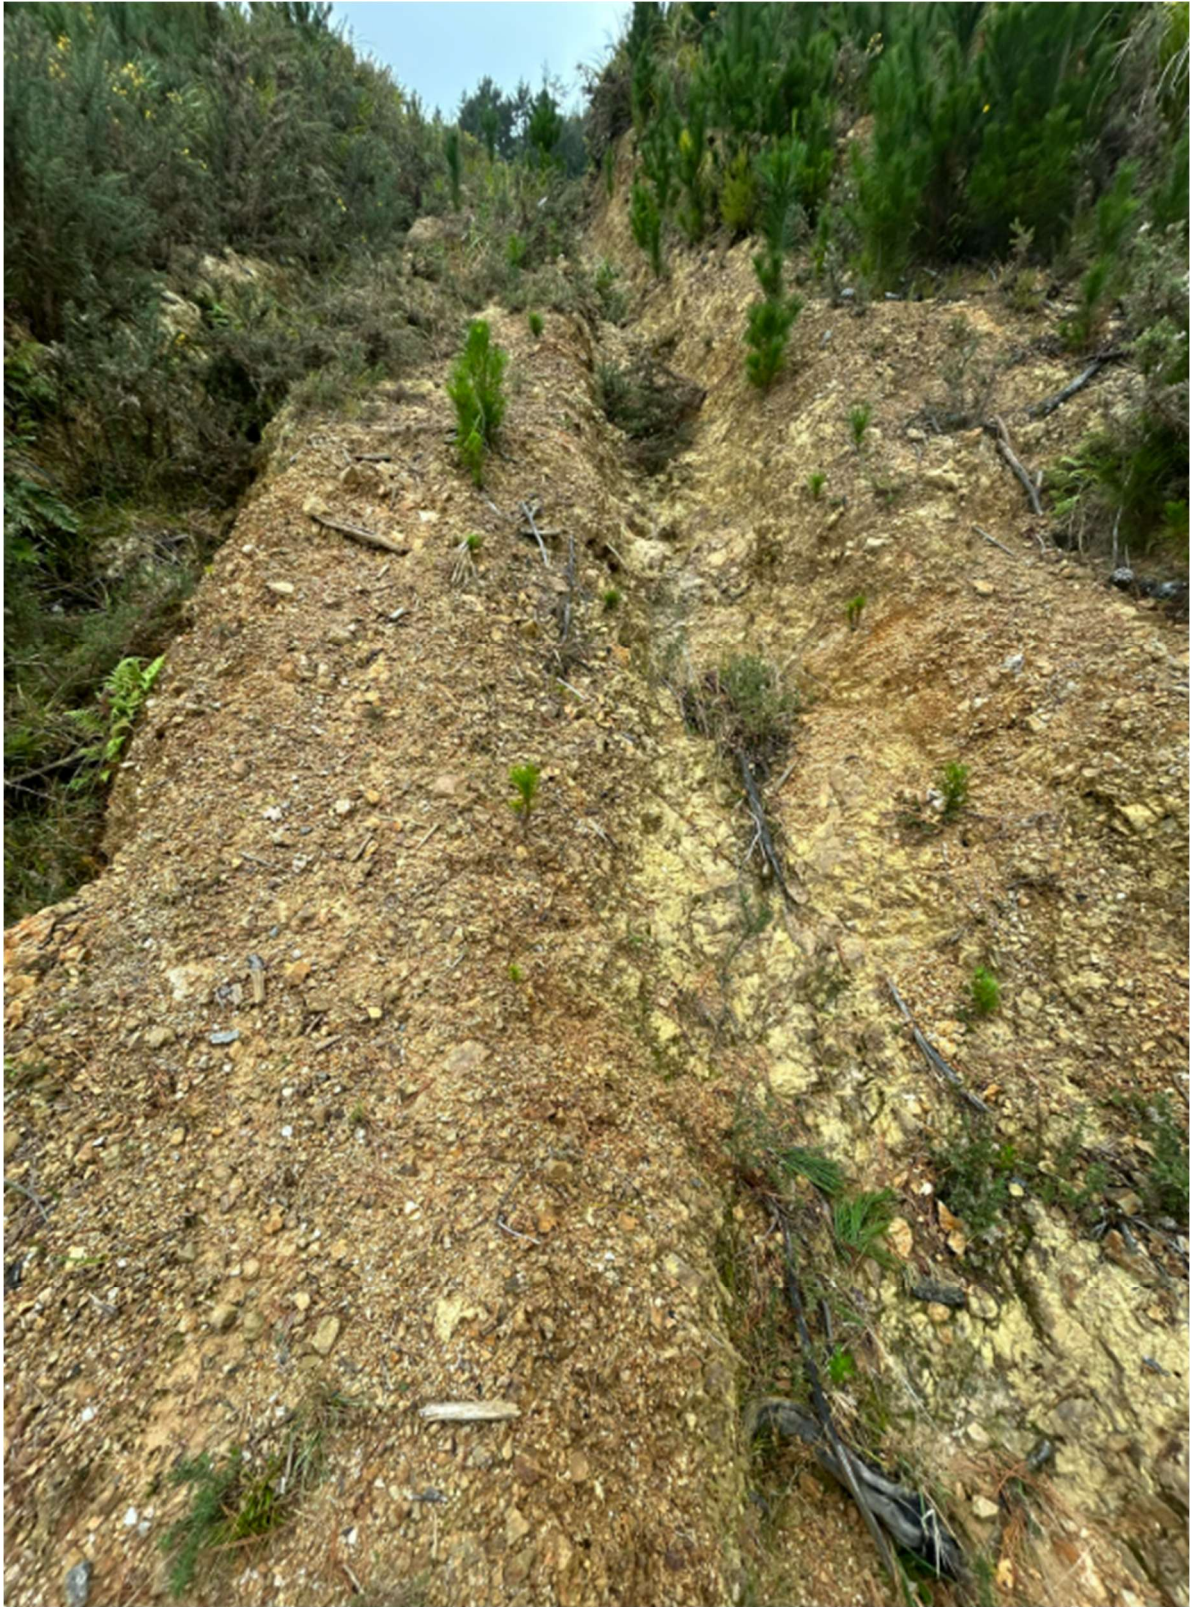
Figure 31 Water channels in old GTC logging tracks.

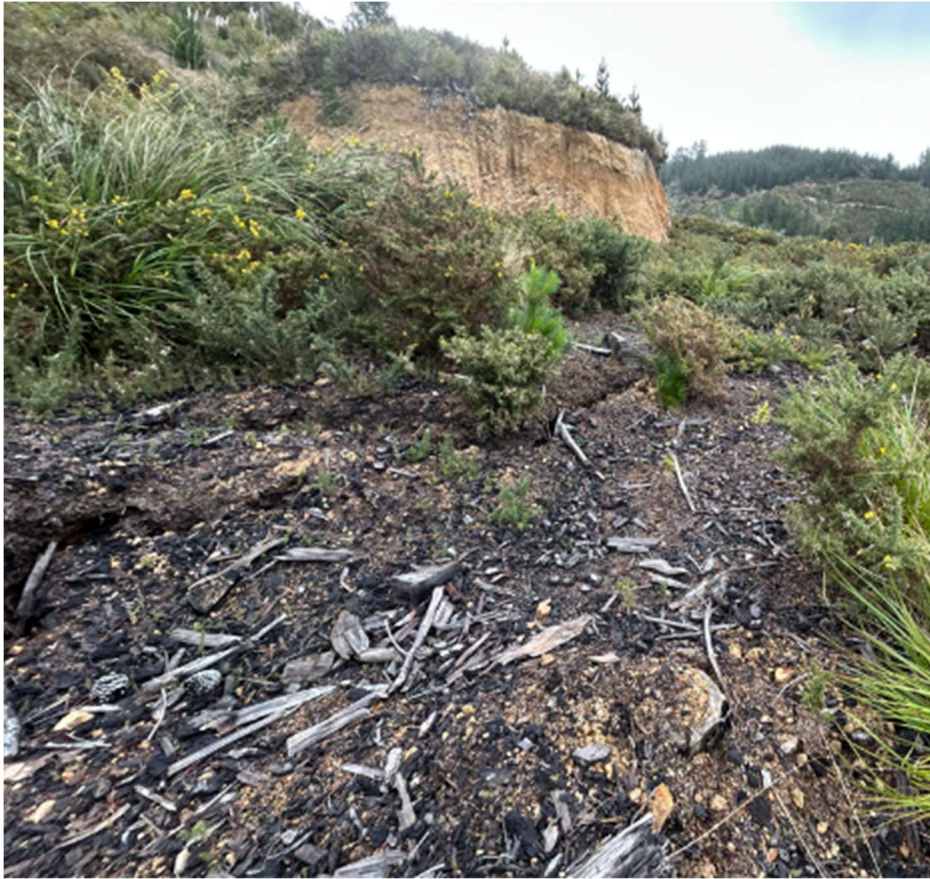
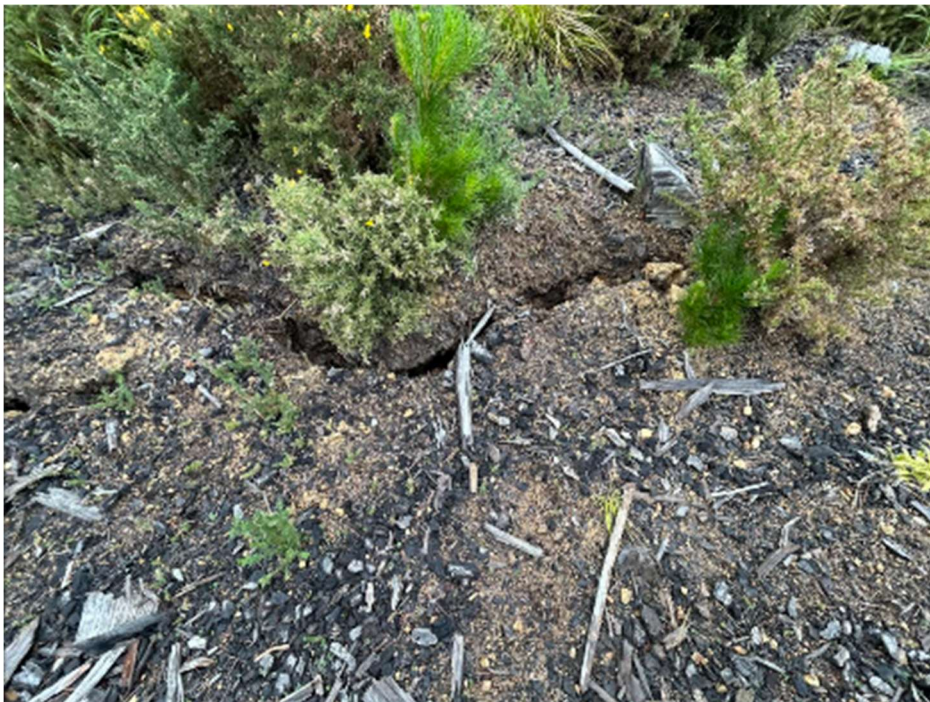
Figure 34 Cracks in GTC ground after forest clearance

Flooding Us NZ Ltd has concerns about what might happen during the next storm if heavy rain and runoff cause more erosion and scouring and there is no longer any effective debris trap capable of holding back the sediment, gravel and debris.

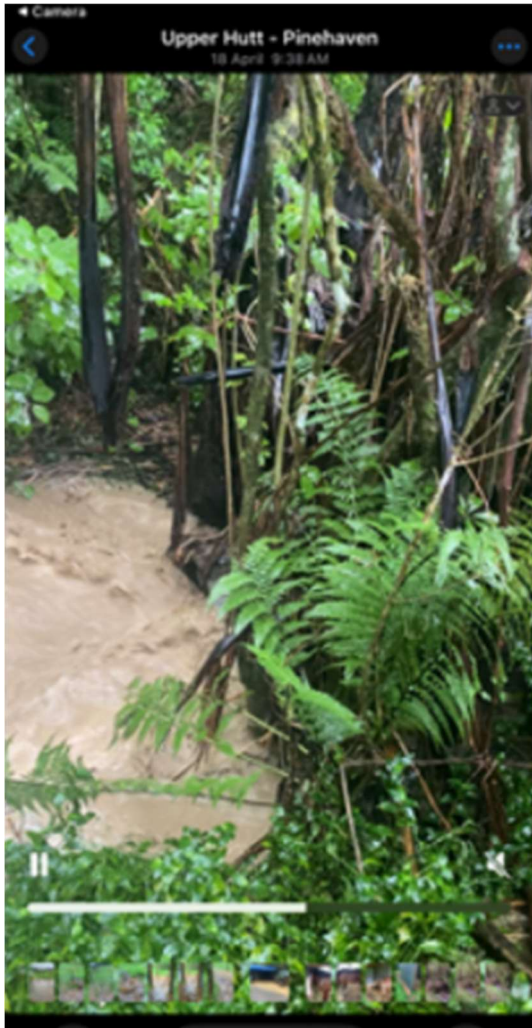
A big downpour will cause water to pour over the catcher and flow quicker into the pipe, likely carrying more gravel and debris with it. As the pipe at the top of our garden was at 100% capacity on 18 April, during the rainfall event that filled the debris trap, I believe this situation now equals significantly increased flooding risk at our house and downstream during future heavy rain events. [Comment by affected resident]

Figure 35 Drainpipe filled to capacity during the storm on 18 April 2026, 9.38am.

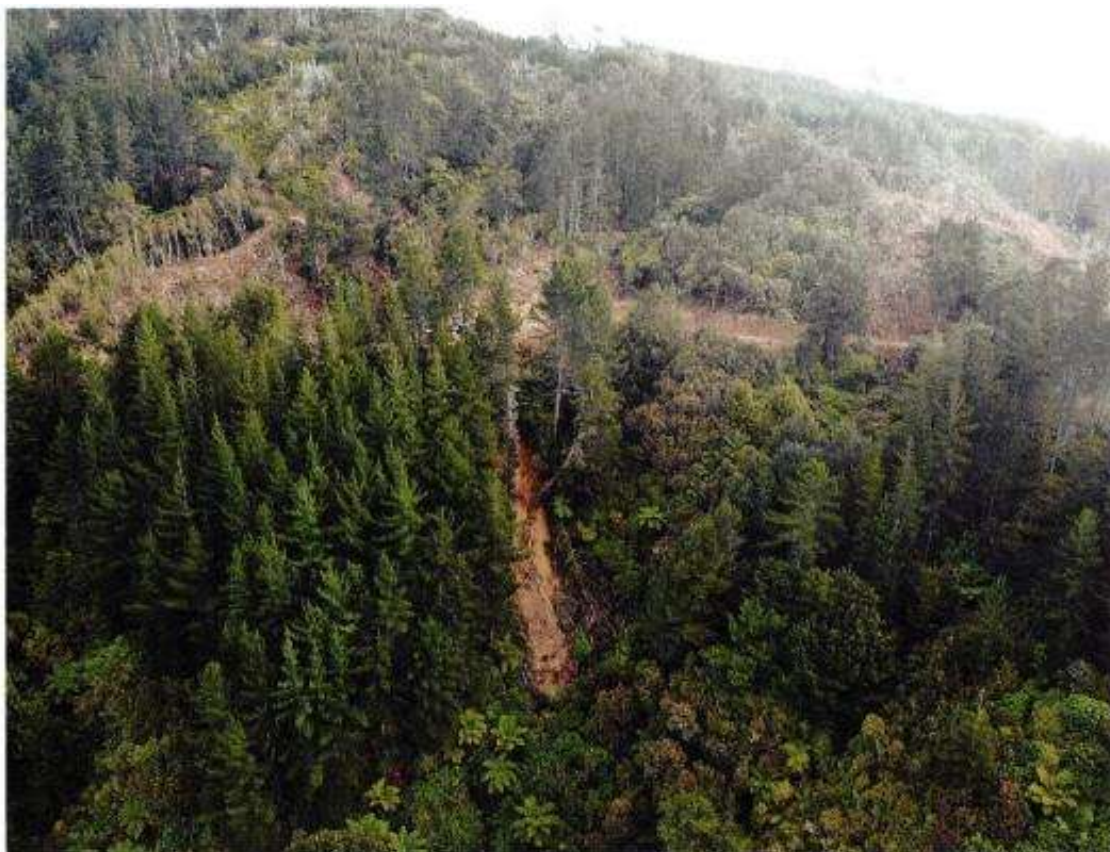
Figure 36 Slip on edge of forestry harvesting, 8 December 2019 (Photo: Janis Martins)

“A huge deluge of water ... carrying tons of silt and stones.... causing an immense amount of damage to our properties ... The drive was full of mud, stones and silt, well over nine inches deep in places ... I started to get quotes for its removal. ... We estimate 26 tons of earth ended up on our land and our neighbours from one event. In total we paid just under \$4000 to deal with this event.... My partner and neighbour trekked back up the hill, tracking up the stream to the ridge, and remain convinced after viewing the slip that it originated at the top, by the logging area.” Owner at 136A Pinehaven Road

Local and central government must implement enforceable rules to ensure runoff, sediment, slash and debris from forestry activity on GTC land are properly managed, so downstream communities are protected. This is not optional. It is essential to prevent property damage from forestry activity like in the 1976 flood.
