Warning Signs from the Hills

Forestry Runoff, Debris and Flood- Modelling Risk in Pinehaven and Silverstream

Report on the 18 April 2026 Storm

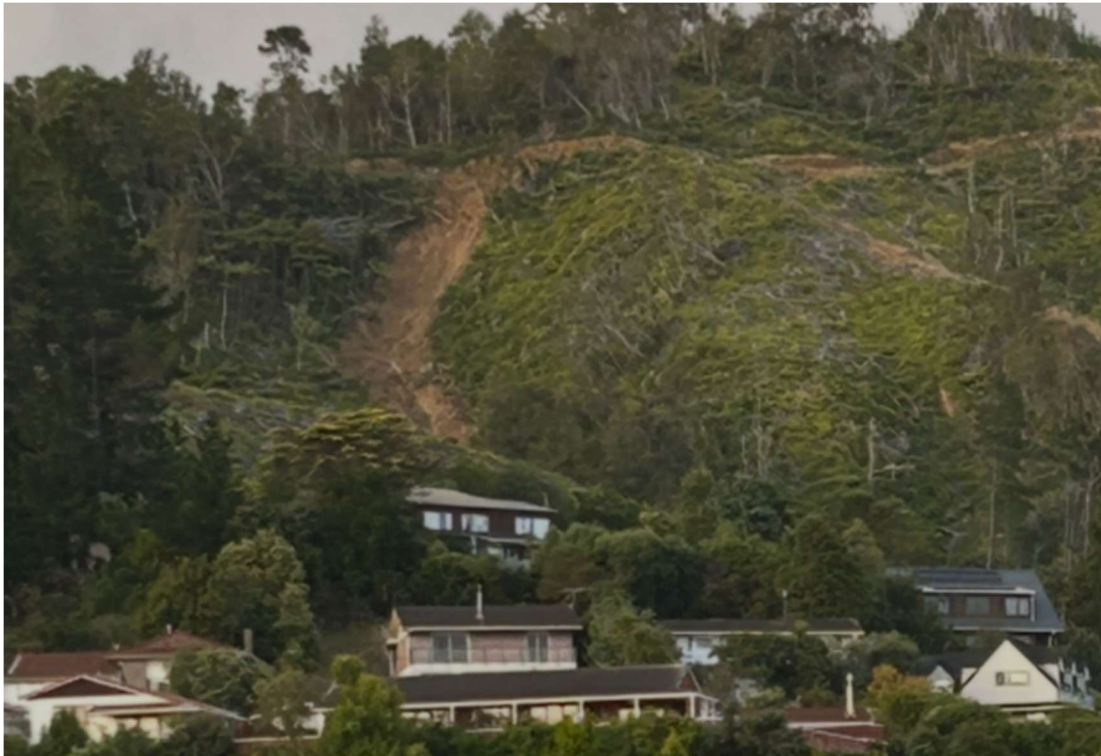
Figure 38 Landslide on harvested hillside, 16 February 2026. Photo: Flooding Us NZ Ltd

Independent flood expert Bob Hall has warned that increased runoff in steep catchments can cause stream-bed scour, bank erosion, increased sediment loading, aggradation of stream beds and blocking of culvert entries. The February 2026 Silverstream landslide is an example of exactly the kind of hillside instability and downstream stormwater risk that Bob Hall and residents have been warning about.

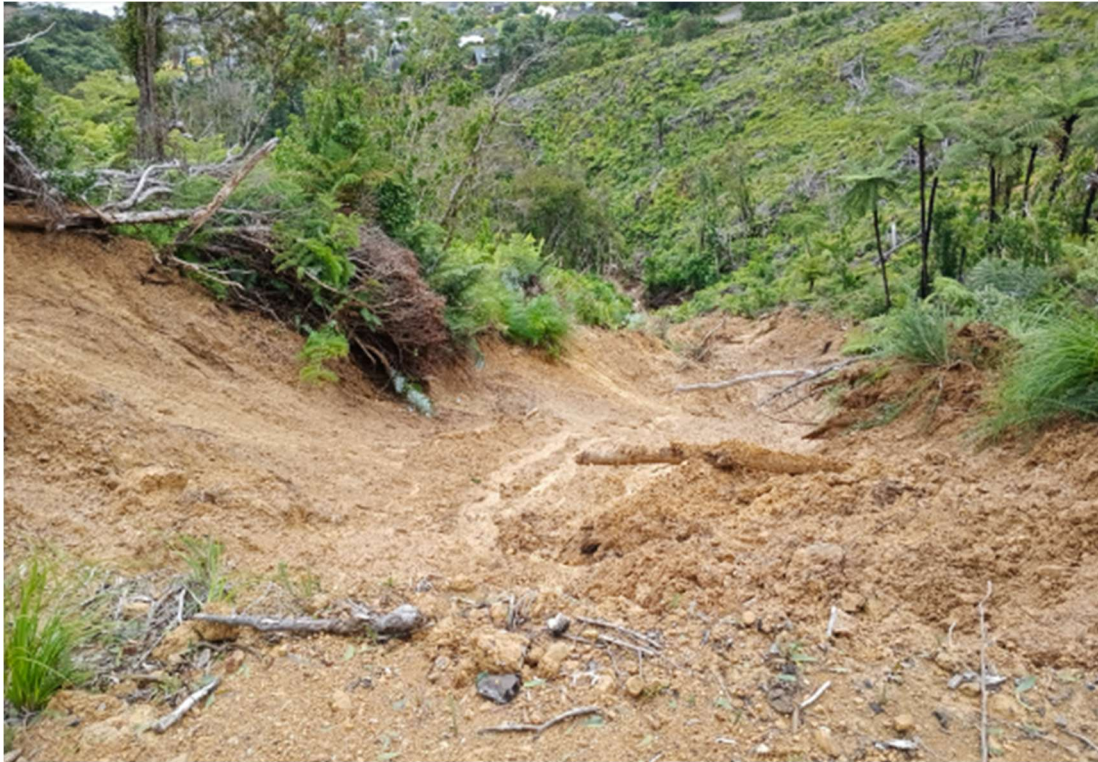
Figure 41 Landslide on steep GTC hills above housing in Silverstream (Photo: Dennis Clark)

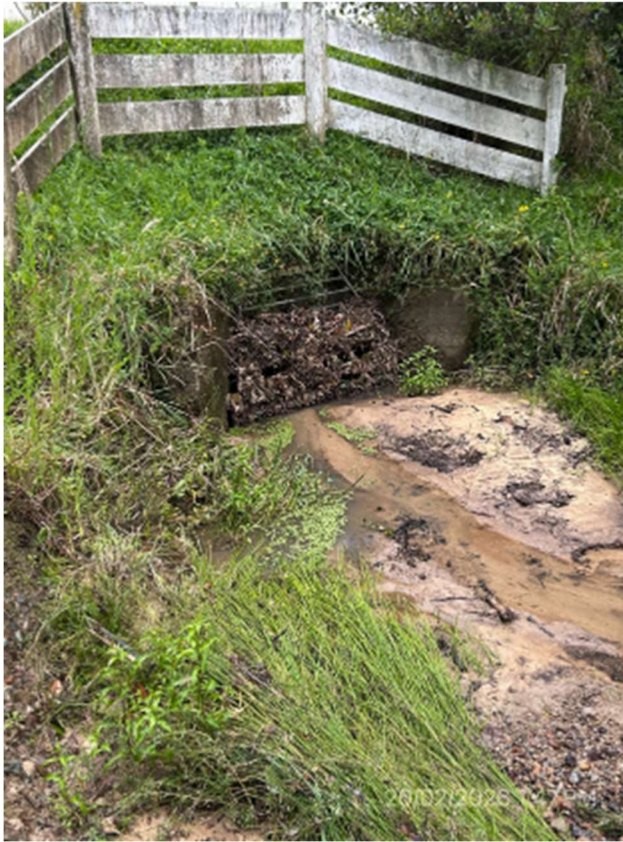
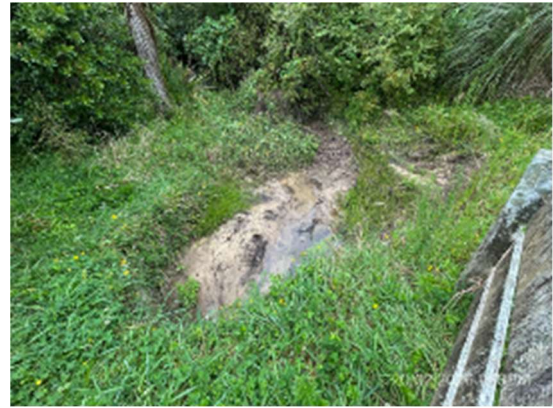
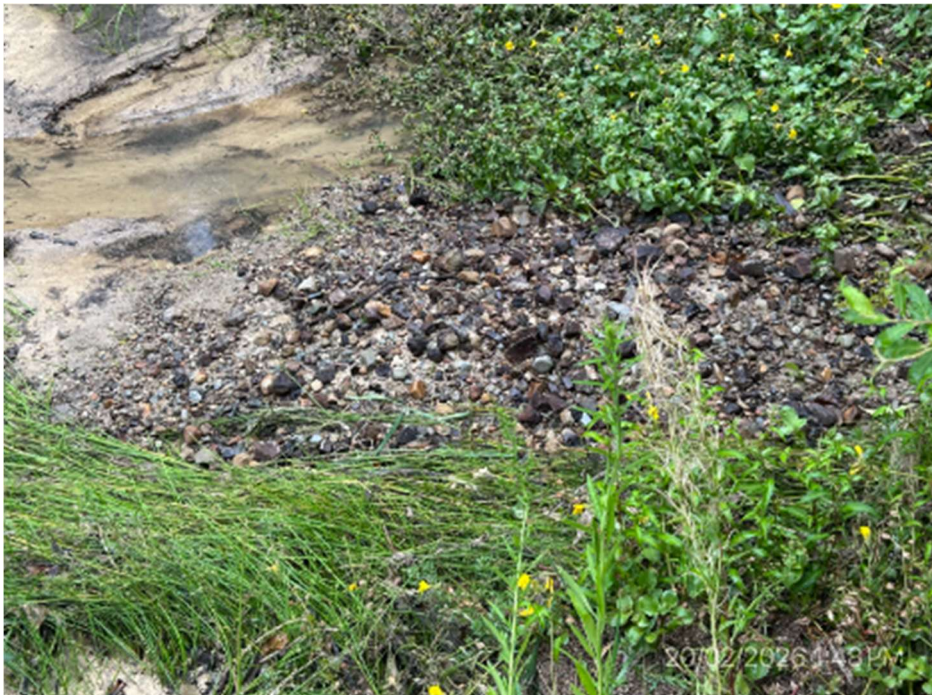
There is evidence of gravel, sediment and debris reaching the stormwater intake (Figure 43) below that gully in a reserve between Pioneer Grove and Sorrento Way. That matters because this is the same hazard pathway: hillside disturbance and erosion above residential areas, followed by material moving down gullies and into public stormwater infrastructure.

Figure 43 Pioneer Grove culvert, 20 Feb 2026, after storm 16 Feb 2026. Photos: Flooding Us NZ Ltd

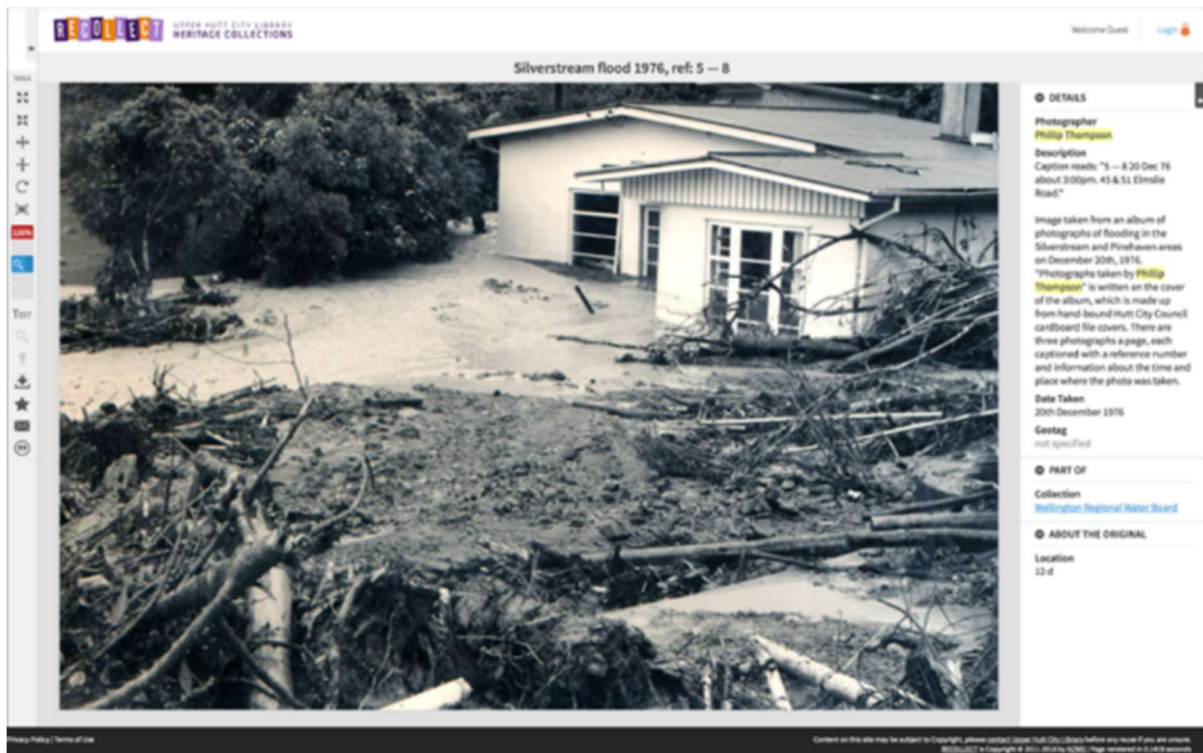
That risk is not new or unforeseeable. During the extreme December 1976 storm, flooding and property damage in Pinehaven and Silverstream were reportedly exacerbated by slash and debris from recent GTC forestry harvesting on the hills above the community. A slash/debris dam burst during that event, releasing water, mud, timber and debris downstream. Some houses were partly buried. There were also many landslides, some of which caused severe property damage. Historic UHCC photographs from the 1976 flood show houses affected by mud, timber and forestry debris following GTC forest harvesting (Figure 47 and Figure 48).

Figure 47 UHCC Library Archives: Phillip Thompson Photos – 20 December 1976 flood following GTC forest harvesting

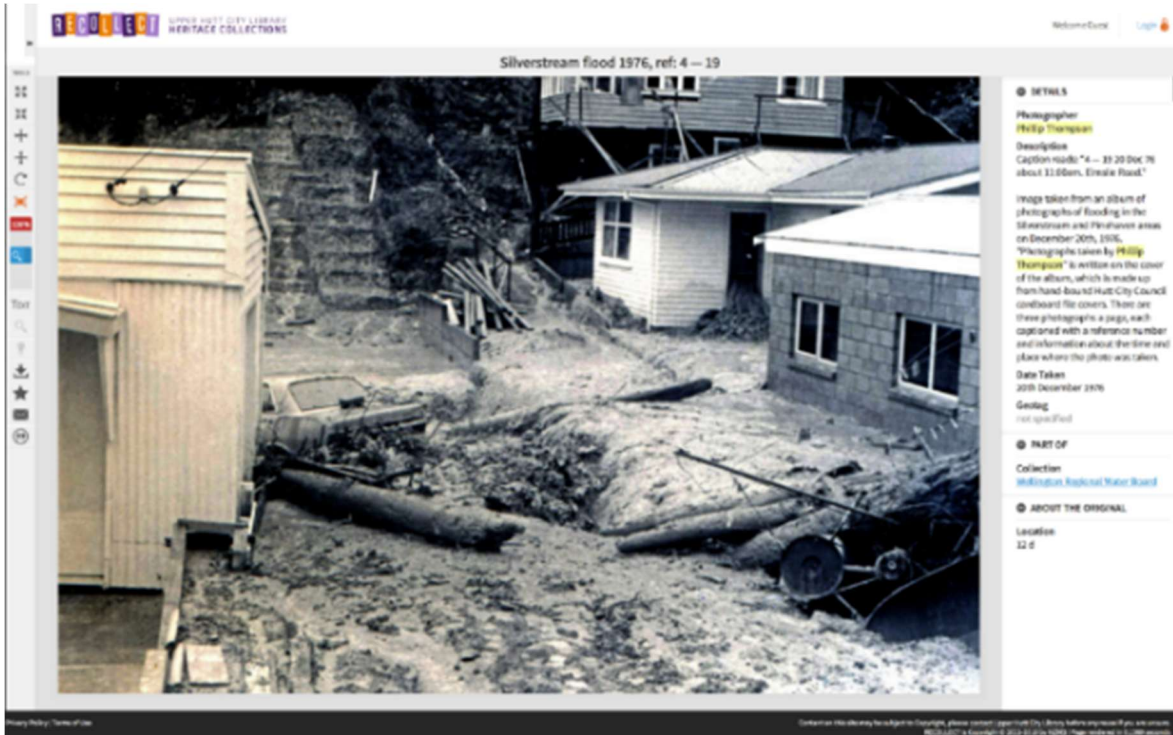
Figure 48 UHCC Library Archives: Phillip Thompson Photos – 20 December 1976 flood following GTC forest harvesting

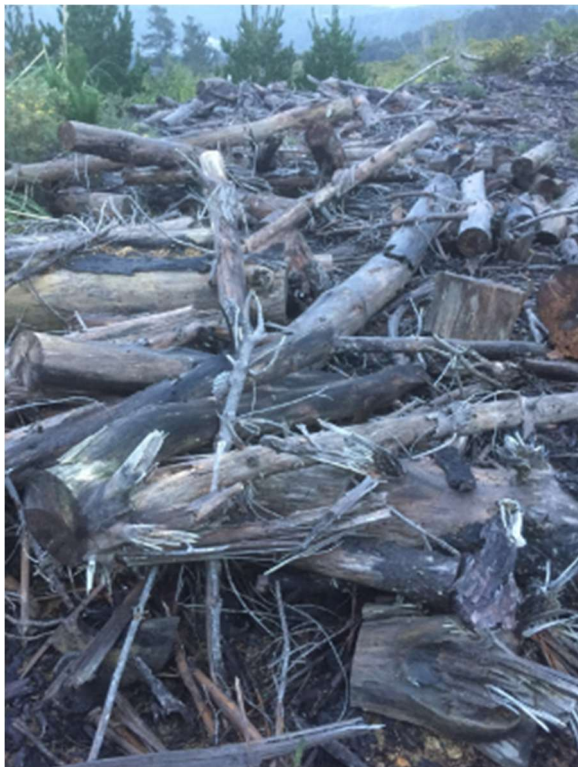
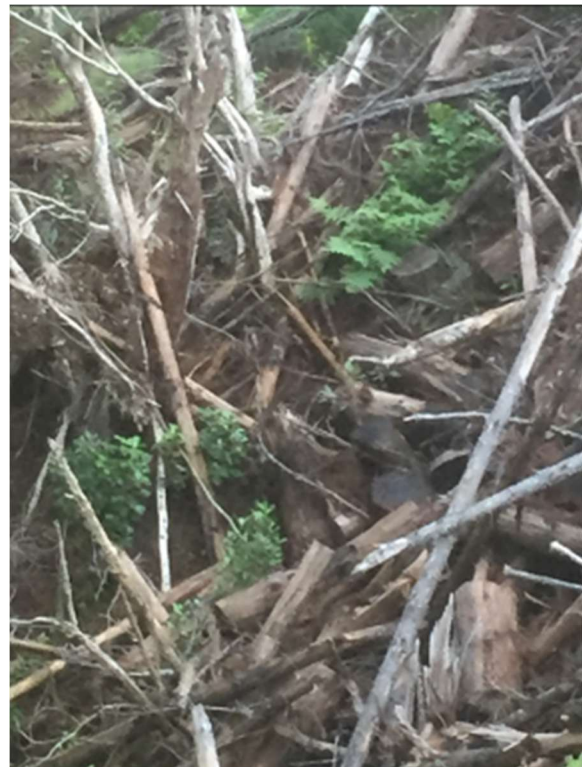
Figure 50 GTC logging offcuts and slash (2021) - this kind of debris contributed to the debris-dam that burst in the 1976 event and half-buried some houses

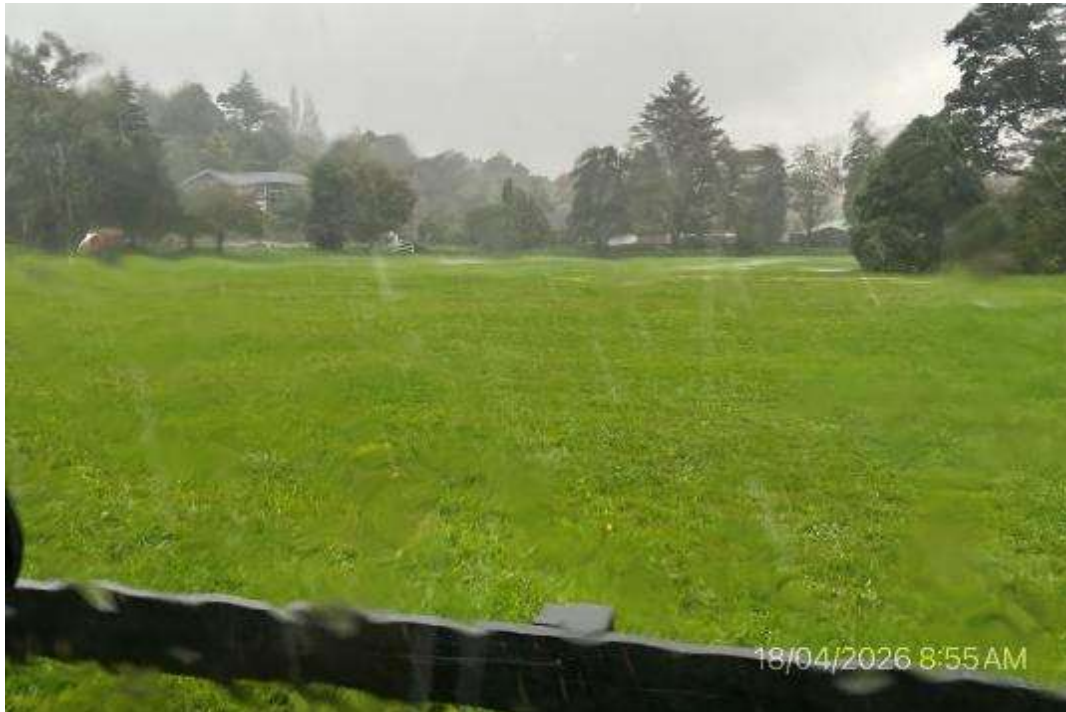
The official 1-in-10-year flood map shows Pinehaven Reserve totally flooded. Photographs taken near the peak of the 18 April flood show that the mapped flooding did not occur. The reserve was wet, and the stream swelled, but the mapped flood extent did not happen.

Figure 52 Pinehaven Reserve looking north 18 April 2026 at 8:55am - not flooded

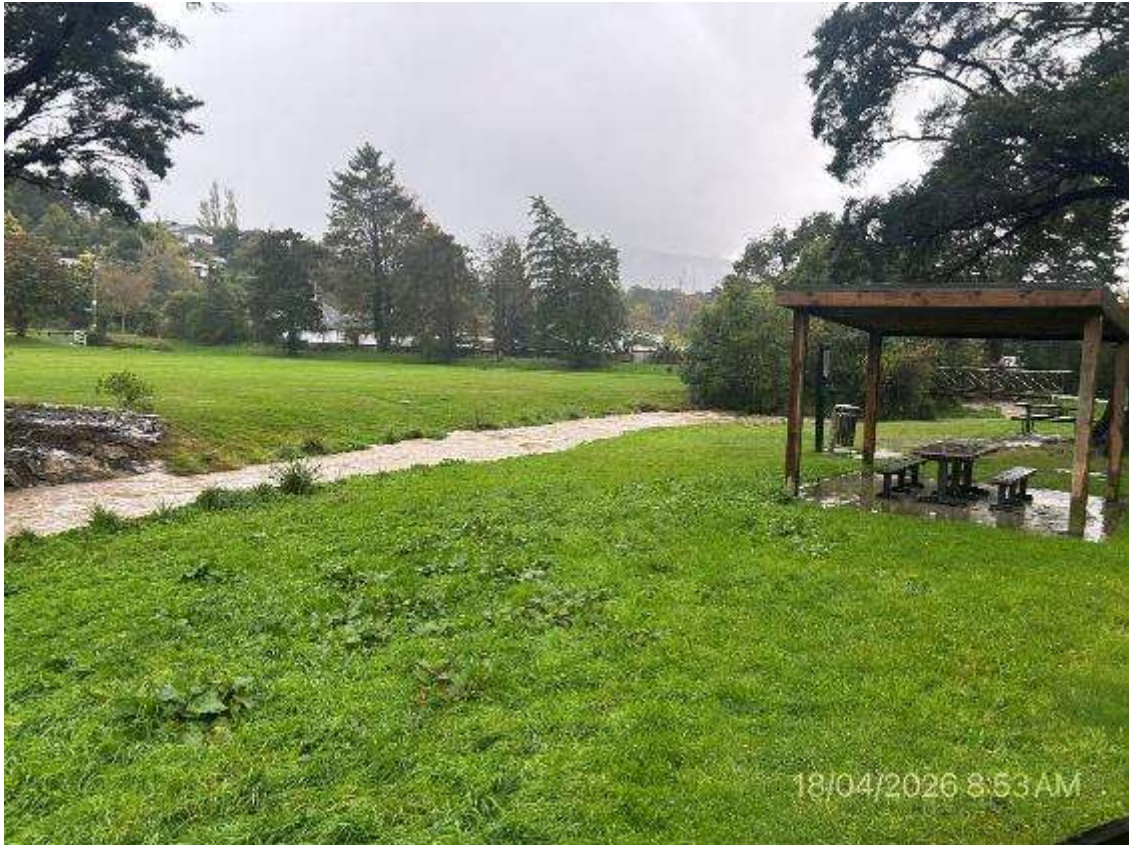
Figure 54 Pinehaven Reserve picnic area 18 April 2026 at 8:55am - not flooded

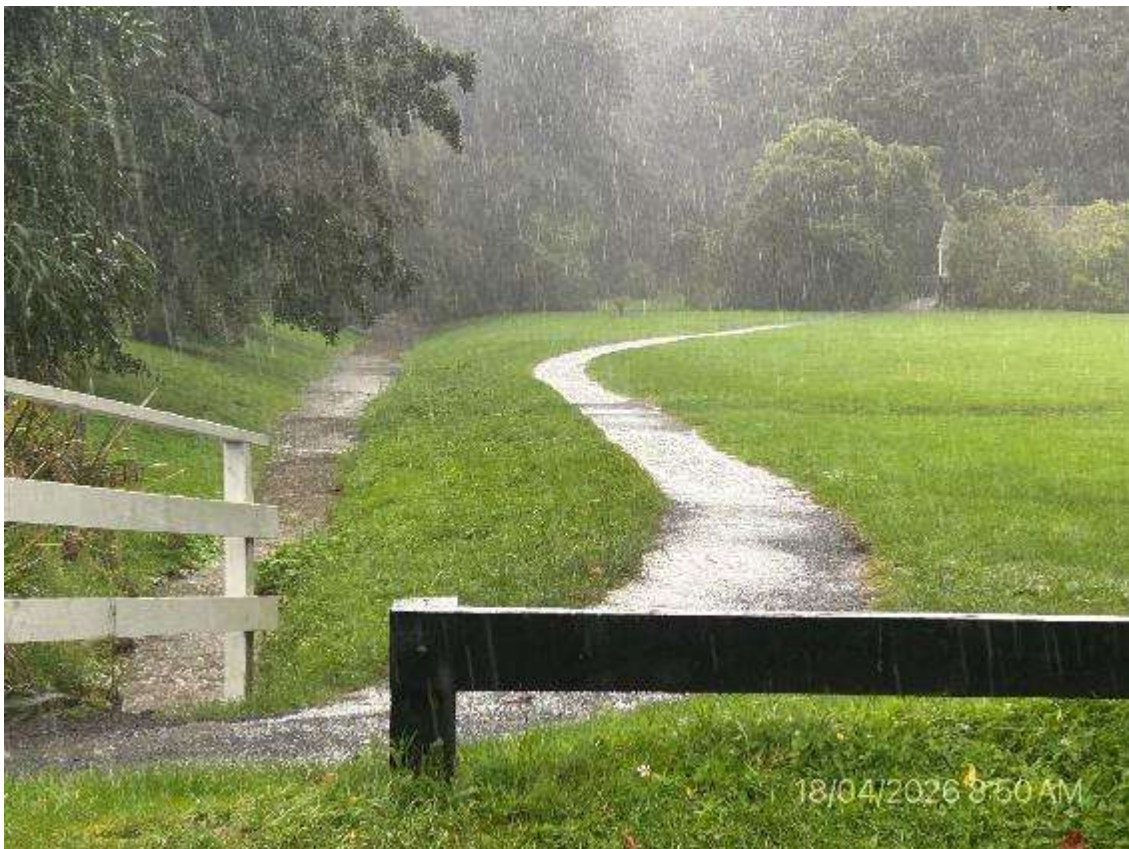
Figure 55 Pinehaven Reserve 18 April 2026 at 08:50am - north end not flooded

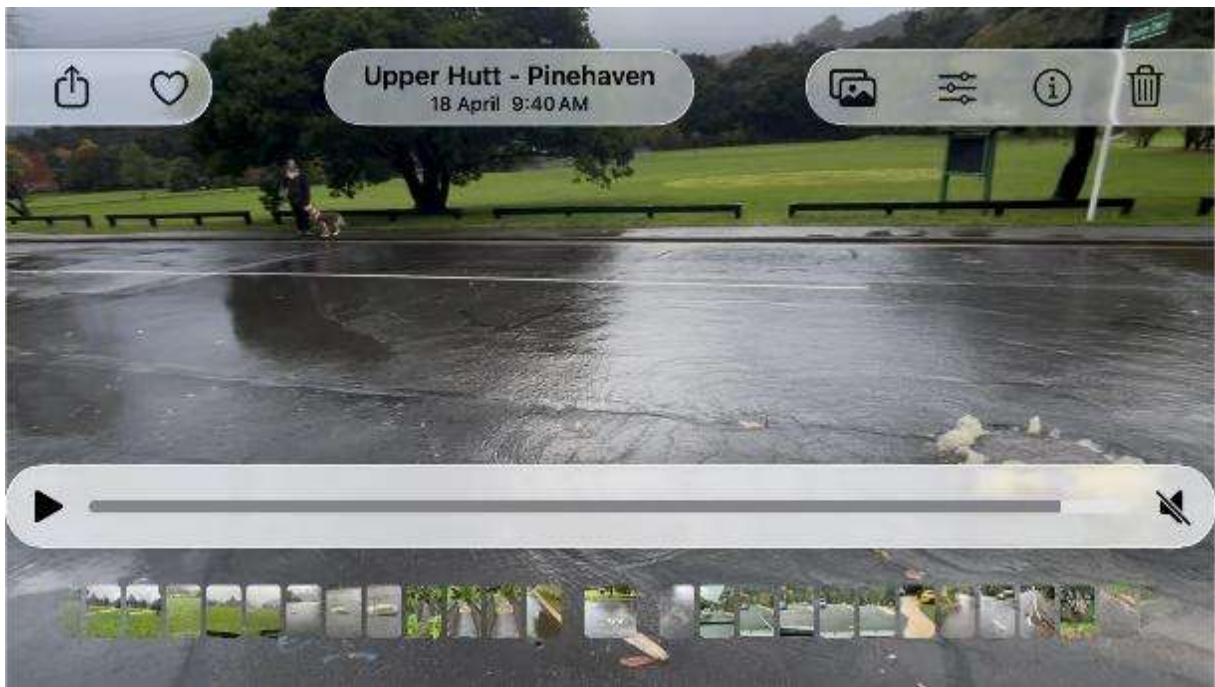
Figure 57 Pinehaven Reserve from Jocelyn Cres., 18 April 2026 at 9:40am – Reserve not flooded

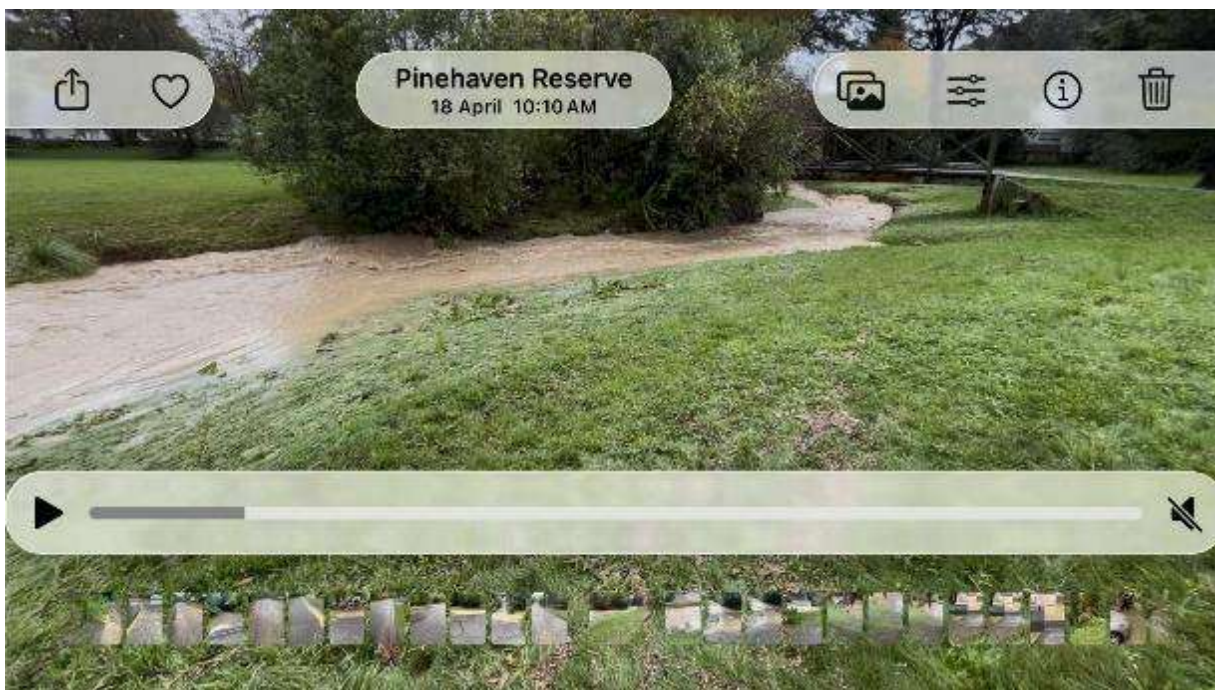
Figure 58 Pinehaven Reserve, 18 April 2026 at 10:10am - water receding

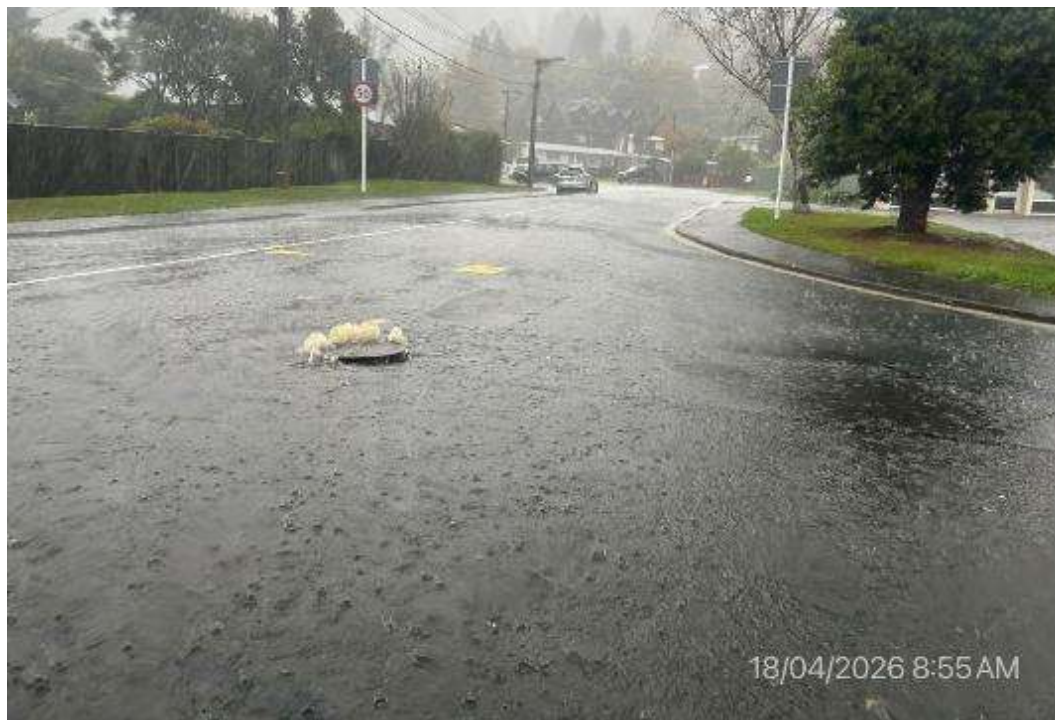
Figure 60 Pinehaven Road and Jocelyn Crescent (north end by Library) wet, but not flooded as shown on GWRC’s 1-in-10-year flood map

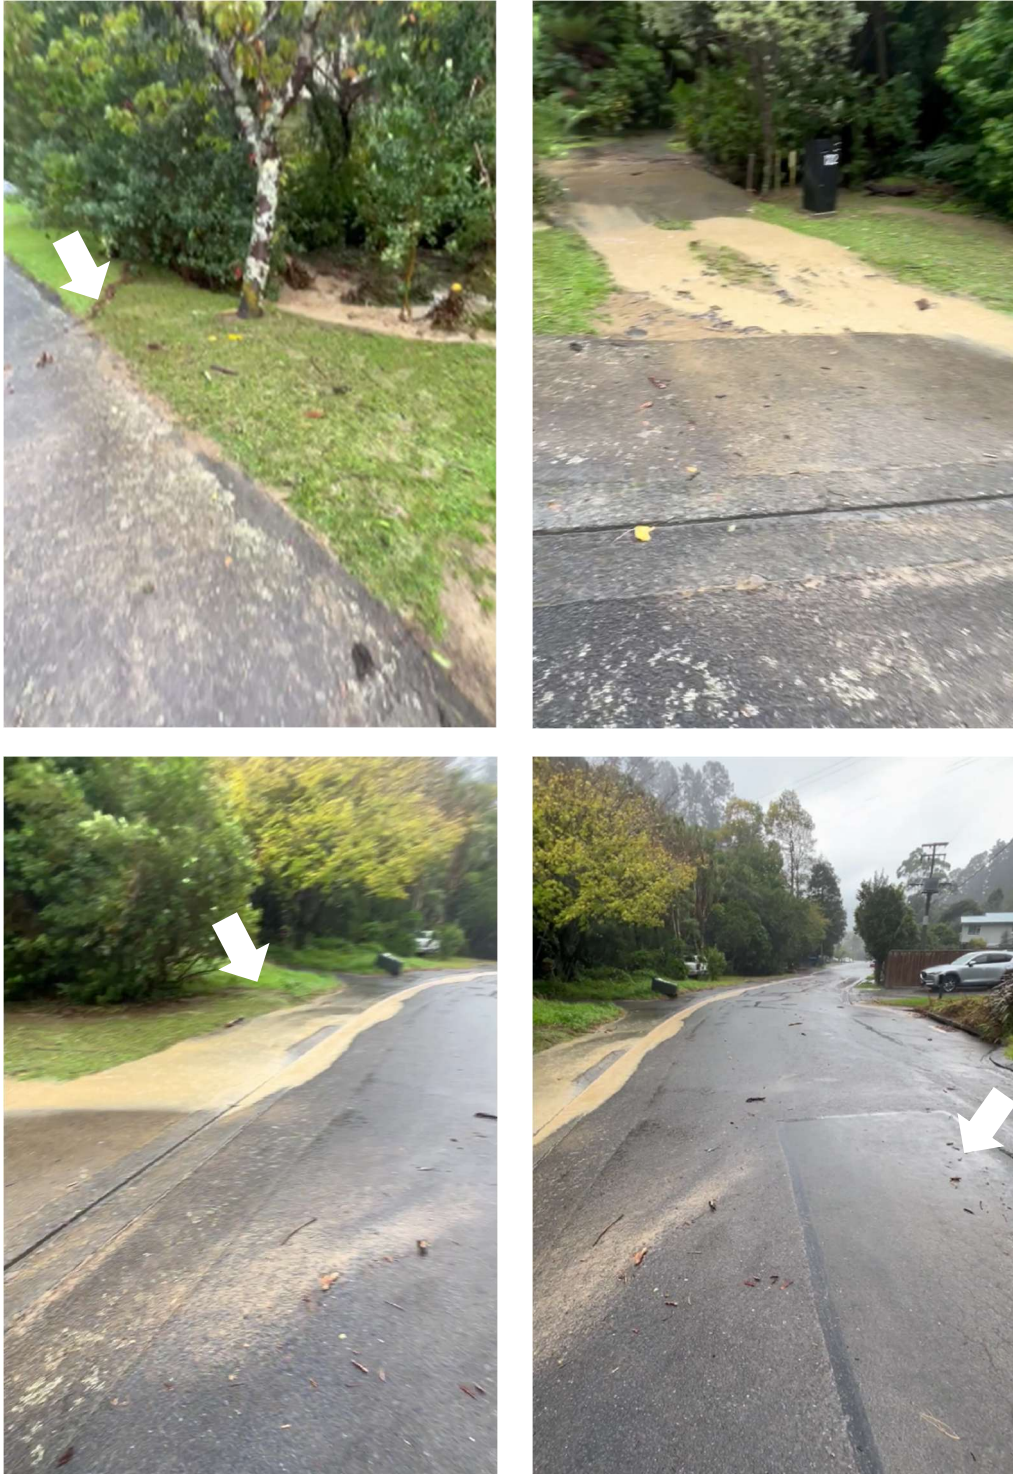
An overtopped driveway culvert at 122 Pinehaven Road caused flooding down the full width of the carriageway to the low point of Pinehaven Road by the Pinehaven School netball courts.

Figure 64 18-4-26 10:01am Debris from overtopped culvert 122 Pinehaven Rd

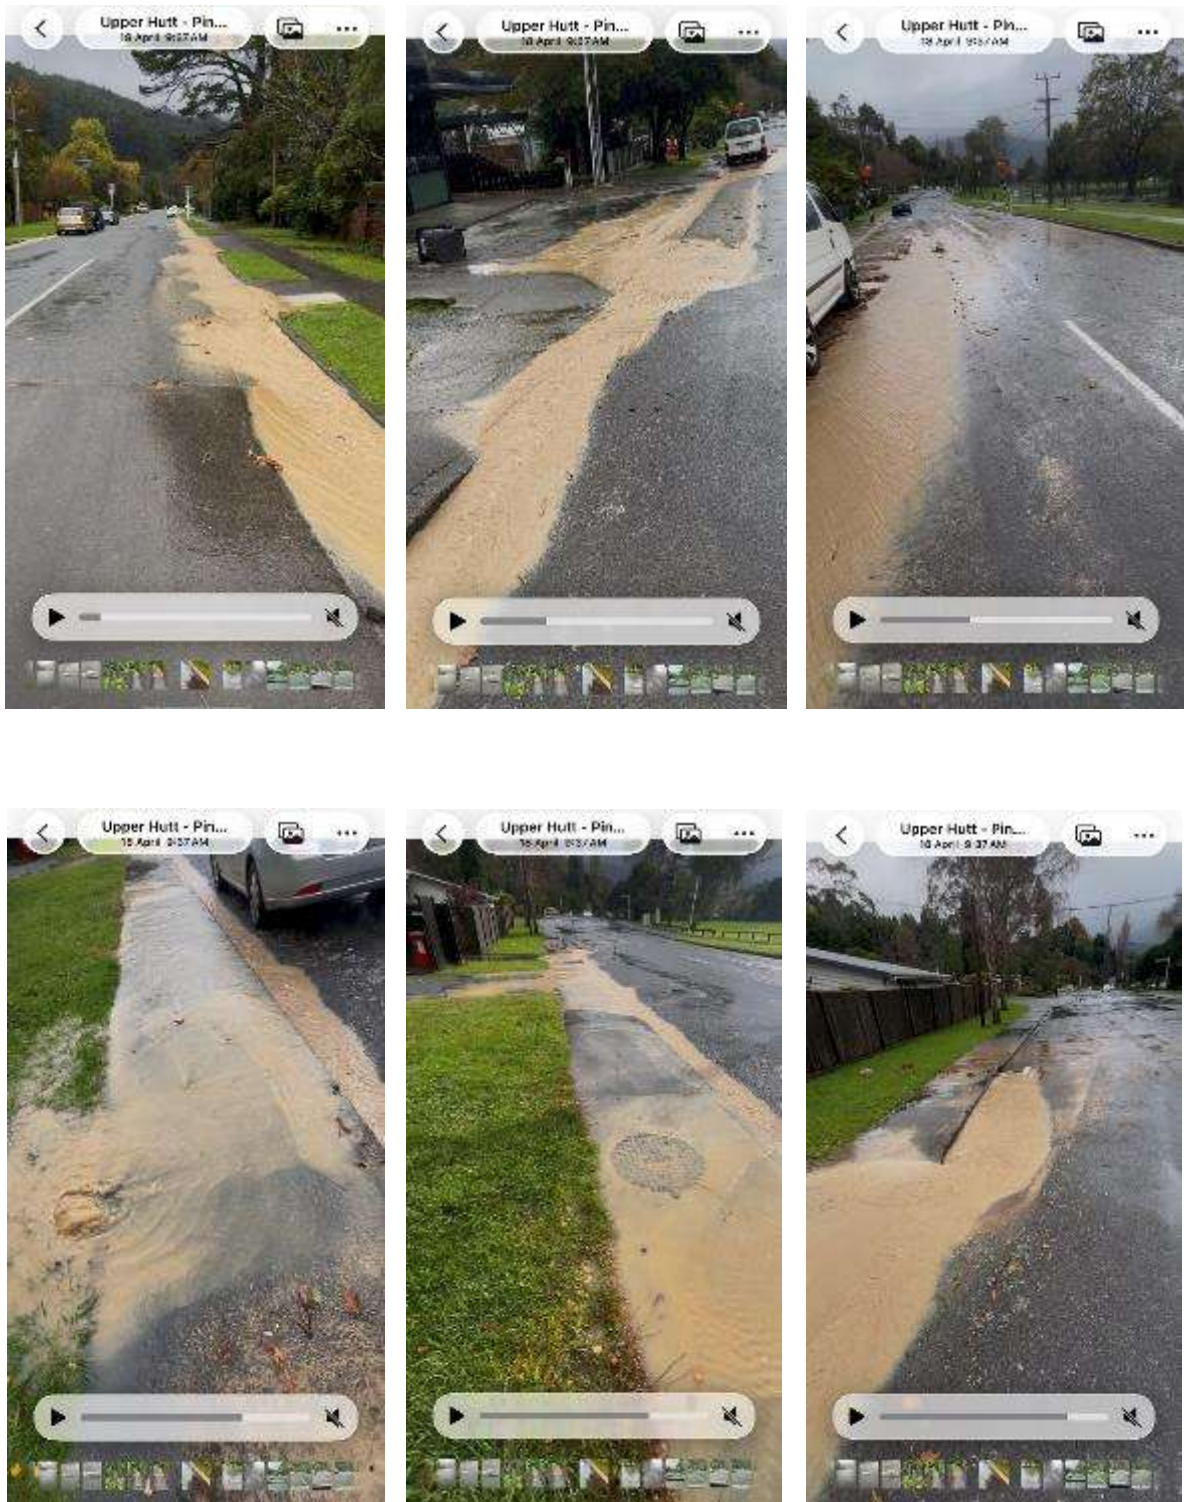
Figure 66 Pinehaven Road (from Forest Road to Library) 18 April 2026 09:37am (after peak flow)

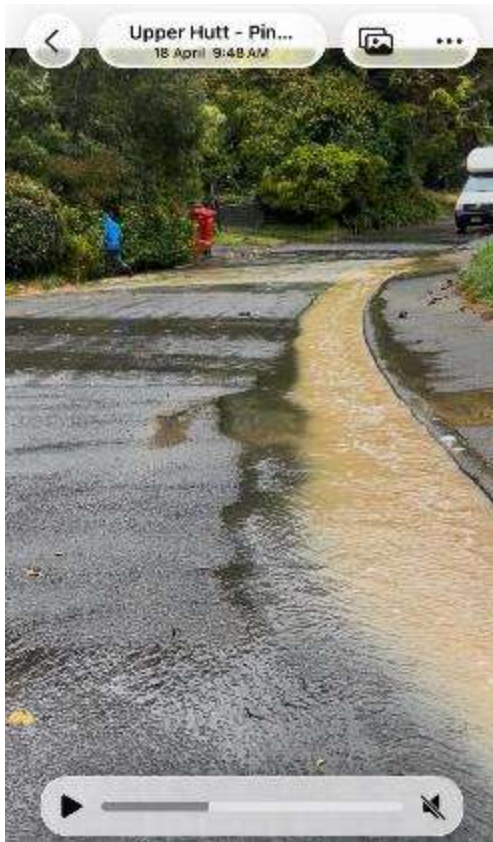
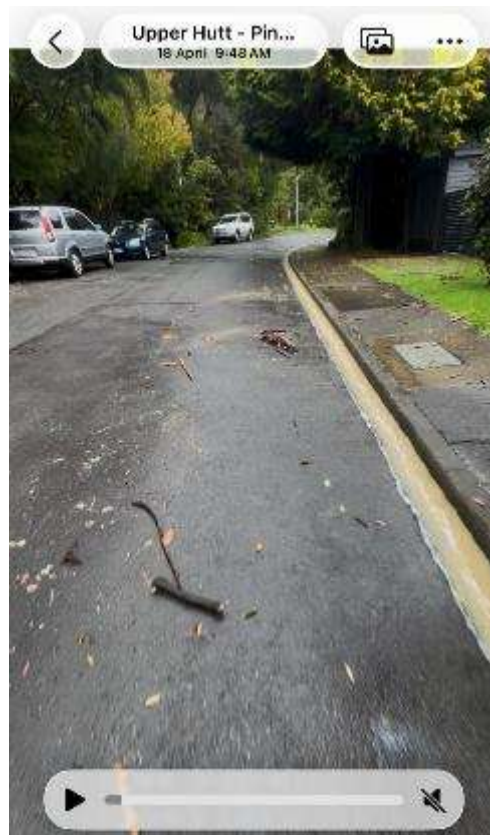
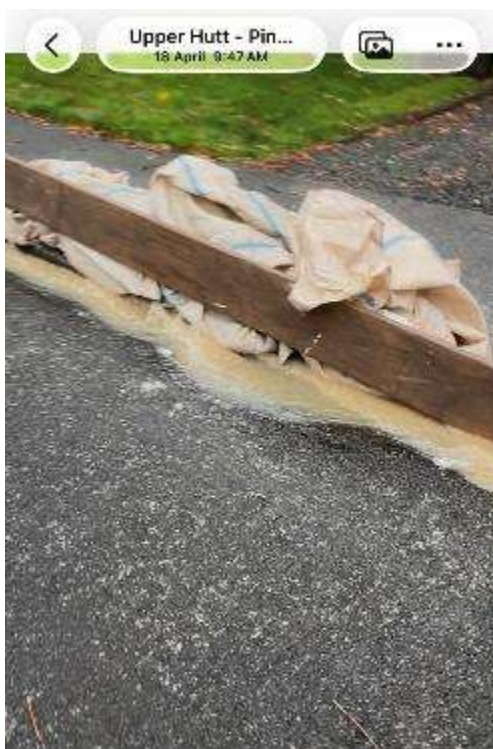
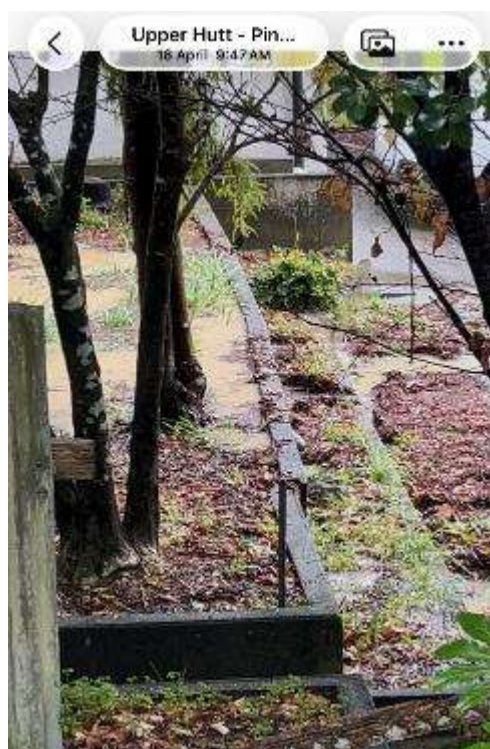
The overtopped culvert near 108A Wyndham Road caused silt-laden water to run down Wyndham Road. Local residents said it ran from the crown of the road to over the footpath.

Figure 74 Wyndham Road, 18 April 2026, 09:47am (after peak flow)

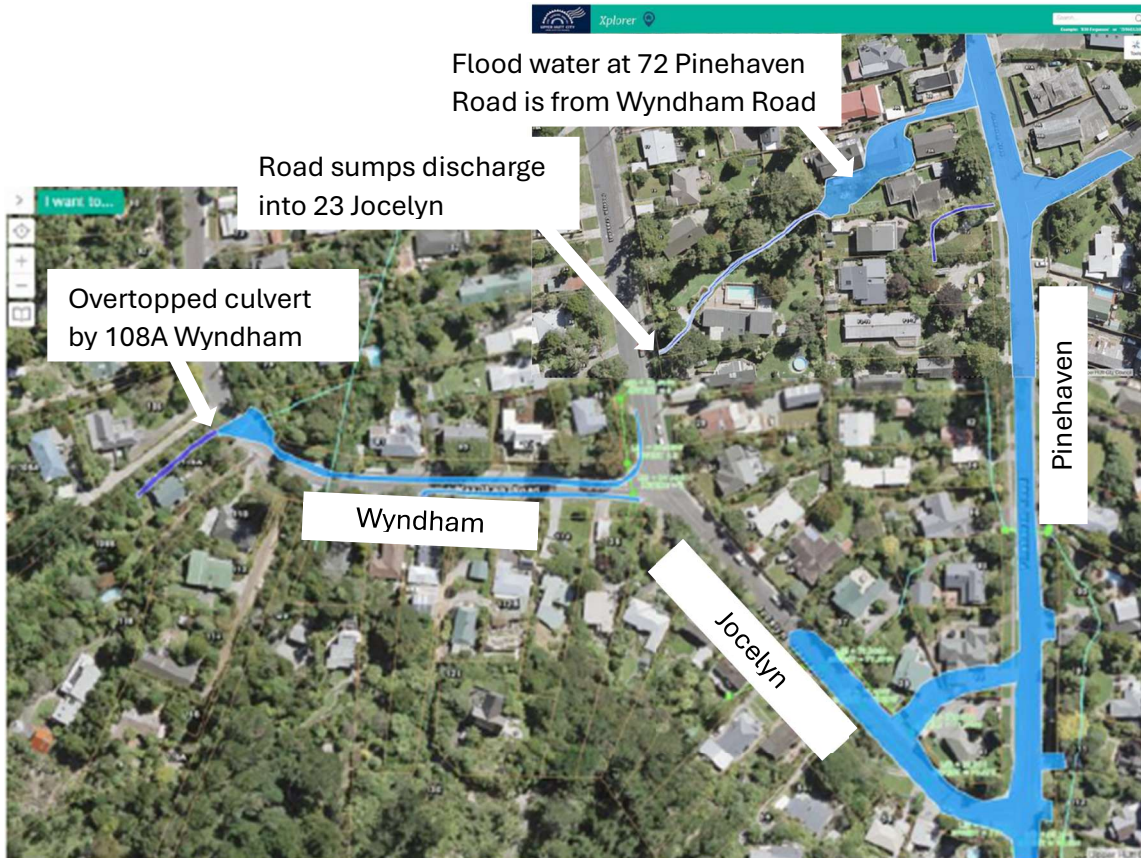
Water from the overtopped culvert near 108A Wyndham Road ran down Wyndham Road and into road sumps on each side of Jocelyn Crescent (Figure 75). These sumps are isolated from the public stormwater main drain which terminates a little further along Jocelyn Crescent. So these two isolated sumps discharge into an open channel on private property at 23 Jocelyn Crescent. After flowing through 23 Jocelyn Crescent, the open channel overtopped and flooded the back yard of 72 Pinehaven Road, similar to what happened on 8 December 2019 (Figure 76).

Figure 75 Flooding 8 Dec 2019 in Wyndham and Jocelyn - similar again 18 April 2026

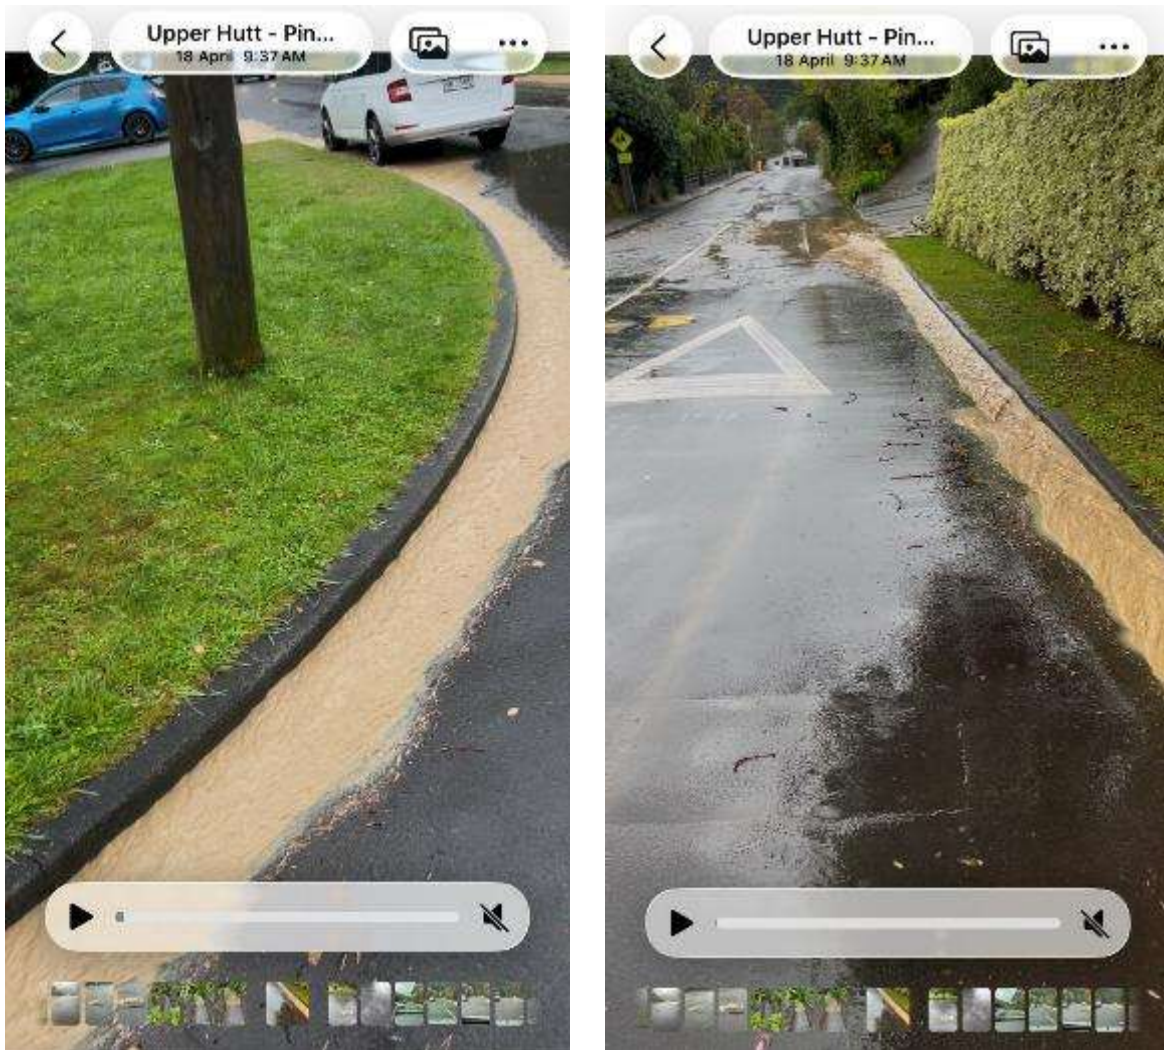
Water running down Pinehaven Road was observed entering Forest Road and ponding around the first road sumps on both sides of Forest Road.

Figure 77 Water from Pinehaven Road entered Forest Road, 18 April 2026, 9:37am

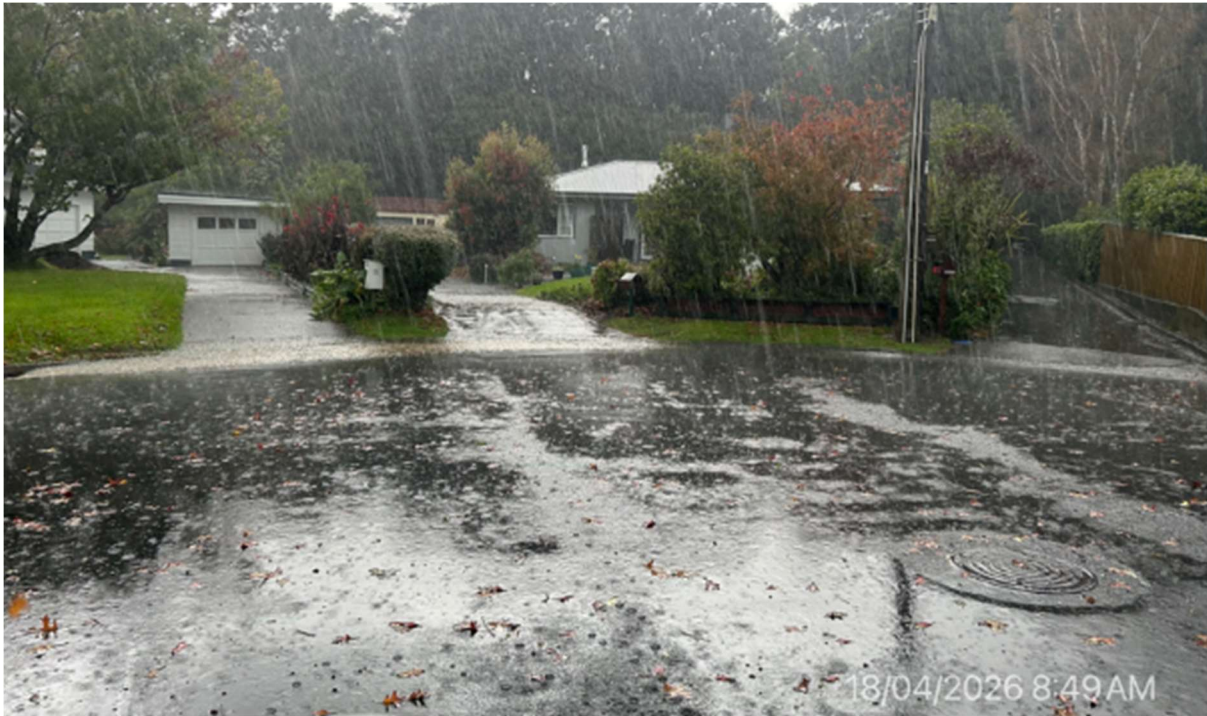
The resident owner at No. 11 commented that water from the stream behind the house at No.12 flowed down the driveway of No. 12 and up his driveway at No. 11 as far the front of the garage, saying that the water rose and receded quickly, and was worse than in February 2026.

Figure 78 Birch Grove cul-de-sac: garage at No. 11 (left); house at No. 12 (centre)

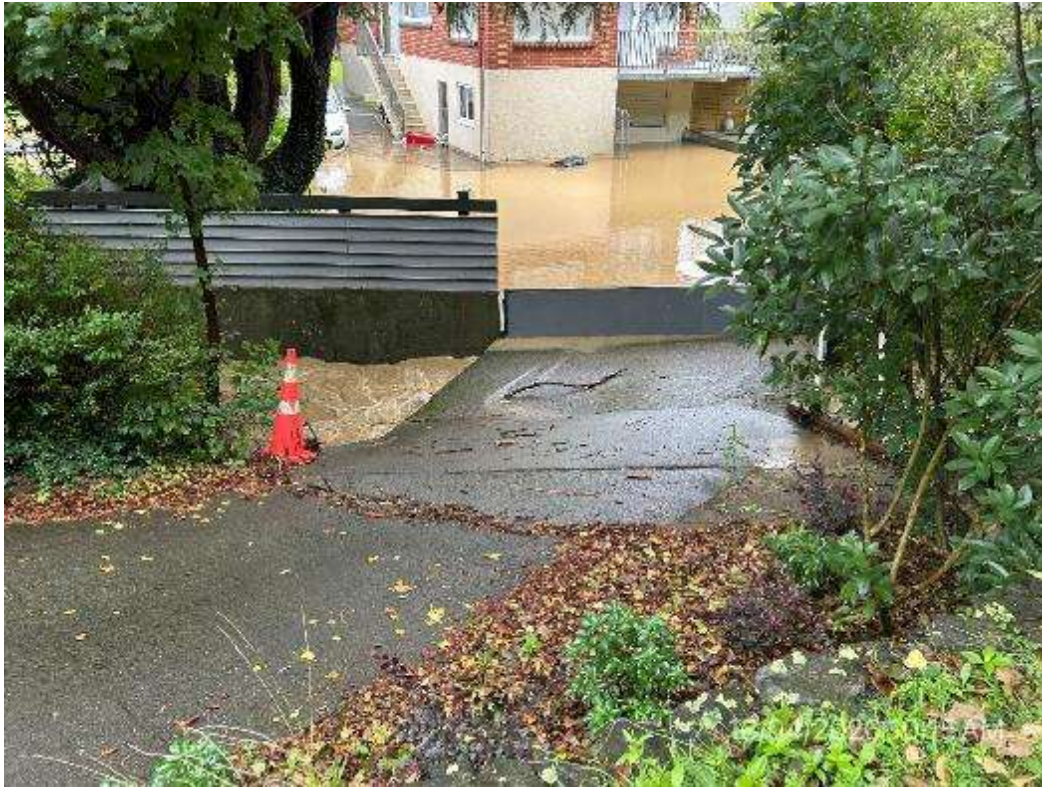
Figure 81 18 April 2026, 10:15am - 32 Blue Mountains Road – water receding

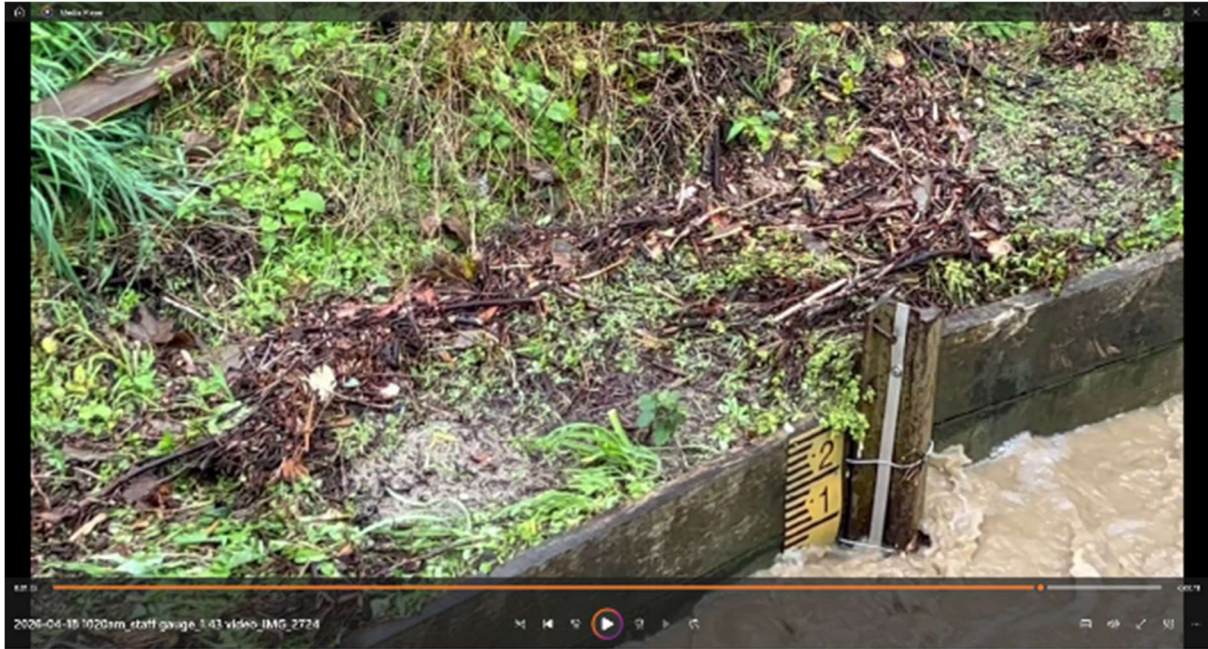
Figure 99 Debris on the bank above the staff gauge on the retaining wall

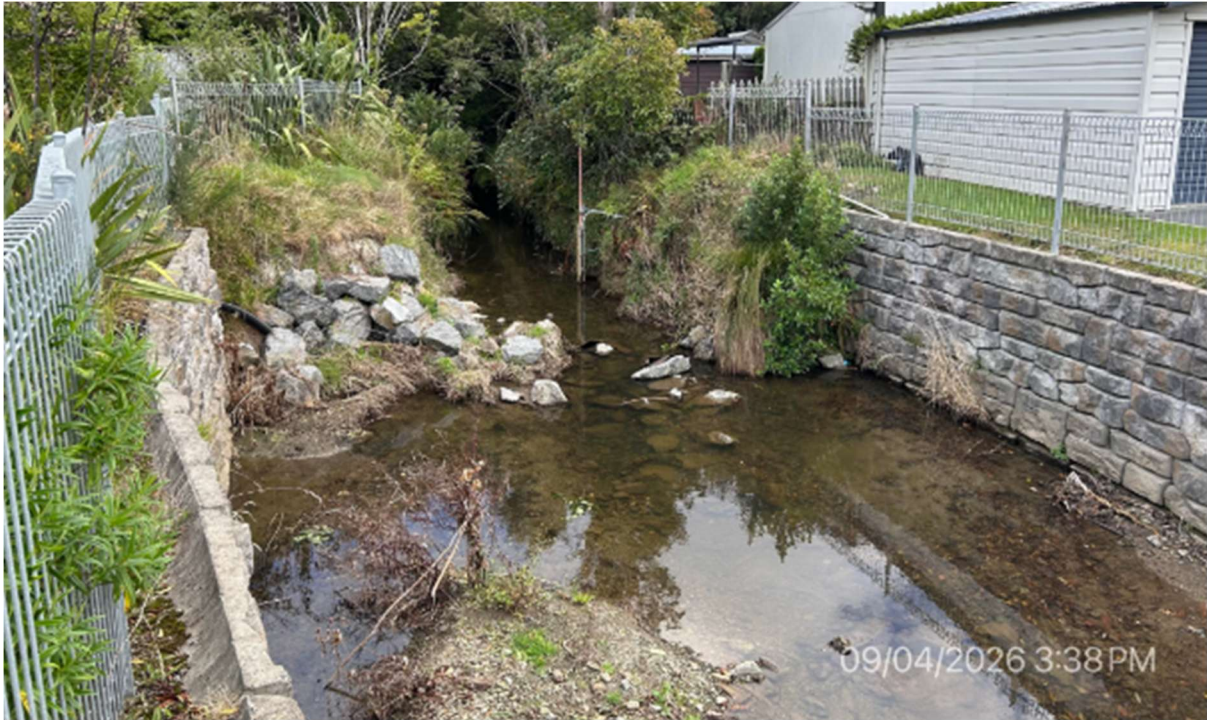
Figure 109 The rock pile on the True Left Bank was swept away in the 16 February 2026 event
