Warning Signs from the Hills

Forestry Runoff, Debris and Flood- Modelling Risk in Pinehaven and Silverstream

Report on the 18 April 2026 Storm

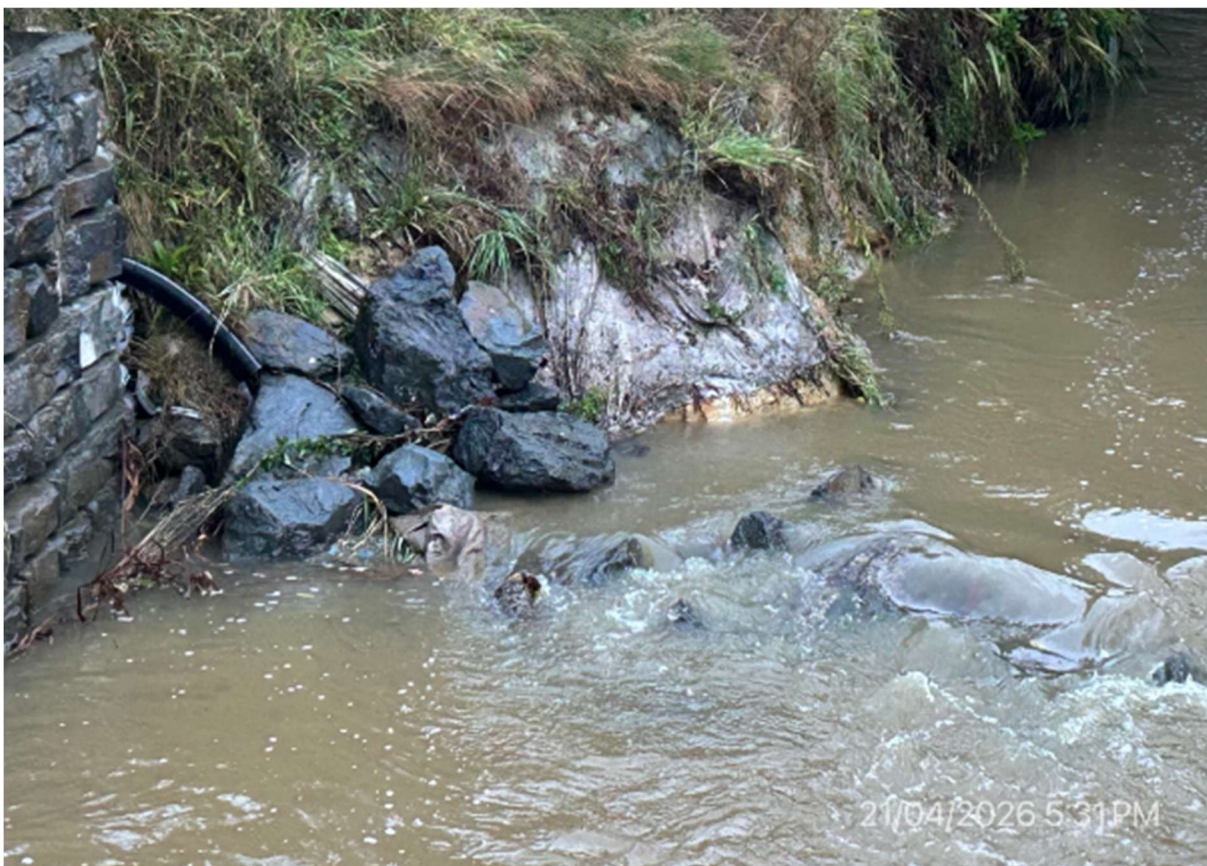
Figure 110 The rock pile on the True Right Bank was swept away in the 18 April 2026 event
