**Report on Storm
16 February 2026
in
Pinehaven and Silverstream
Upper Hutt**

Executive Summary

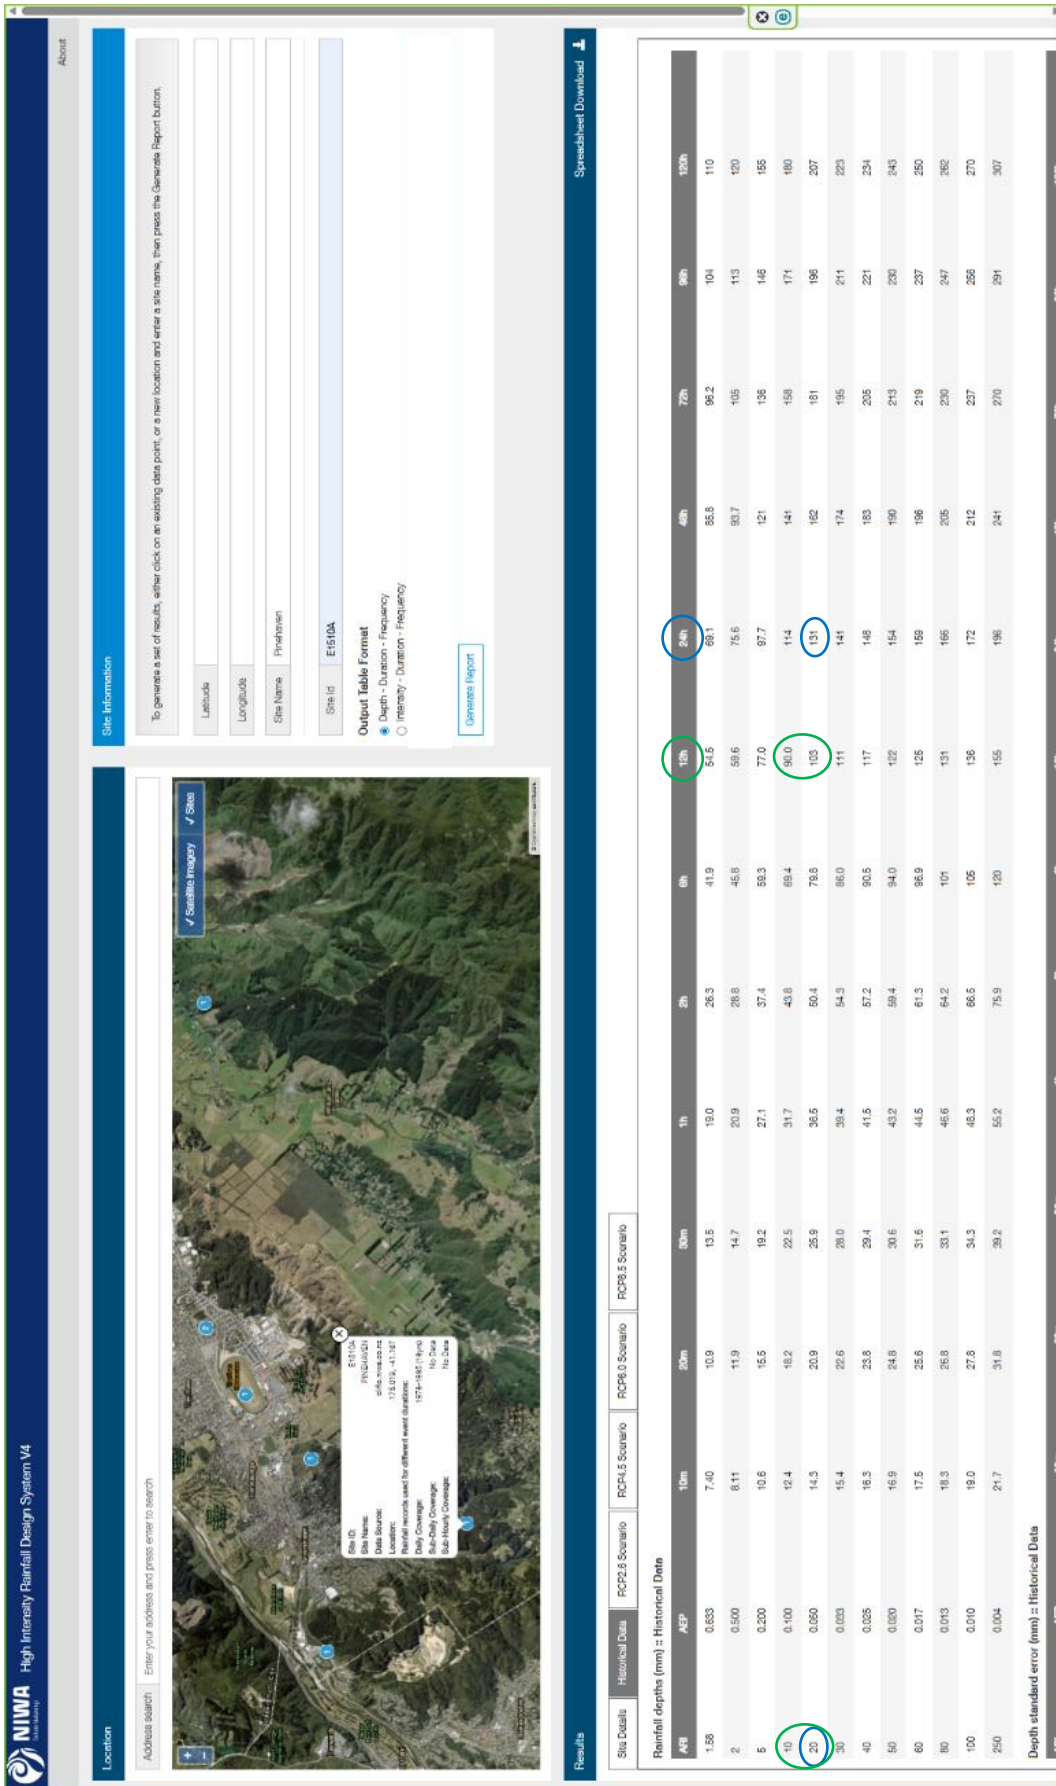
Figure 4 NIWA - HIRDSv4 - Pinehaven Reservoir Rain Gauge - Historical Rainfall Data

According to NIWA High Intensity Rainfall System v4 (HIRDSv4), 131mm of rainfall in 24 hours recorded at the Pinehaven Reservoir Rain Gauge in the Pinehaven Stream catchment is a 1-in-20-year rainfall event, and 97.7mm of rainfall in 12 hours is about a 1-in-17 year rainfall event. This suggests that this storm was between a 1-in-15 and 1-in-20 year rainfall event.

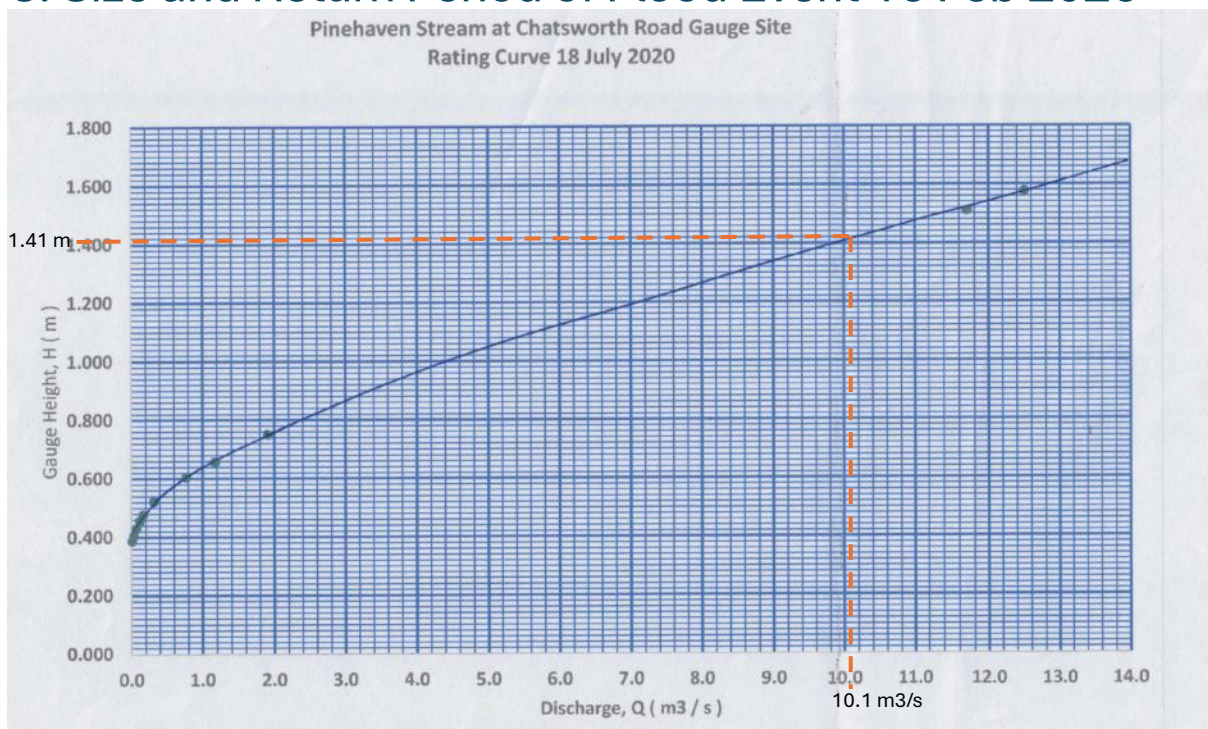
Figure 9 Rating Curve at Pinehaven Stream Staff Gauge Site (R J Hall & Associates Ltd)

The peak water level at the staff gauge on 16 February 2026 was about 1.41m at around 8:20am. Using the rating curve by R J Hall & Associates Ltd, at 1.41m depth the flow is about 10.1m³/s. On R J Hall & Associates' Flood Frequency Curve, a flow of 10.1m³/s is about a 1-in-15 year flood.

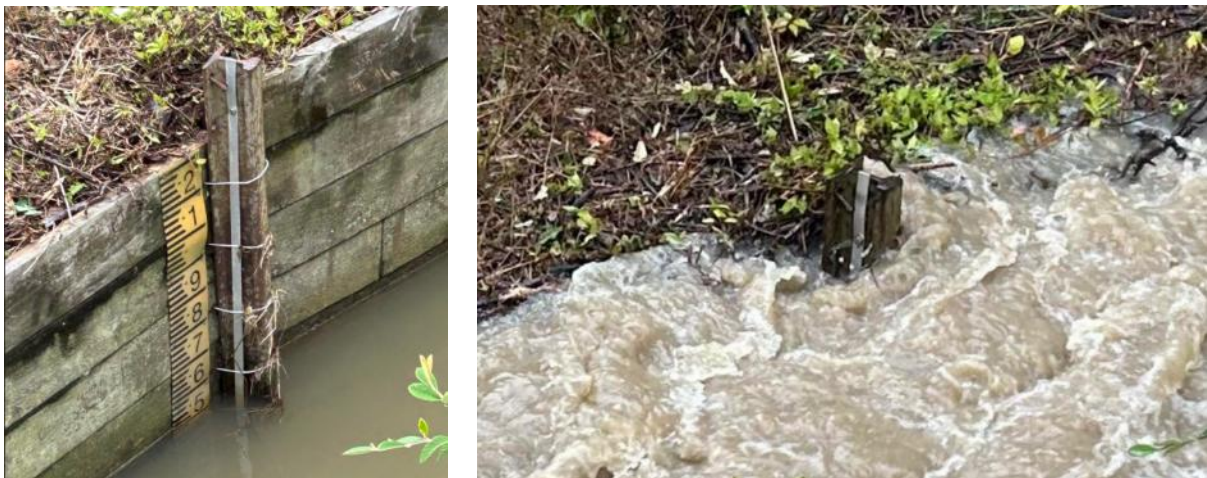
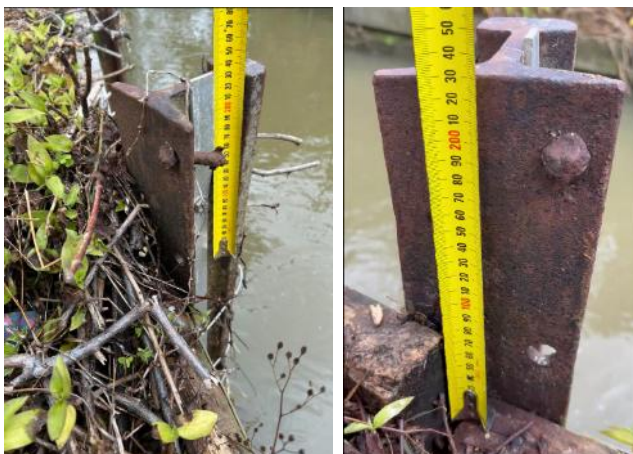
Figure 12 (Above left) Staff Gauge in Pinehaven Stream (12:30pm, 17-2-2026)

The top of the timber retaining wall at the staff gauge is 1.31m. The peak water level on 16-2-2026 (above right) is about 25mm above the timber retaining wall on the upstream side of the railway iron, which is 75mm higher than the retaining wall on the downstream side. We estimate that the peak water level is about 1.31 plus 75mm plus 25mm = 1.41m peak water level.

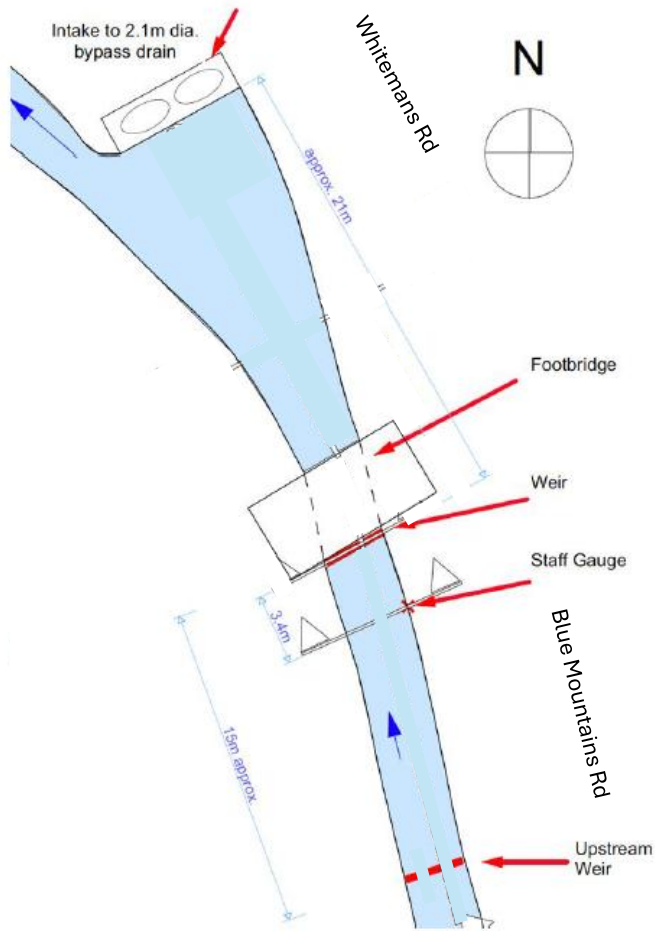
Figure 15 Plan View of Staff Gauge Site, Pinehaven Stream

There is another weir about 15m upstream of the footbridge, and water spilling over this weir is visible at the top of the image (left). See below (Figure 15) for a plan view of the staff gauge site.

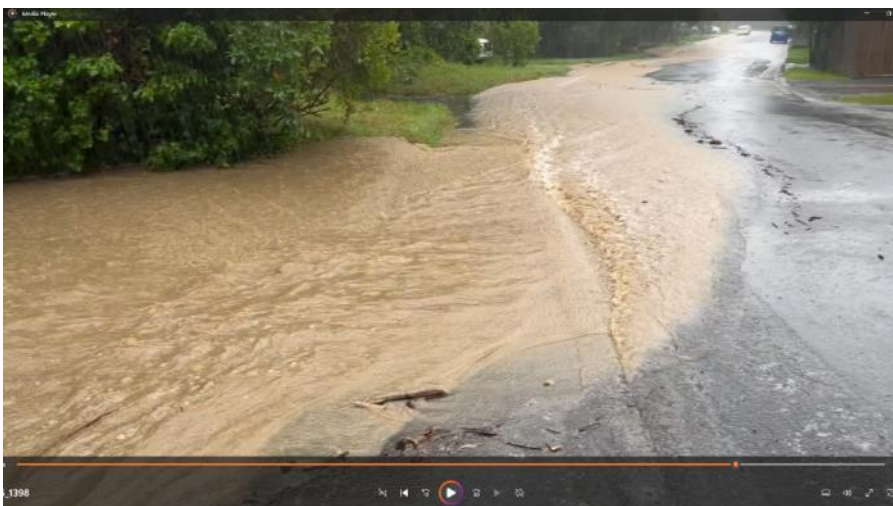
Flood water from 122 runs all the way down Pinehaven Road to the school and also into Jocelyn Crescent

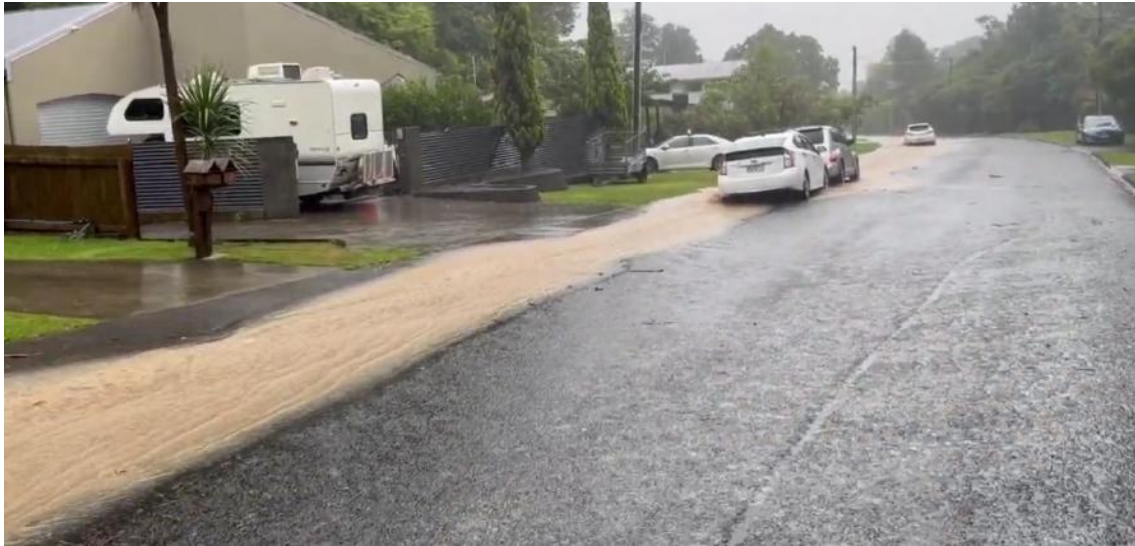
Looking north down Pinehaven Road near 108 Pinehaven Road

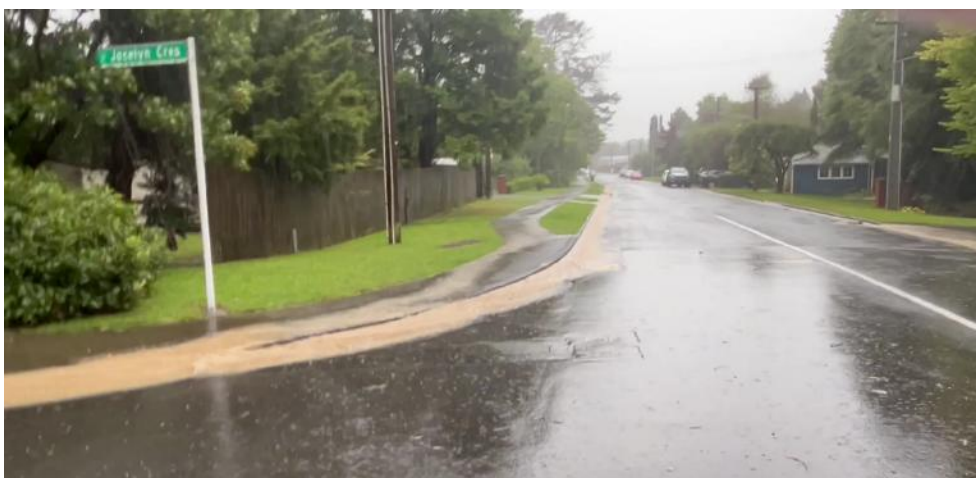
Some of the flow continues north down Pinehaven Road towards Pinehaven School.

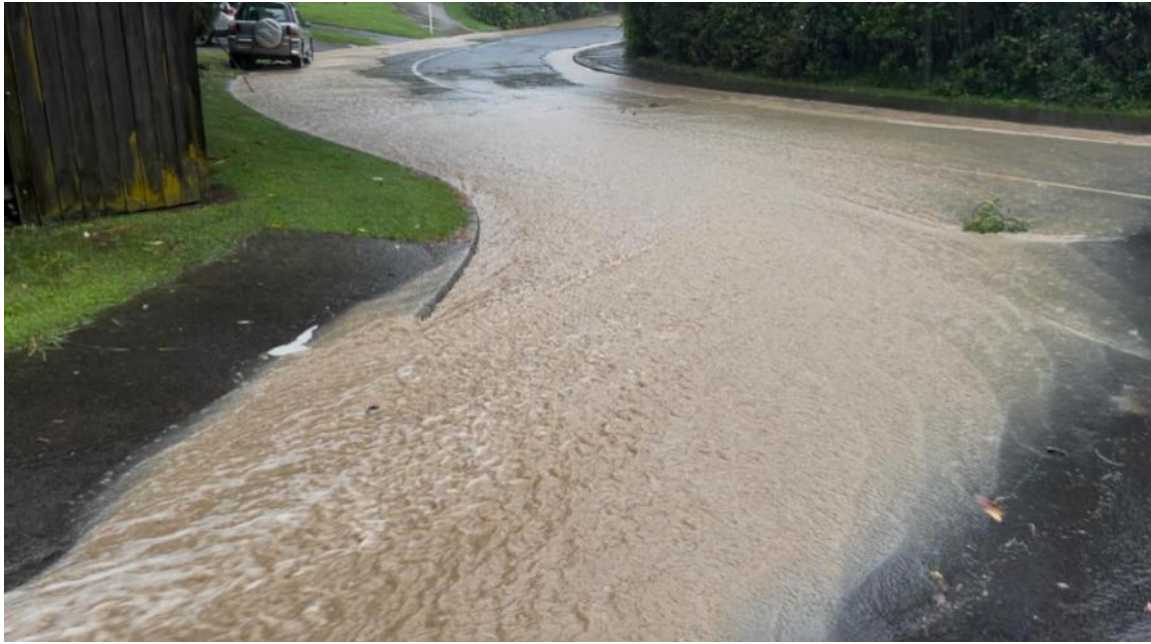
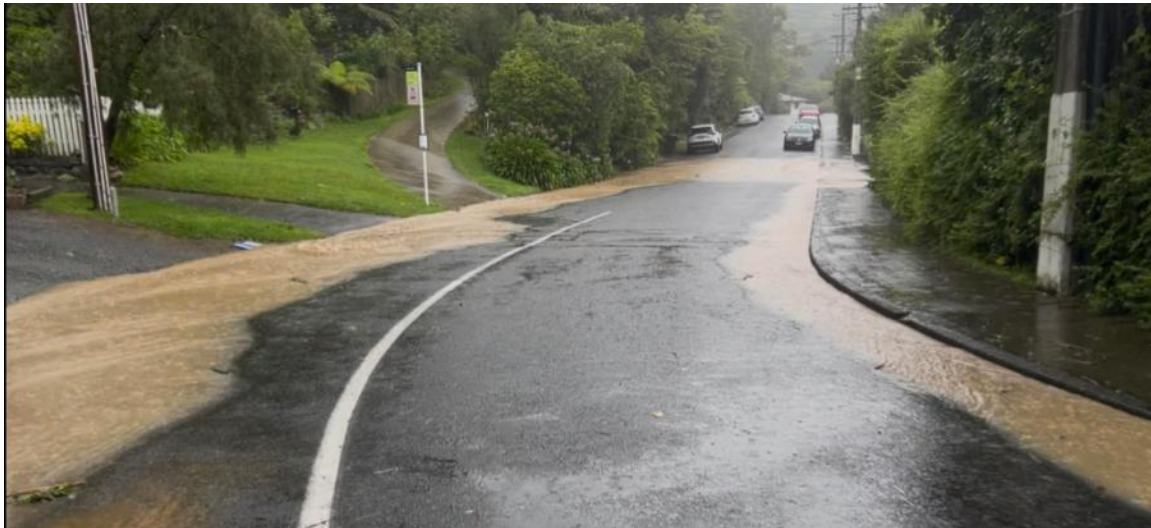
8:00am - water flowing into Jocelyn Crescent ran into 39 Jocelyn Crescent (right) - find out from local residents how this water finds its way back into the stream further down Pinehaven Road.

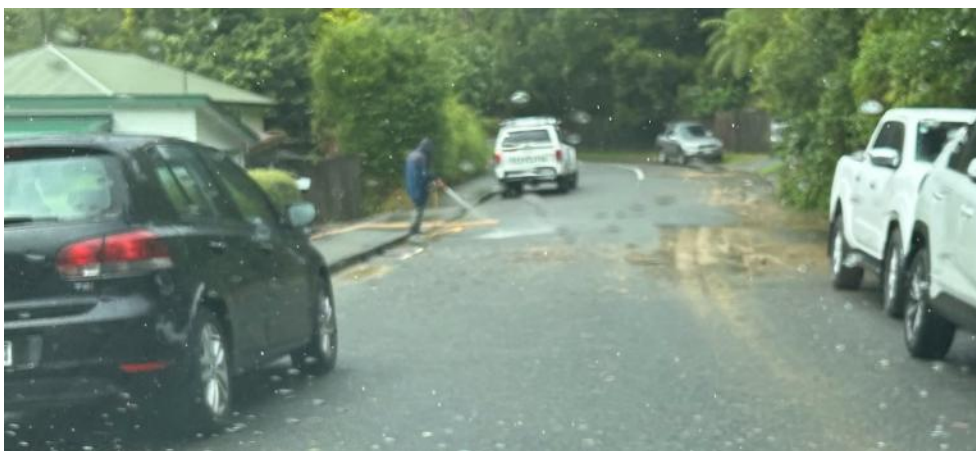
Resident cleaning debris off road at 39 Jocelyn Cres illustrates why it is important to observe flooding as it happens, not the next day like GWRC and SKM, July 2009.

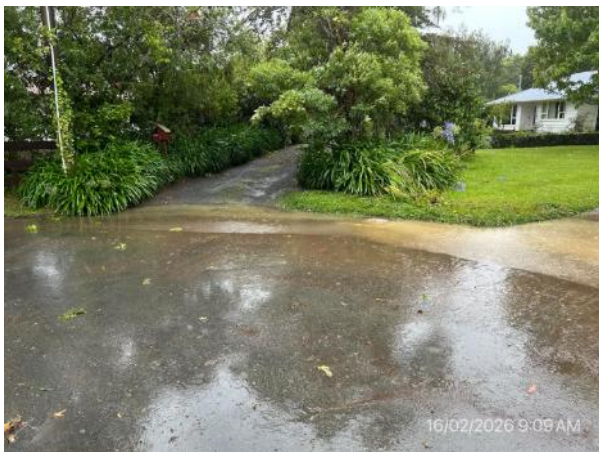
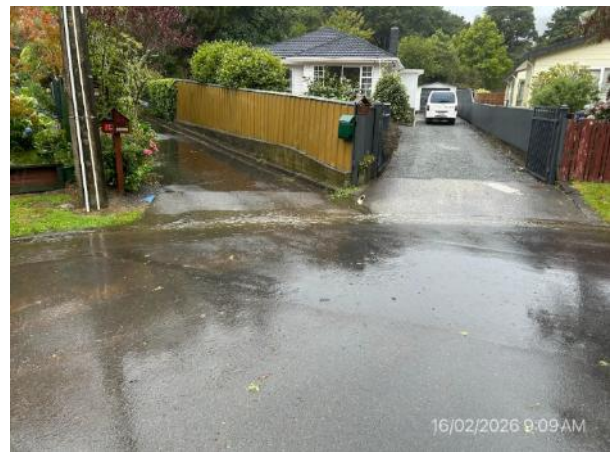
Figure 19 Minor flooding in Birch Grove cul-de-sac, 9:09am just after peak flow

The ponding in Birch Grove was minor compared to flooding that occurred here in December 2019 when the whole cul-de-sac was flooded. On Monday 16 February 2026, there was evidence of water starting to break out of the stream channel behind the house at 12 Birch Grove and running down the driveway into the cul-de-sac. There it mixes with surface water flowing down the Birch Grove road channels and ponding in the cul-de-sac. The ponding seems to be due to the drainpipes from the road sumps (under water in the top photo above) being unable to discharge properly into the stream channel because they are below the surface of the swollen water level. The pipes may also be receiving backflow from the flooded stream channel.

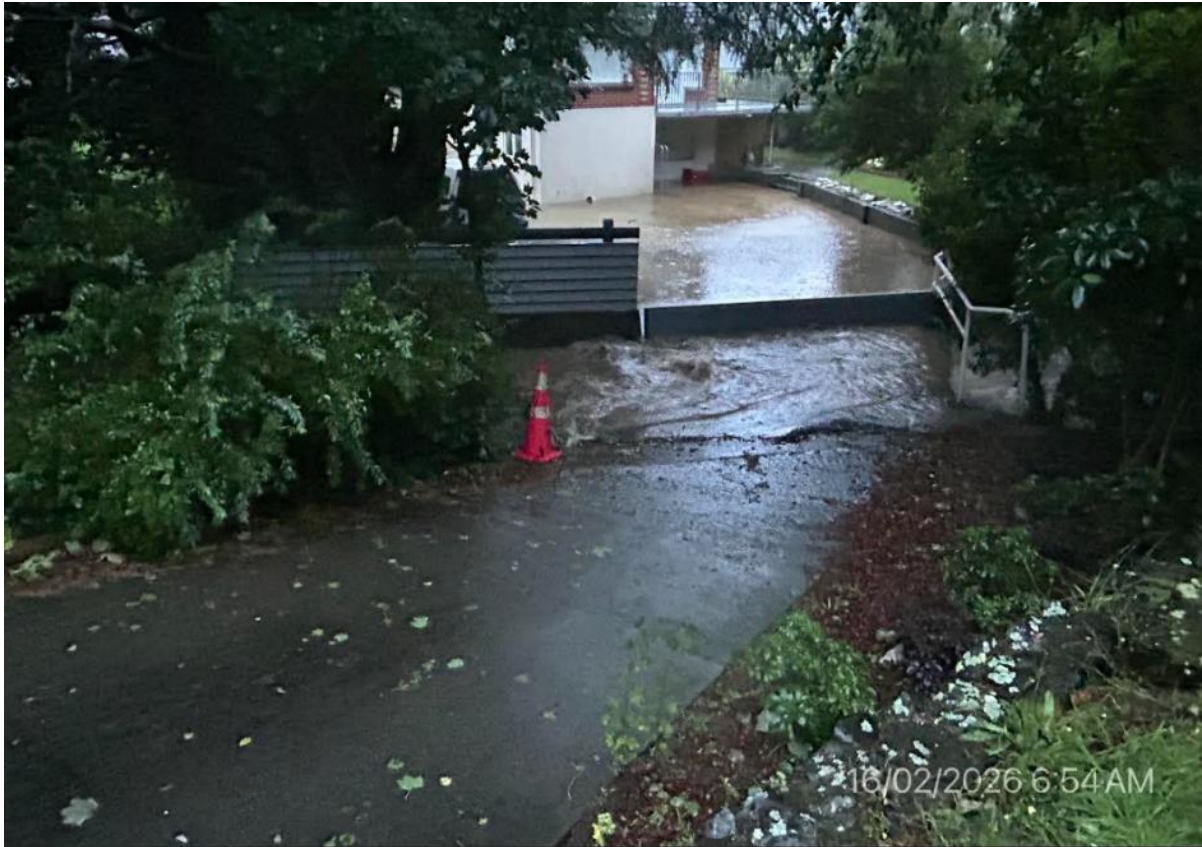
32 Blue Mountains Road, 6:54am (above) and 9:02am just after peak flow (below)

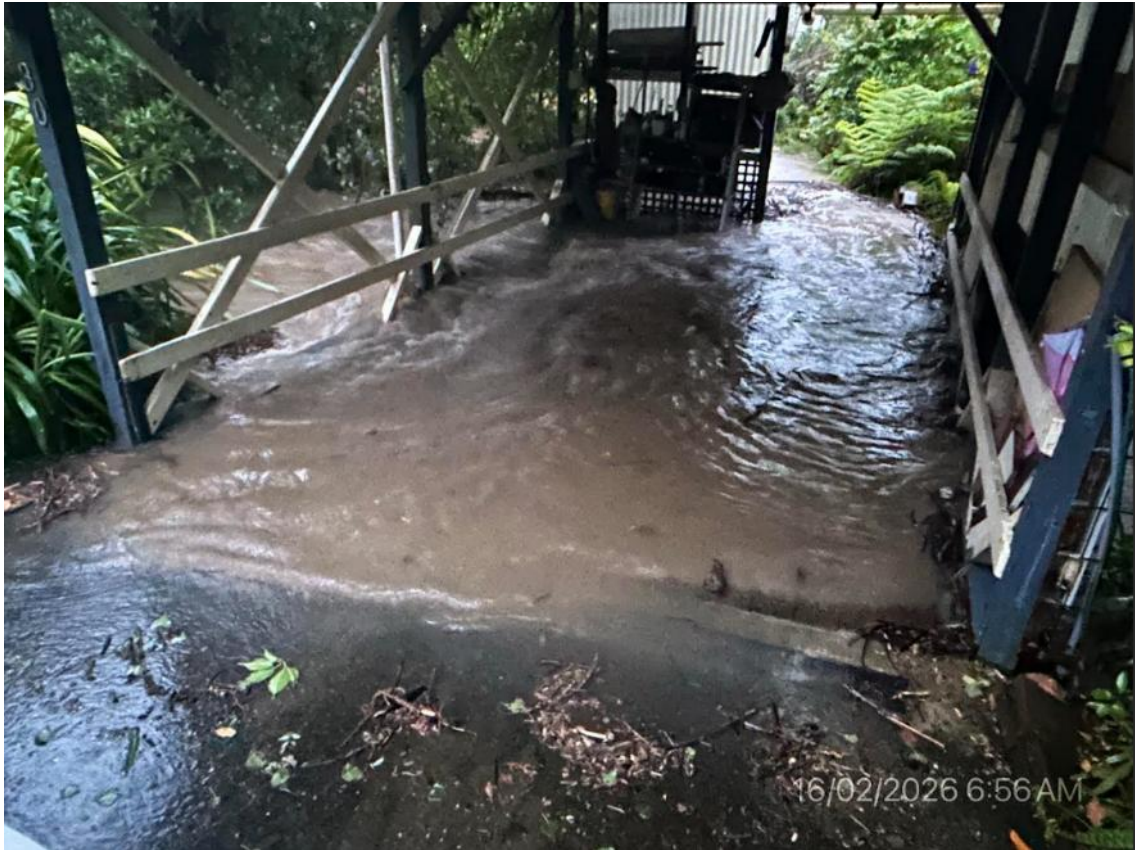
30 Blue Mountains Road, 6:56am (above) and 9:03am just after peak flow (below)

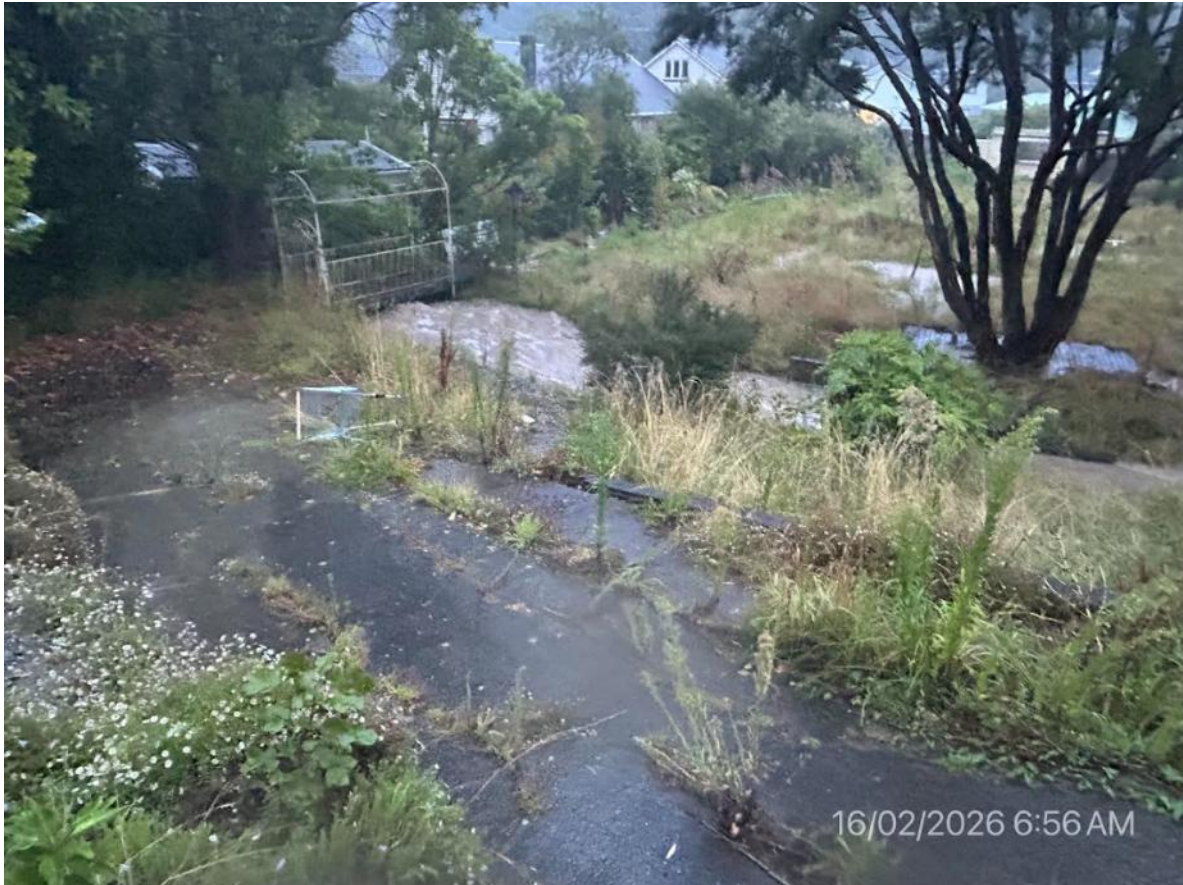
28 Blue Mountains Road – the house was removed when the property was bought by GWRC
6:56am (above) and 9:04am (below)

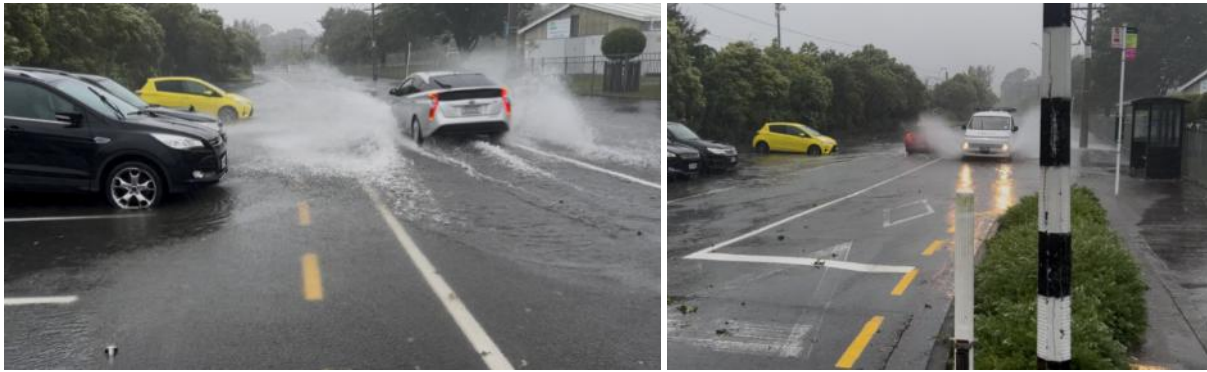
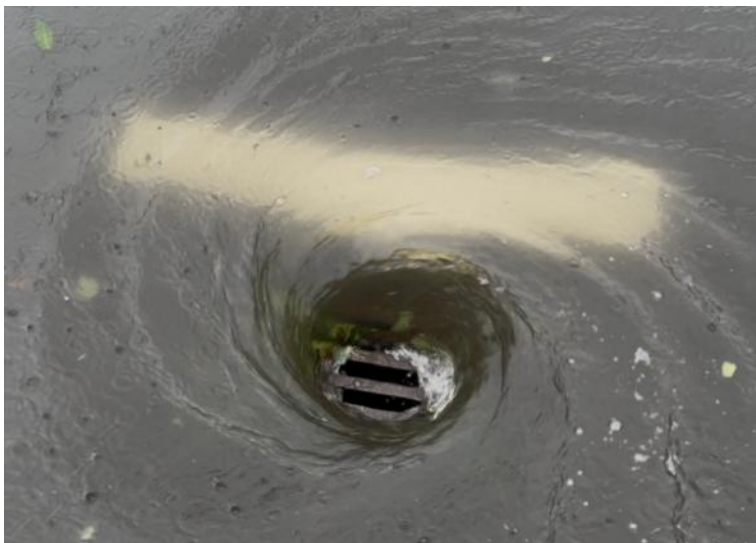
Figure 21 Ponding in Gard Street due to blocked road sumps

After clearing leaves and twigs at around 8:30am from the blocked road sumps, the ponding drained away within about 20 minutes.

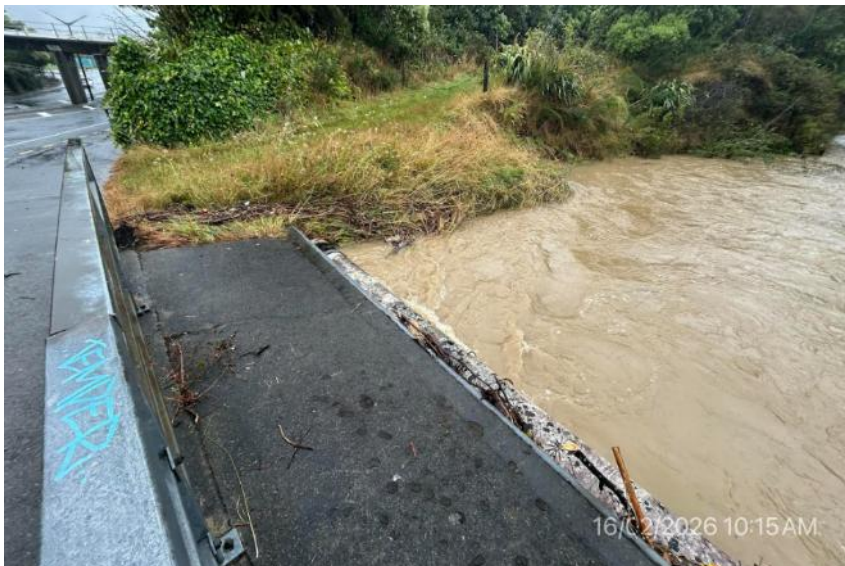
10:15am

The debris lines in these two photos (left) indicate that the road culvert overtopped a little at the peak of the flood almost two hours earlier.

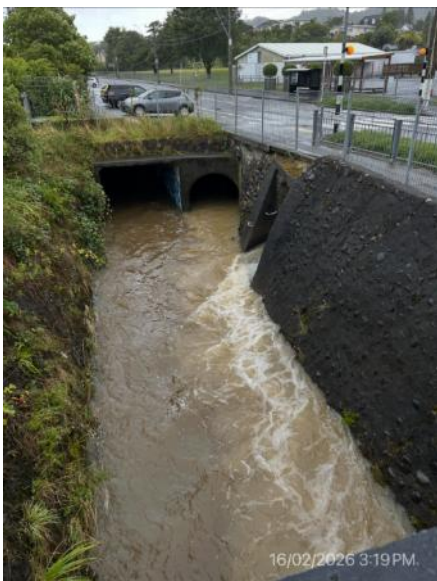
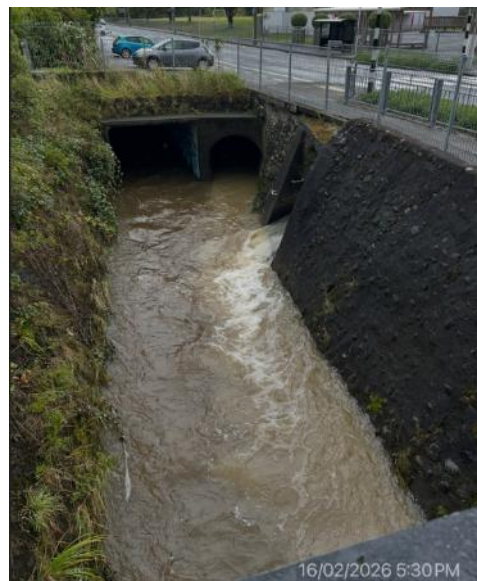
Figure 23 Photos of Pinehaven Stream discharging into Hulls Creek at 3:19pm and 5:30pm on 16 February 2026

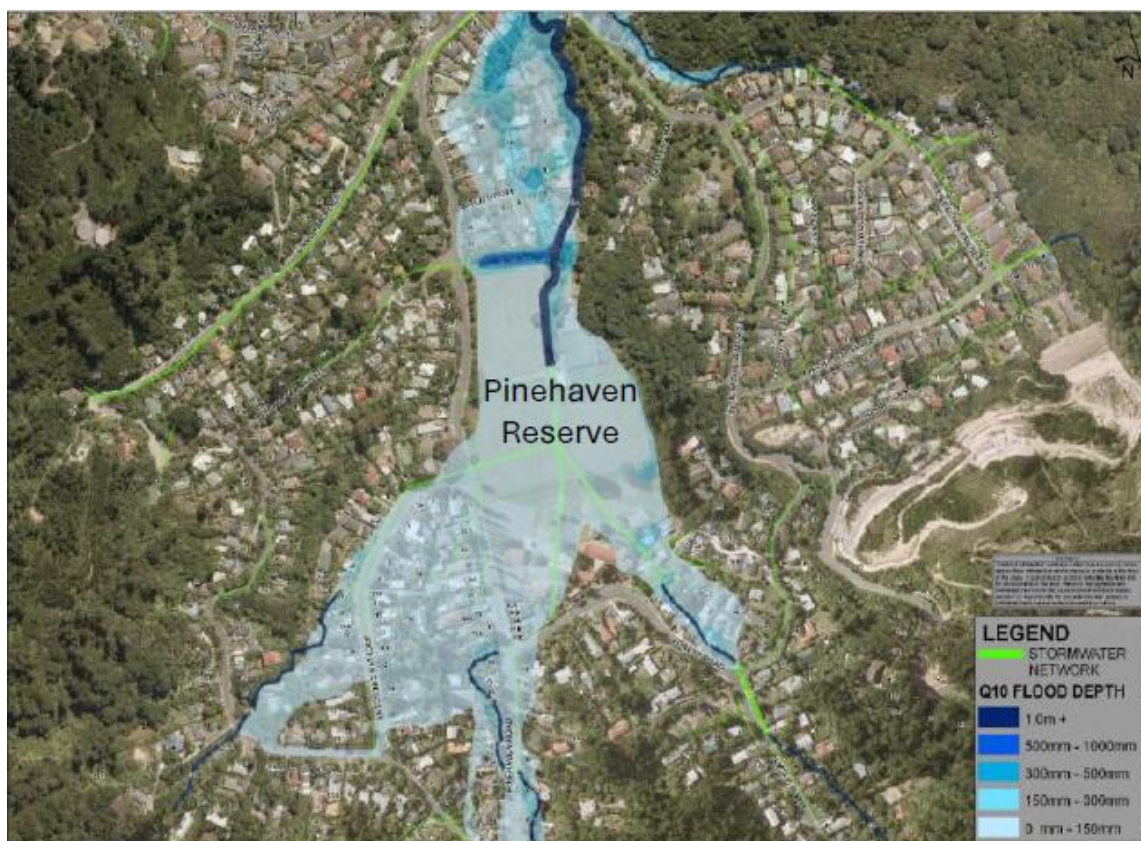
Council's 10-year flood map (above) shows Pinehaven Reserve under water.

We estimate that the storm on 16 February 2026 was about a 1-in-20 year rainfall event and about a 1-in-15 year flood event in Pinehaven. GWRC's 1-in-10 year flood map (above) shows Pinehaven Reserve inundated, but that did not happen on 16 February 2026. GWRC's flood map grossly overstates flooding, not only of Pinehaven Reserve but also many homes in Pinehaven are falsely shown inundated in GWRC's inflated and unreliable flood maps.

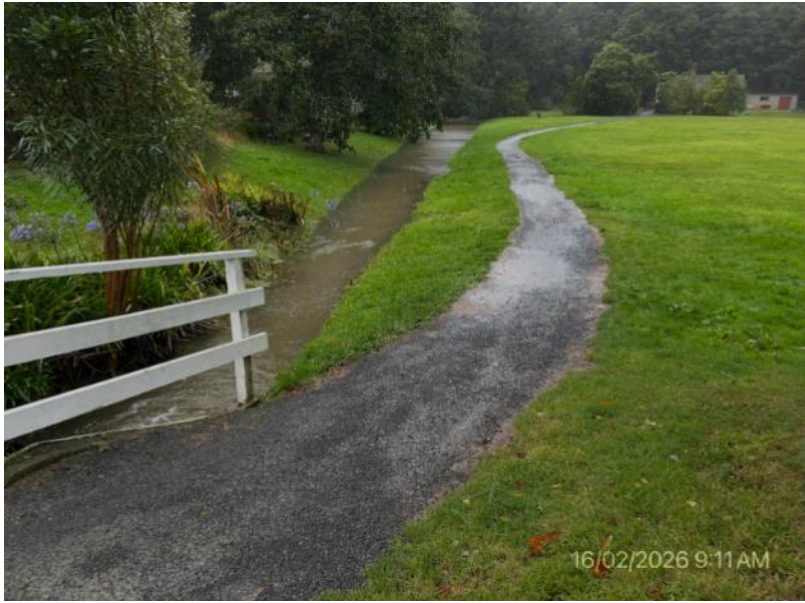
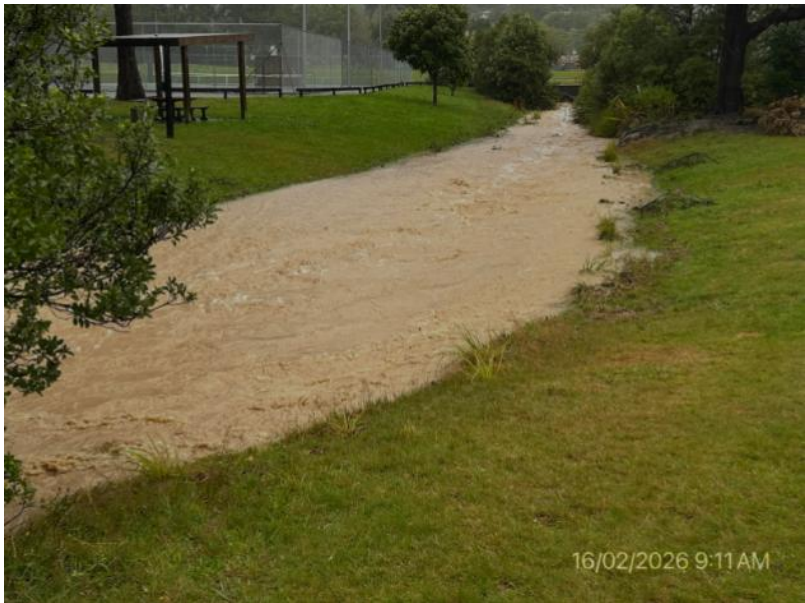
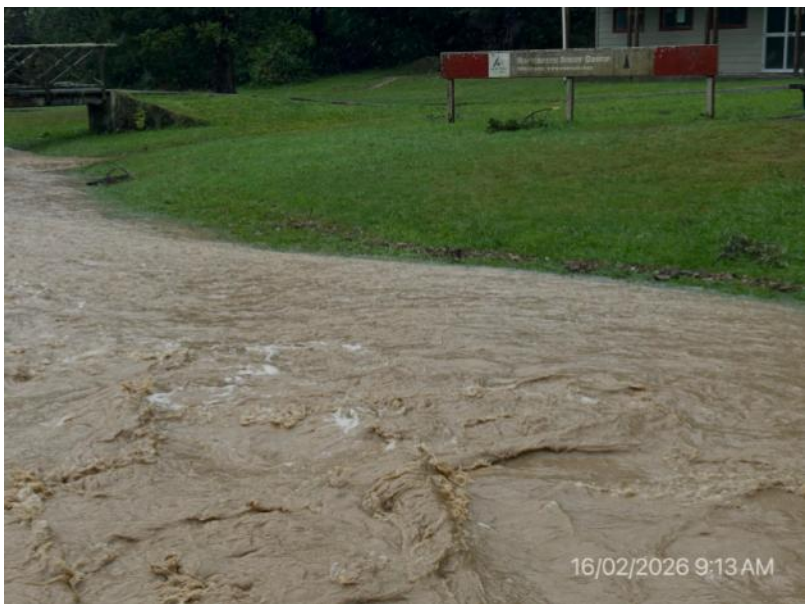
Figure 25 Debris lines in Pinehaven Reserve

At around 9:12am, almost an hour after peak flow, debris lines indicate that the stream flow is receding.

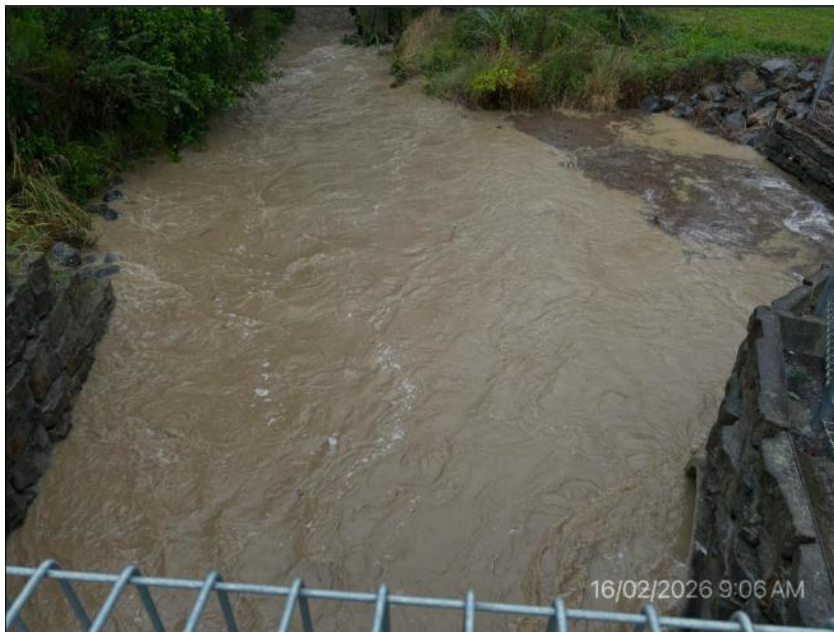
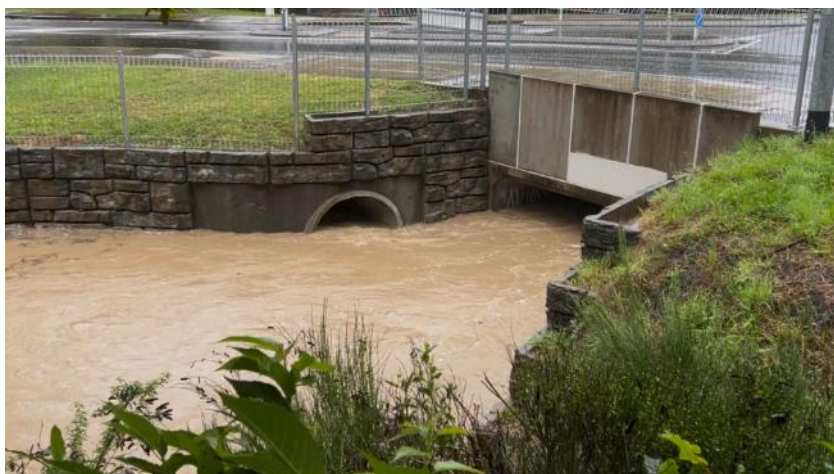
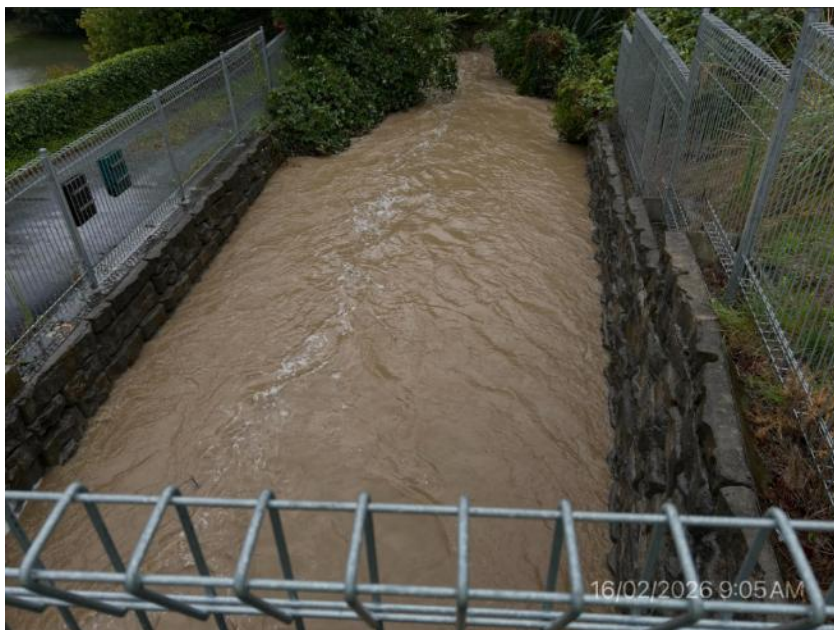
Figure 28 Pinehaven Road new culvert, 9:06am

Observed flood behaviour at recently modified sites shows mixed outcomes from recent public investment in flood works. The new Pinehaven Road culvert primarily transfers floodwater more efficiently downstream, without materially reducing flooding at known problem locations. The upgraded Sunbrae Drive culvert performed adequately during the 16 February 2026 event, although previous flooding at this location appears to have been strongly influenced by blocked road sumps and inadequate drainage performance when stream levels are high. By contrast, the recent modifications at Willow Park demonstrably increased flood storage and provided effective protection to nearby properties at 10 – 12 Blue Mountains Road during this event.

Looking upstream from the footpath above the intake

Pinehaven Road culvert: View of the Wyndham Road discharge pipe and the new culvert intake

Looking downstream from the footpath above the new culvert outlet

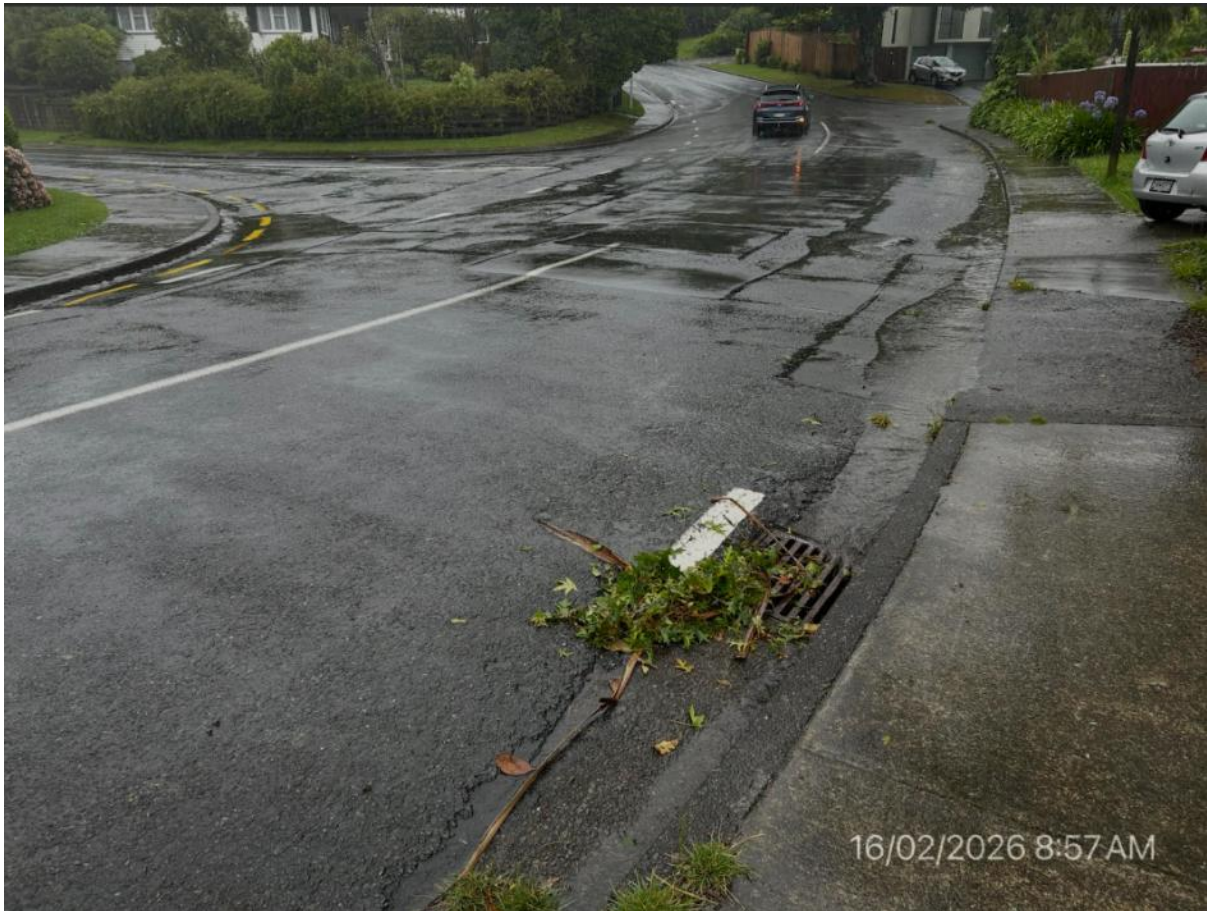
Figure 29 No flooding at Sunbrae Drive and Deller Grove intersection

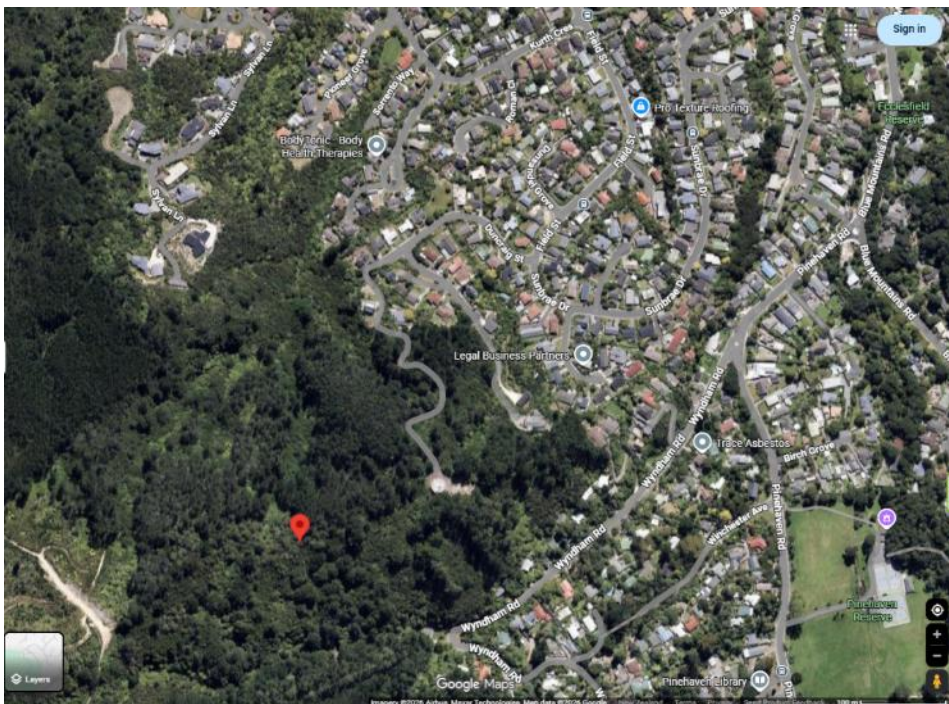
Figure 31 Location of the landslide pinned on Google map by Dennis Clark

The gully in which this slip occurred drains down to the stormwater intake pipe in the small reserve between Pioneer Grove and Sorrento Way.

R J Hall & Assoc. note that intense rainfall can wash eroded soils and rocks into stormwater networks and reduce the capacity of pipes.

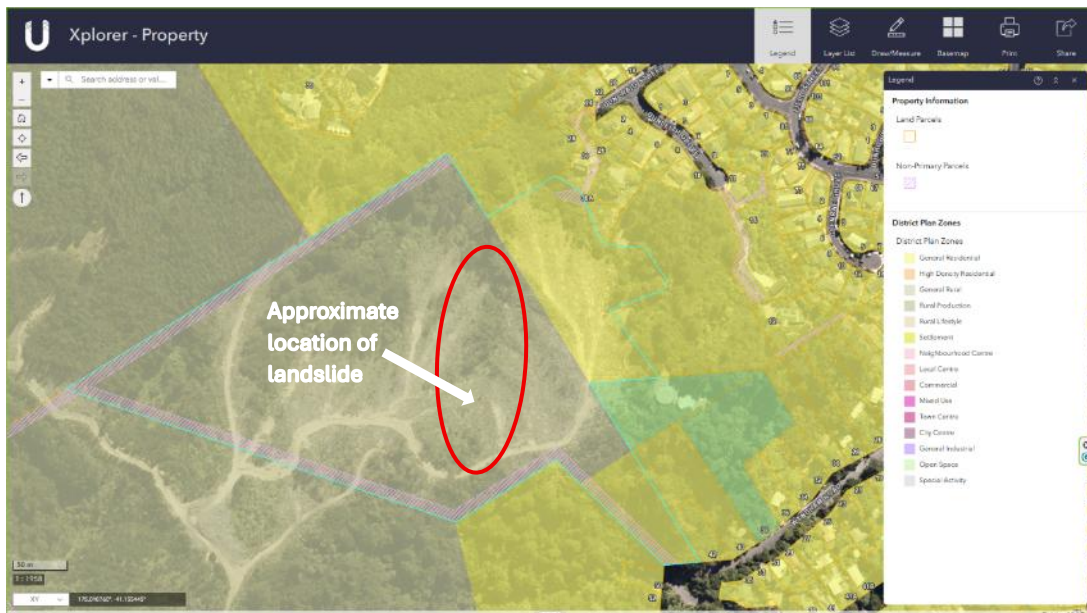
Figure 37 UHCC District Plan Zones - General Residential zone below landslide

Part of GTC’s site below the landslide is already zoned ‘General Residential’ (Figure 37), with apparent access for residential development on GTC’s site from the top end of Dun Craig Street.

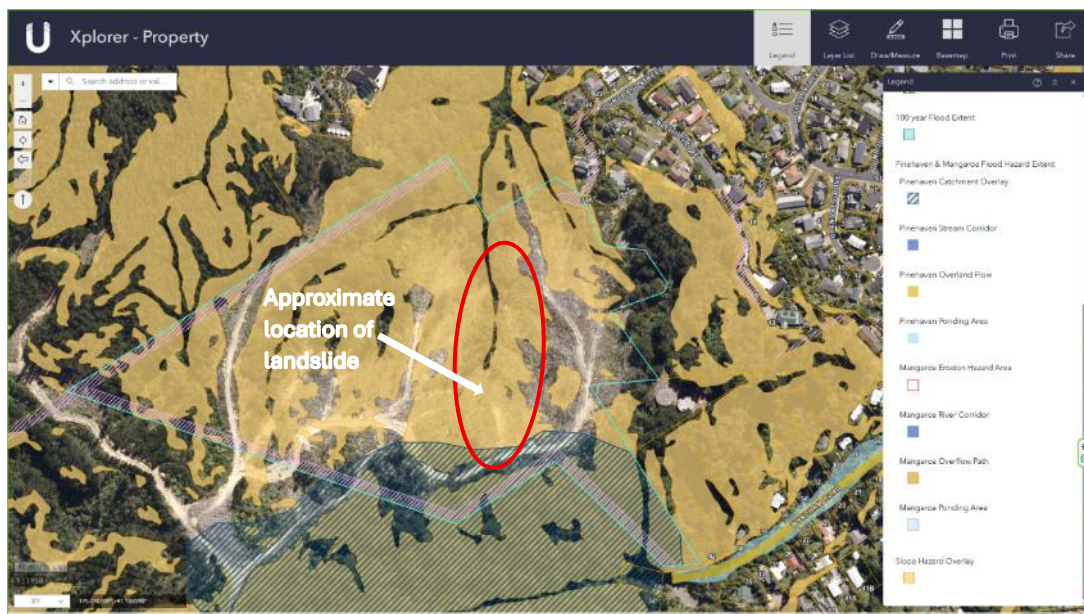
Figure 38 UHCC Slope Hazard Overlay (brown shading)

Most of GTC’s site on which the landslide occurred is known ‘slope hazard’ (Figure 38) because of the steepness of the land. The combination of land-use change (whether forestry harvesting or development) plus steep unstable land plus heavy rainfall can be lethal, as the recent tragic events in the Bay of Plenty have shown.

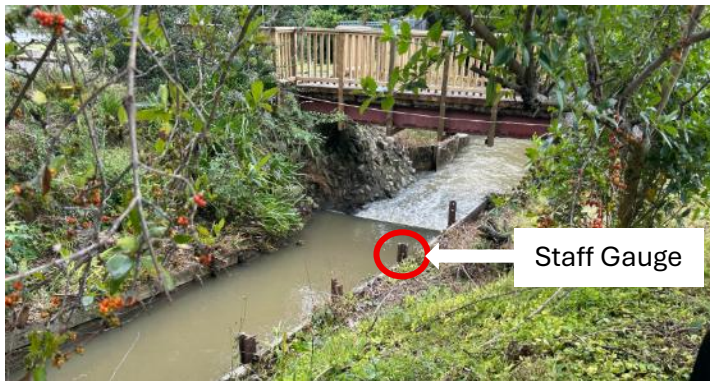
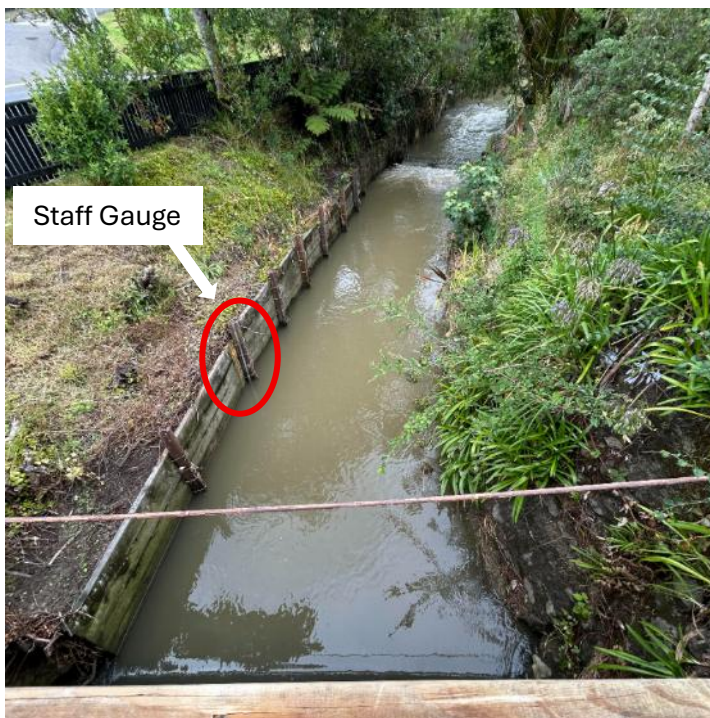
Figure 41 Location of the reinstalled stream gauge is a matter for engagement and collaboration of Council with the local community.

The original stream gauge was located at the second railway iron from the footbridge that supports the timber retaining wall on the true right bank of the stream channel. The gauge was located here from 2008 to 2013. Because this reach of the channel has not been modified by recent streamworks, it is sensible and responsible to reinstall the stream gauge here at its original location. This would allow new stream depth data to be related to historical records for this location.

It is only because this reach has not been modified that we were able to use the rating curve and flood frequency curve developed by R J Hall & Associates to assess the flood flow and frequency for the storm on 16 February 2026 and compare it with previous events such as the flood on 8 December 2019.

The continued absence of a functioning stream gauge at the Pinehaven gauge site is a critical failure in flood-risk governance. Reliable, continuous water-level data is foundational to any credible flood model. The immediate reinstallation of an automated gauge of the same type and at the same location as the historic 2008–2013 gauge, together with formal protection of the gauge site from channel modification, is essential if future flood modelling is to be evidence-based and defensible.
