**Report on Storm
16 February 2026
in
Pinehaven and Silverstream
Upper Hutt**

Executive Summary

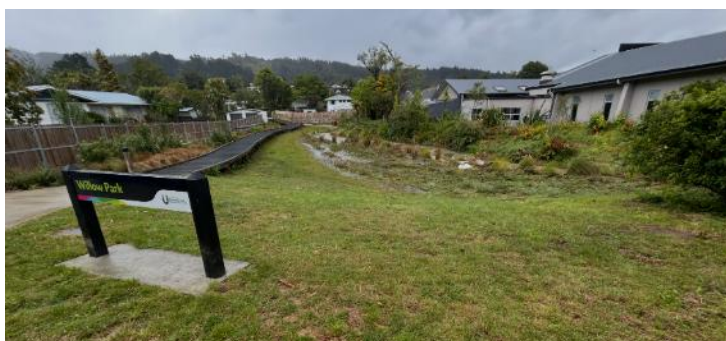
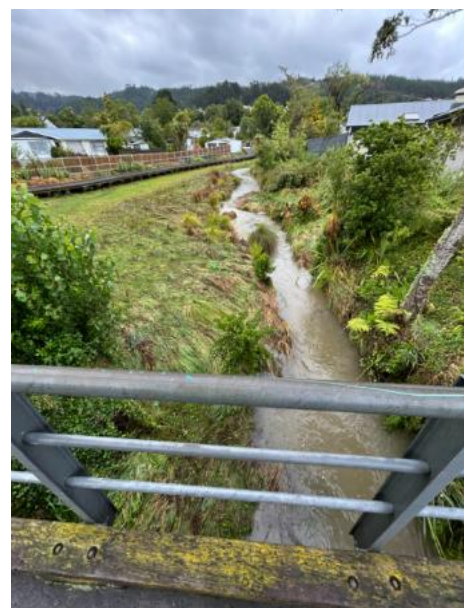
It seems that Greater Wellington Regional Council is considering reinstalling the stream gauge in Willow Park (below and right), but it has been heavily modified by the streamworks after the last significant storm event on 8 December 2019. In this location, estimation of discharge would be complicated and not be directly relatable to historical data from the previous gauge site (above).
