Warning Signs from the Hills

Forestry Runoff, Debris and Flood- Modelling Risk in Pinehaven and Silverstream

Report on the 18 April 2026 Storm

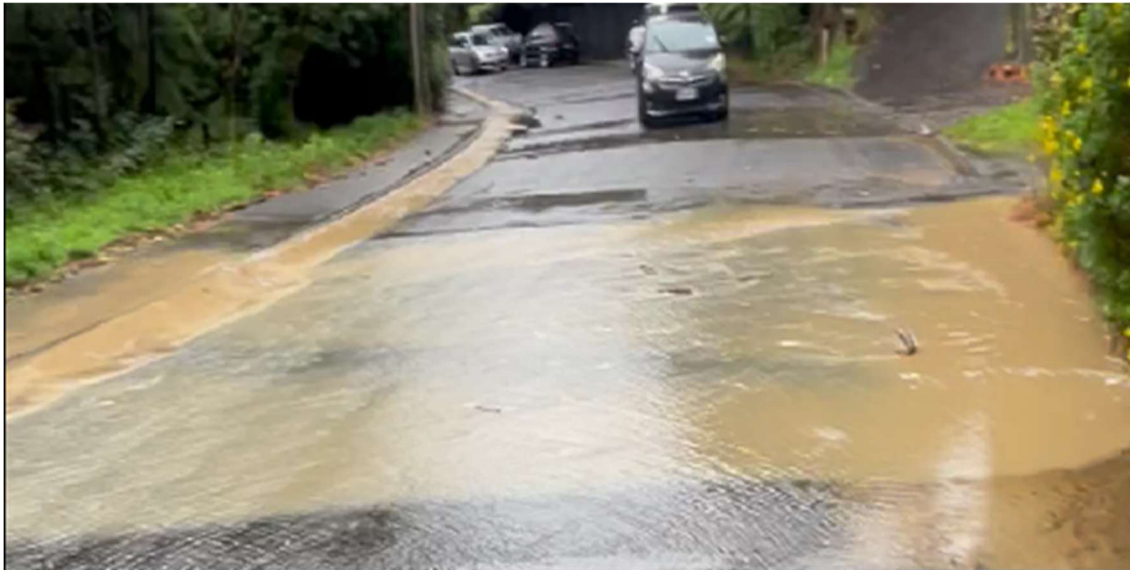
On the morning of 18 April 2026, the drain intake near 108A Wyndham Road became blocked, causing sediment-laden water to overtop onto the road.

Figure 4 Overtopped culvert near 108A Wyndham Road, 18 April 2026, 9:49am

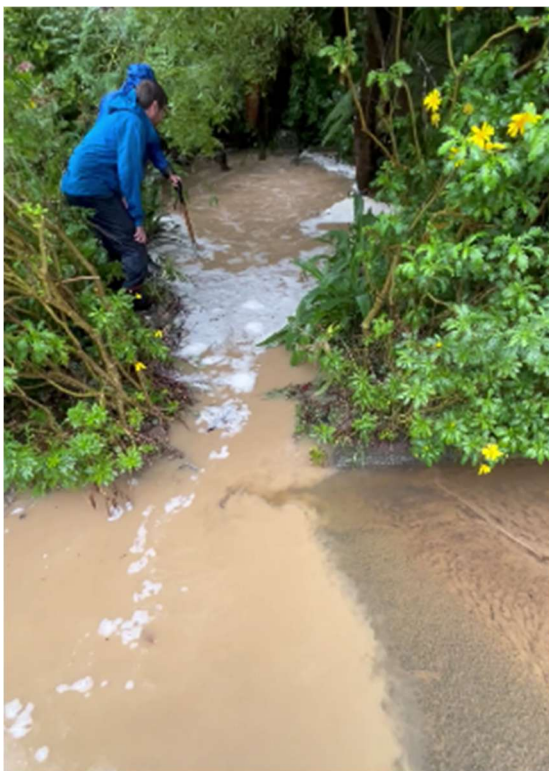
Figure 5 Wyndham Rd culvert blocked, 9:49am

Efforts were made to clear the culvert intake (Figure 5) but it was not possible until after the storm had passed. The intake was buried under rocks, gravel, wood and other debris (Figure 6). Where did this material come from?

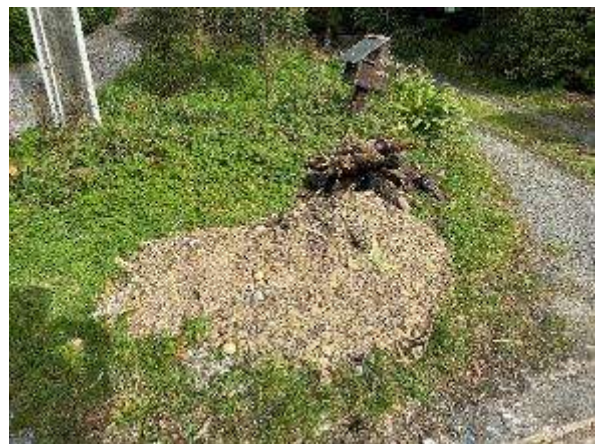
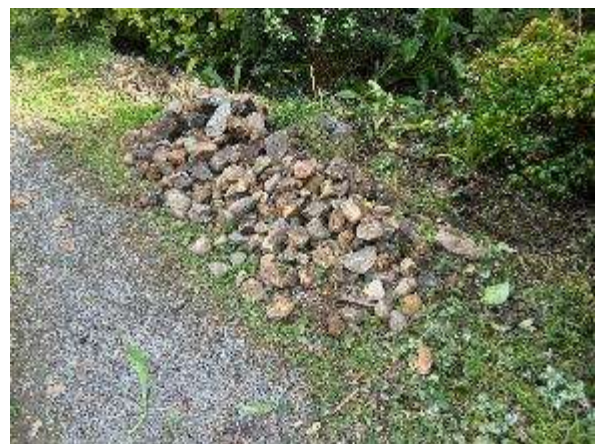
Figure 6 Gravel, rocks cleared from culvert

The culvert near 108A Wyndham Road was blocked by gravel, rocks, wood, debris and sediment. This does not prove that the recently cleared hillside was the only source of the blockage. However, the location of the forest clearance, the downhill runoff pathways, and the type of material found at the culvert are consistent with that explanation.

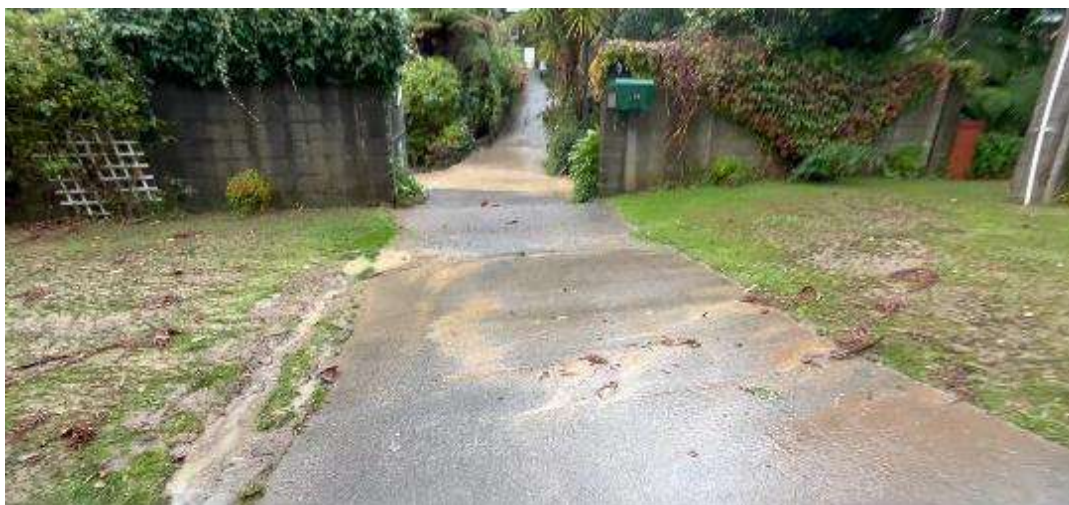
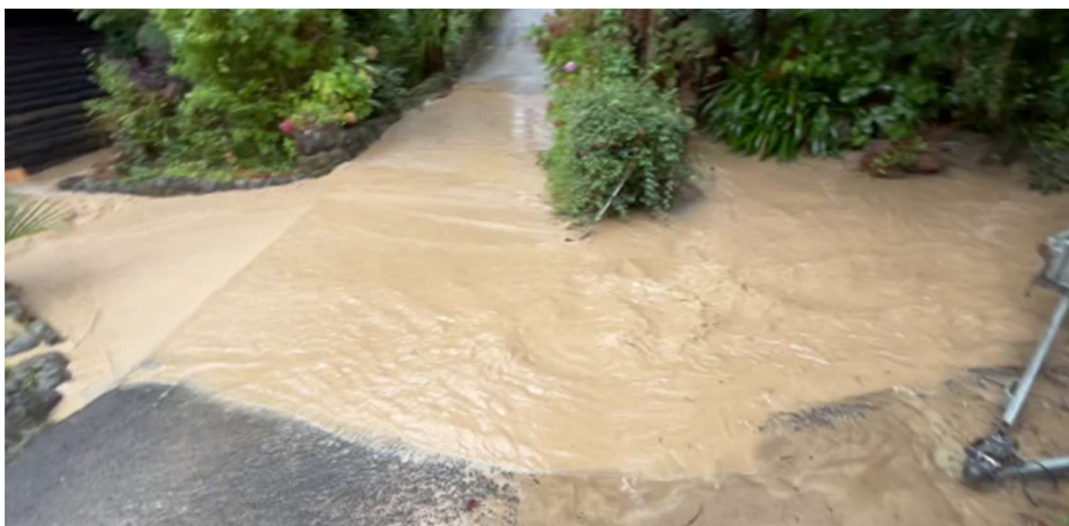
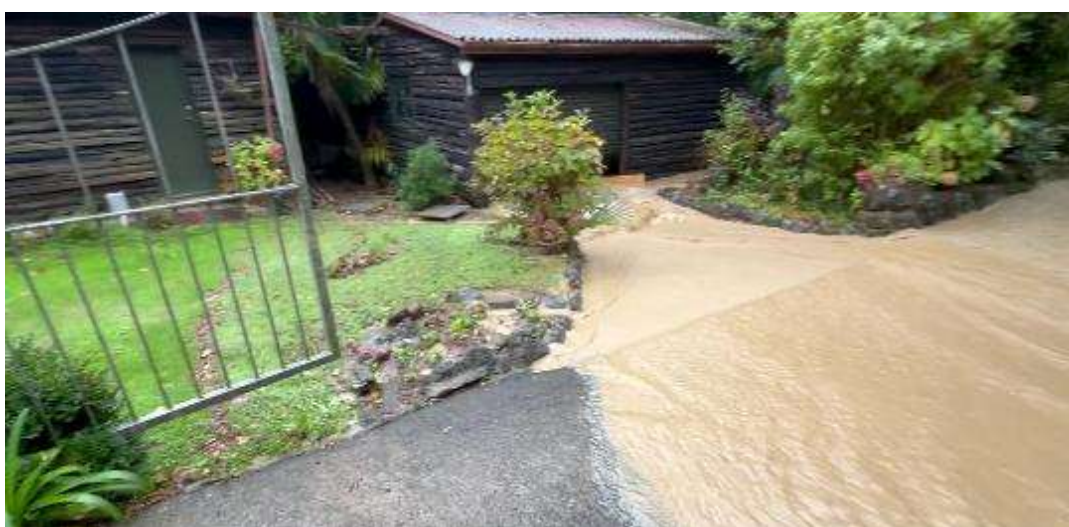
Figure 8 Blocked driveway culvert at 125 Pinehaven Road, 18 April 2026, 10:05am

Figure 9 Flooding of driveway at 125 Pinehaven Road, 16 February 2026, 11:37am

The clogged channel on 16 February diverted a torrent of water over the driveway and through the garage (Figure 9). The owner said the water reached 18 inches / 450mm deep in the garage. The floodwater damaged the car, which was written off and covered by insurance. Some tools and other equipment were also damaged.

A similar problem occurred again on 18 April 2026, when the driveway culvert was again unable to convey the flood flow and water overtopped the driveway (Figure 8).

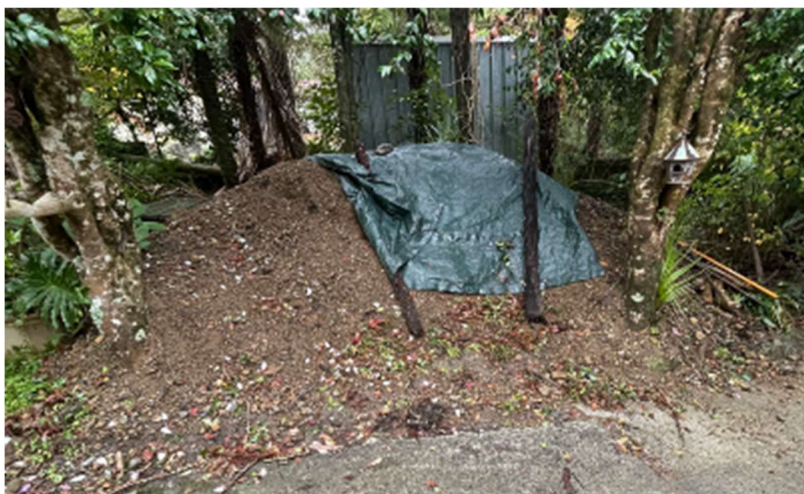
After the 16 February flood, the owners removed a large quantity of gravel, rocks and debris from the stream channel. Figure 11 shows part of that material piled beside the driveway. The owners said this was only about half of the material removed; the remainder was used to reinstate land behind the garage that was scoured away by the floodwater.

Figure 11 Gravel and debris from 16 February 2026 flood

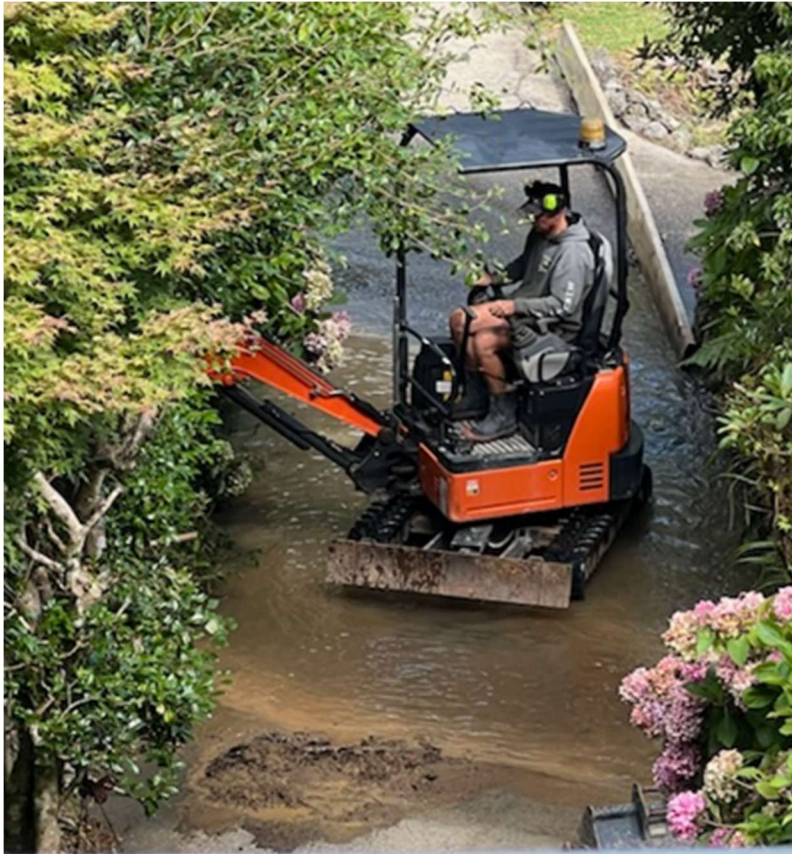
Figure 12 Contractor removed about 30m³ of gravel and debris from the stream channel at 125 Pinehaven Rd

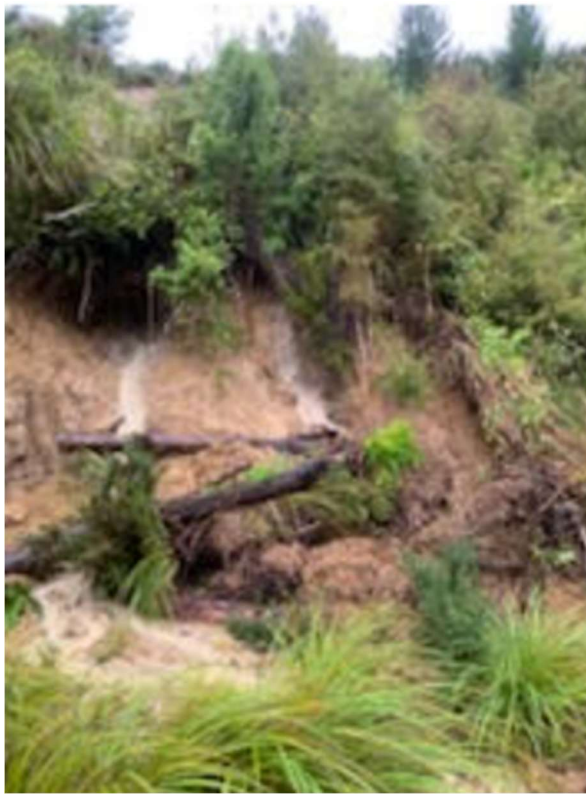
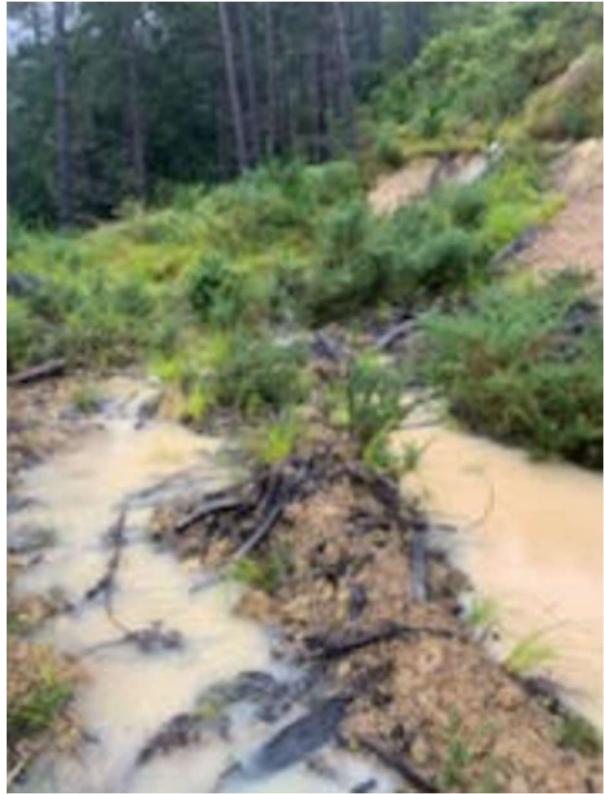
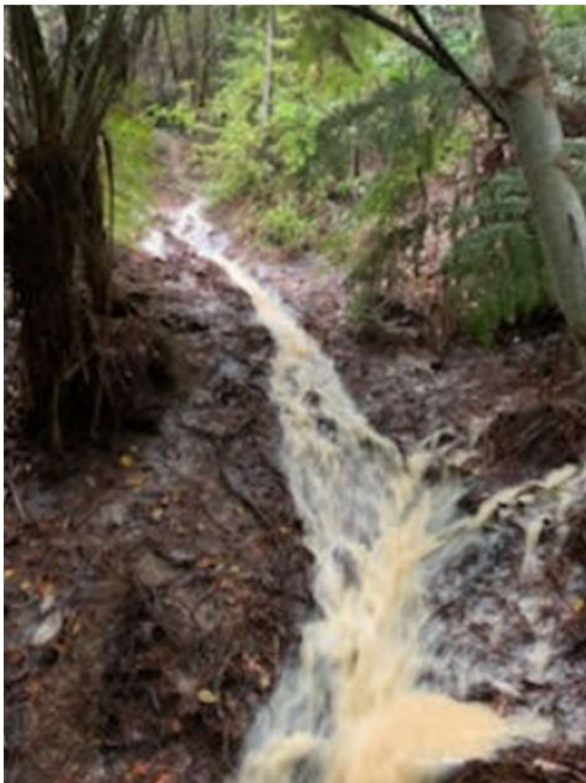
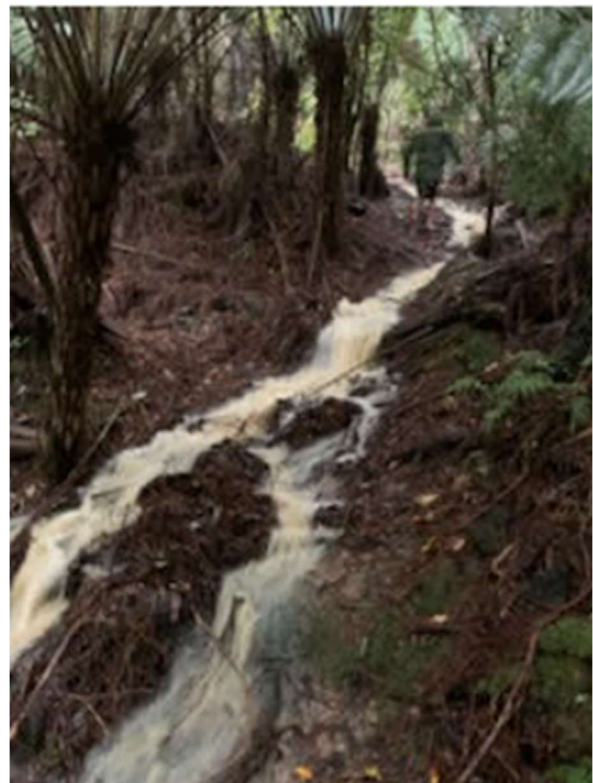
Figure 18 "We've never had this before", 16 February 2026. Photos: Affected resident

Affected resident, 16 February 2026: "We've never had this before... Huge amounts of water coming down the gully from the forestry clearing up top. ... So this is just coming down from the forestry, and we've never had water coming down like this before ... one long stream coming down the hill."

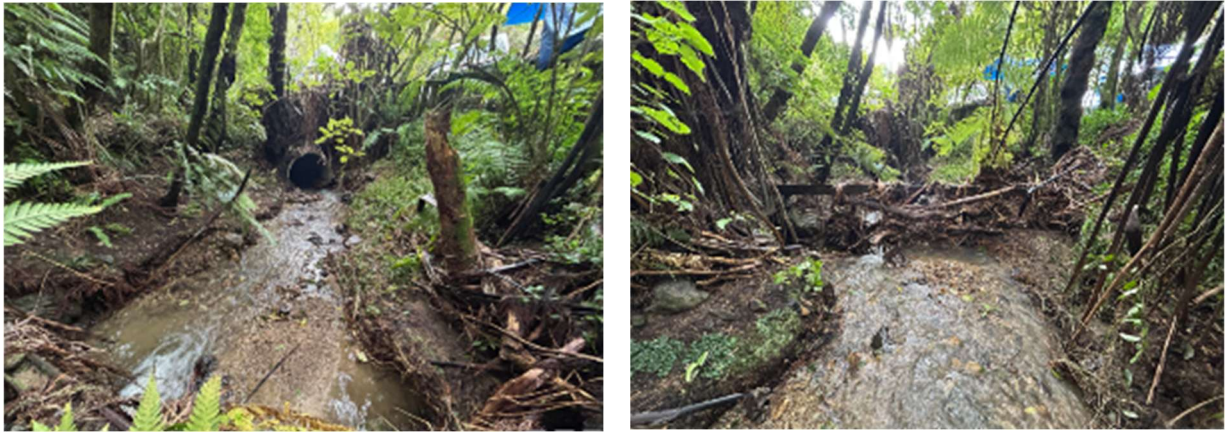
Just beyond the affected property’s back yard is the intake of a pipe that runs down to the open channel near the cul-de-sac at the end of Pinehaven Road. A little upstream from the pipe is a small debris trap (Figure 19), and a little further again upstream is a larger debris trap (Figure 20). “The debris traps and pipe here were pretty bad during the February storm, then higher flow and more gravel came down and filled the larger trap on 18 April” (affected resident).

Figure 19 The intake pipe (left, view downstream) and a small debris trap (right, view upstream)

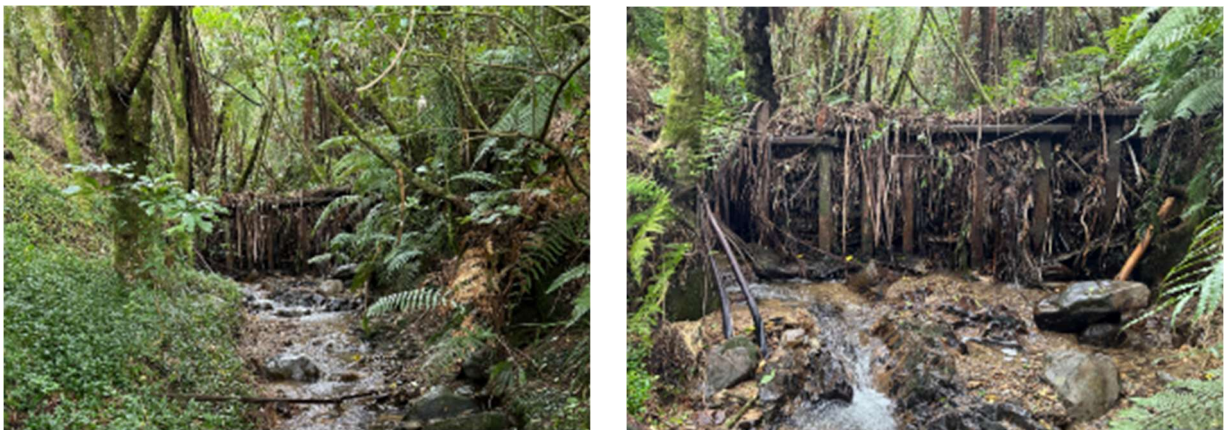
Figure 20 Upstream is a larger debris trap (both views looking upstream). Photos: FloodingUs NZ Ltd

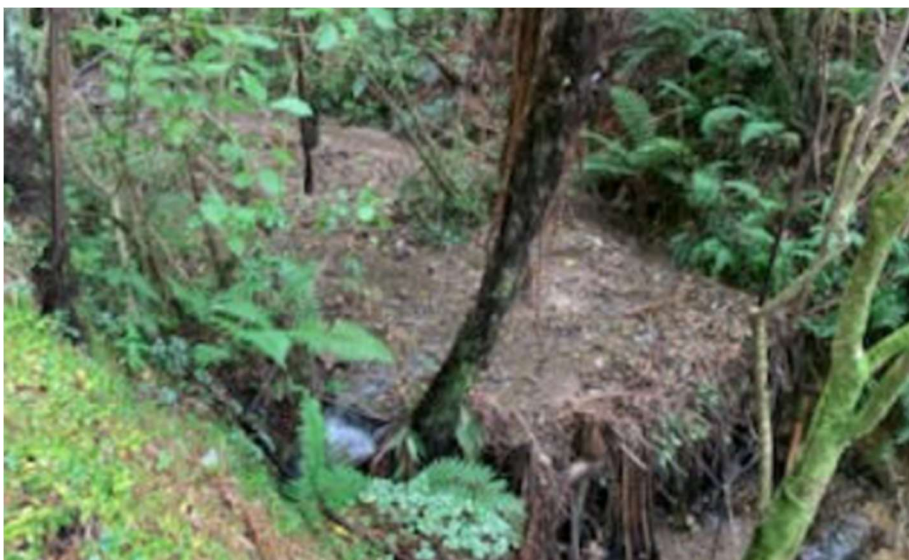
Figure 21 The debris dam began forming in February and then was substantially enlarged on 18 April, 2026

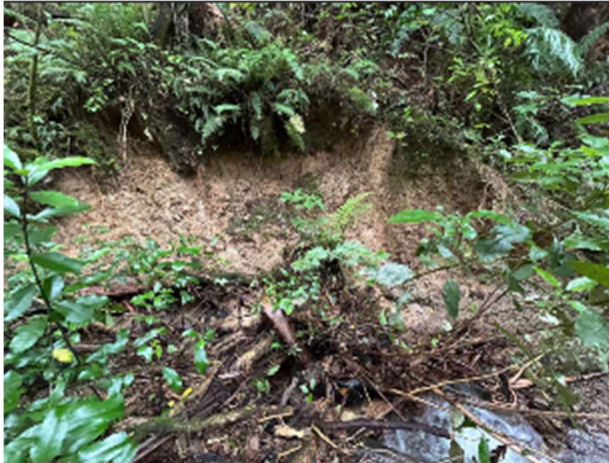
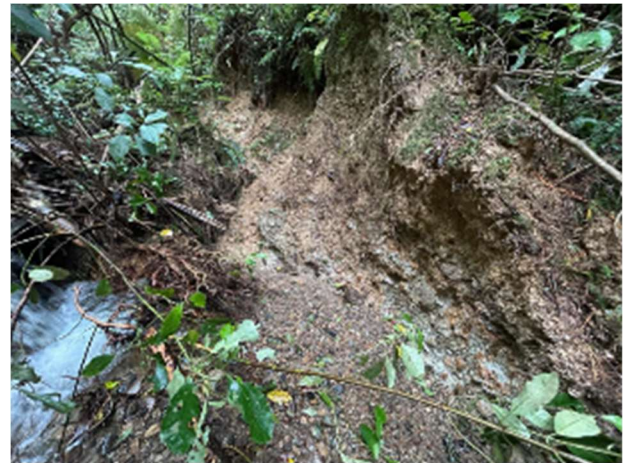
“the most significant erosion (scouring of bank, new gravel and debris, fallen trees) occurred in the 18 April event. My teenager goes exploring upstream regularly with our dog and has noticed significant changes after that rainfall event.”

Figure 24 Bank erosion upstream of the debris dam. Photos: Flooding Us NZ Ltd

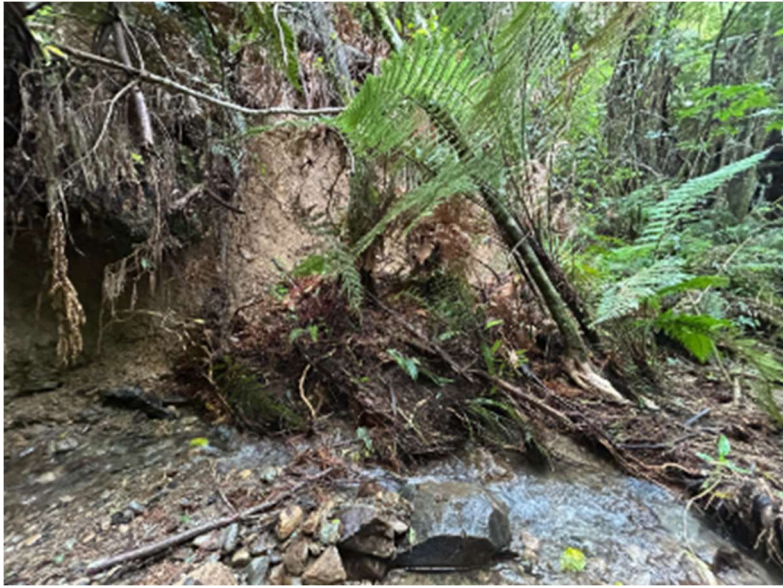
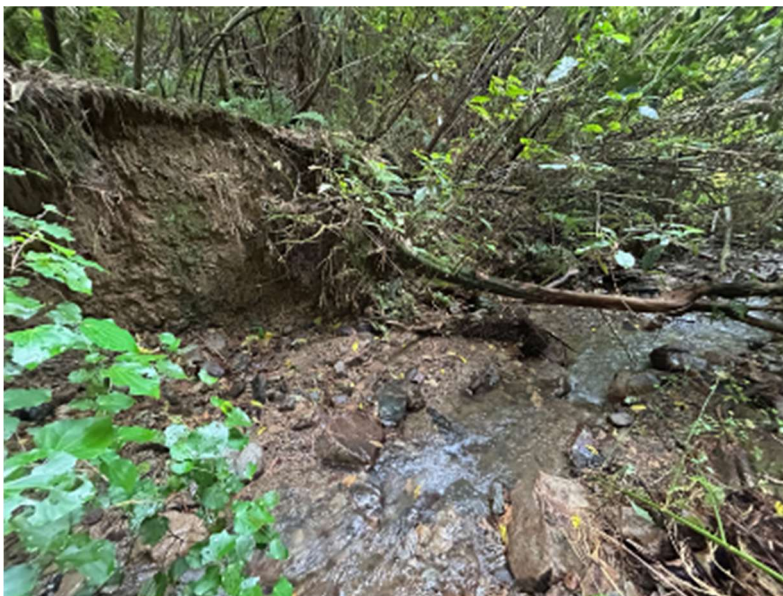
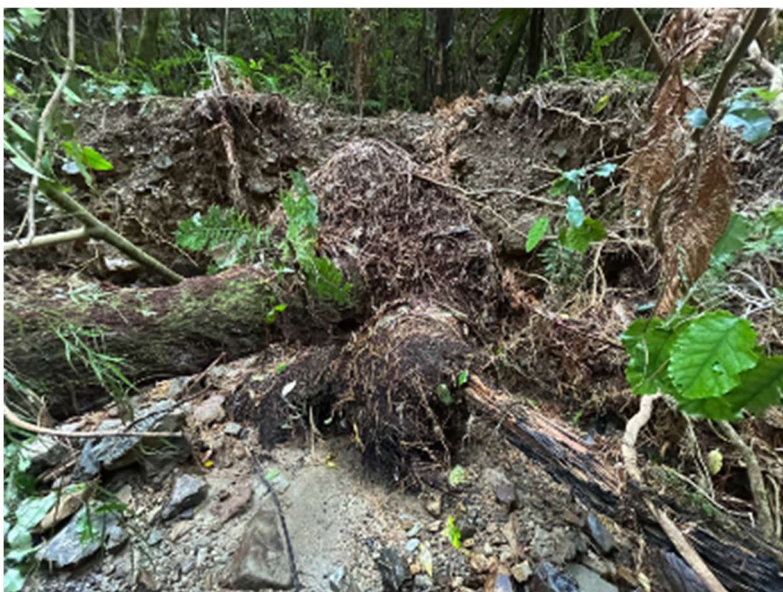
Figure 26 More examples of bank erosion upstream from the debris dam

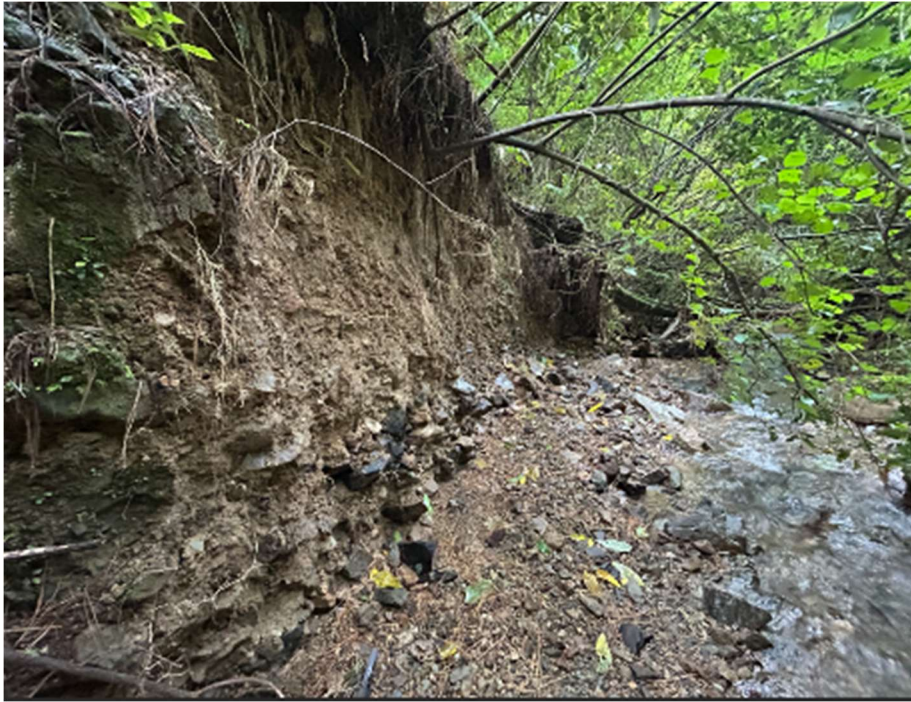
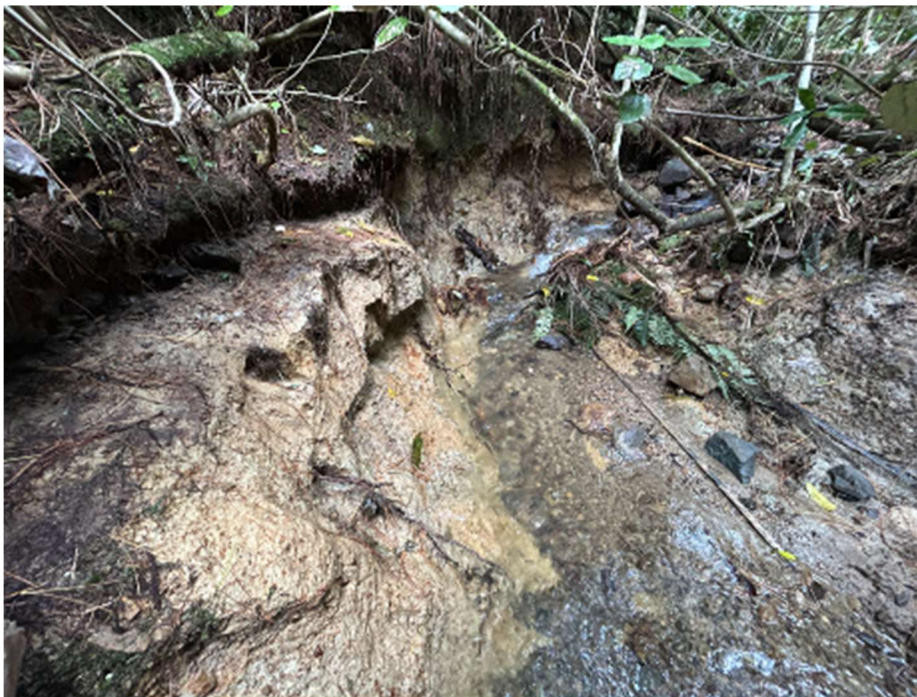
Figure 28 Scouring of the stream banks and bed. Photos: Flooding Us NZ Ltd

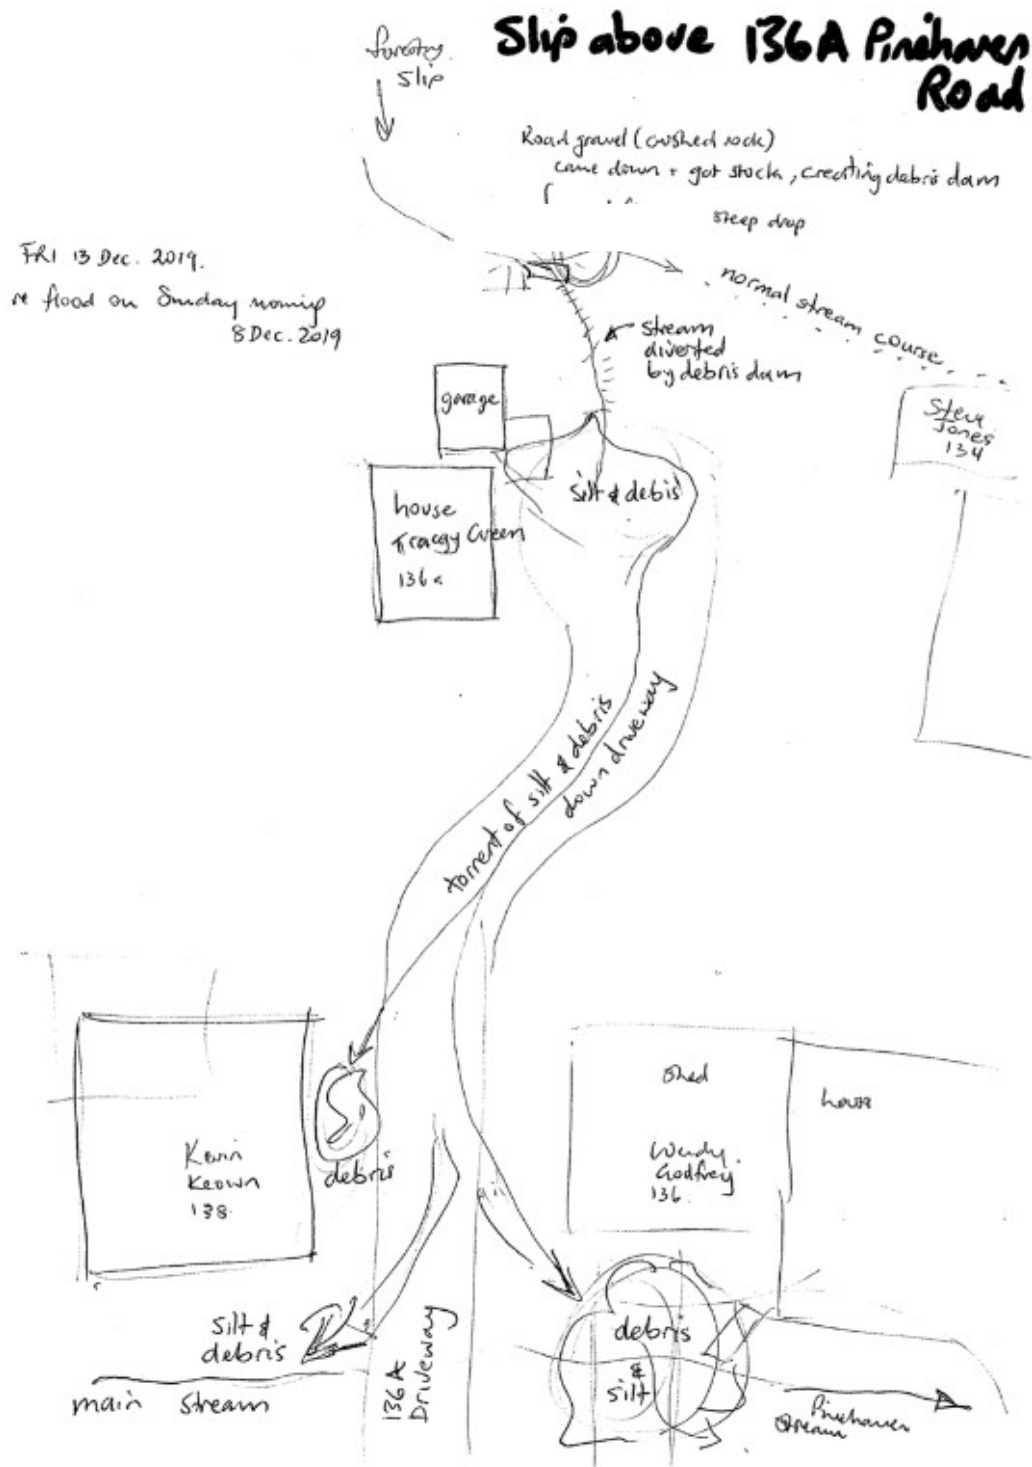
“A huge deluge of water ... carrying tons of silt and stones.... causing an immense amount of damage to our properties ... The drive was full of mud, stones and silt, well over nine inches deep in places ... I started to get quotes for its removal. ... We estimate 26 tons of earth ended up on our land and our neighbours from one event. In total we paid just under \$4000 to deal with this event.... My partner and neighbour trekked back up the hill, tracking up the stream to the ridge, and remain convinced after viewing the slip that it originated at the top, by the logging area.” Owner at 136A Pinehaven Road

Figure 37 Sketch (by nearby neighbours) of the slip at 136A Pinehaven Road

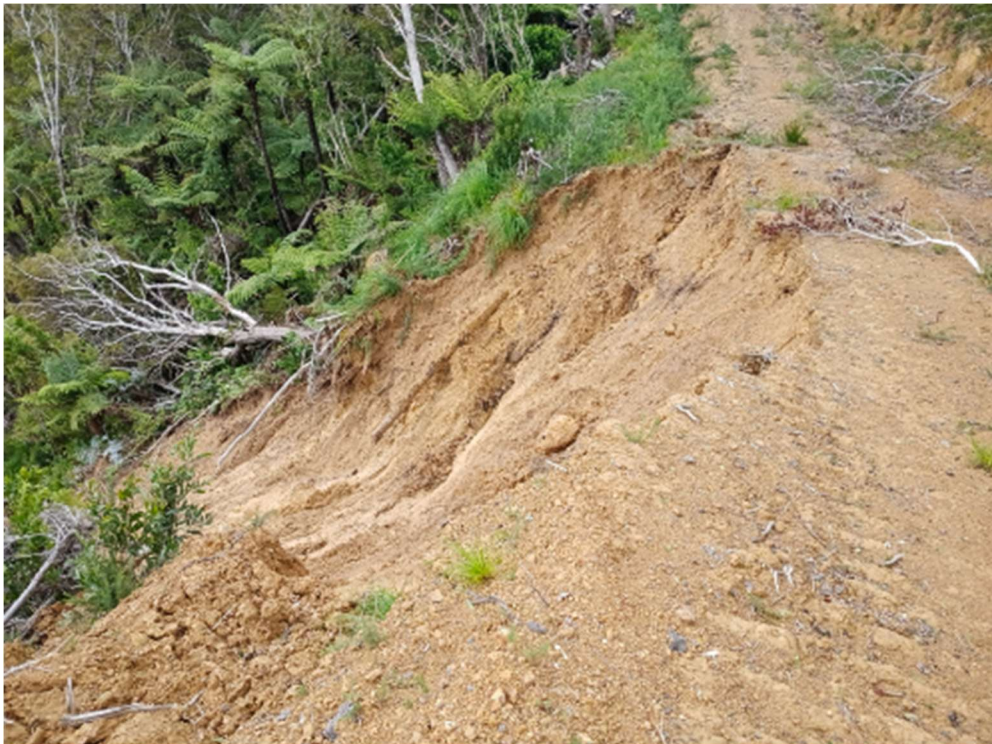
The slip occurred on the edge of a forestry road cutting (Figure 40). The gully in which it occurred drains down toward the stormwater pipe intake in the small public reserve between Pioneer Grove, Sorrento Way and Kurth Crescent.

Figure 40 Landslide occurred on edge of GTC logging track (Photo: Dennis Clark)

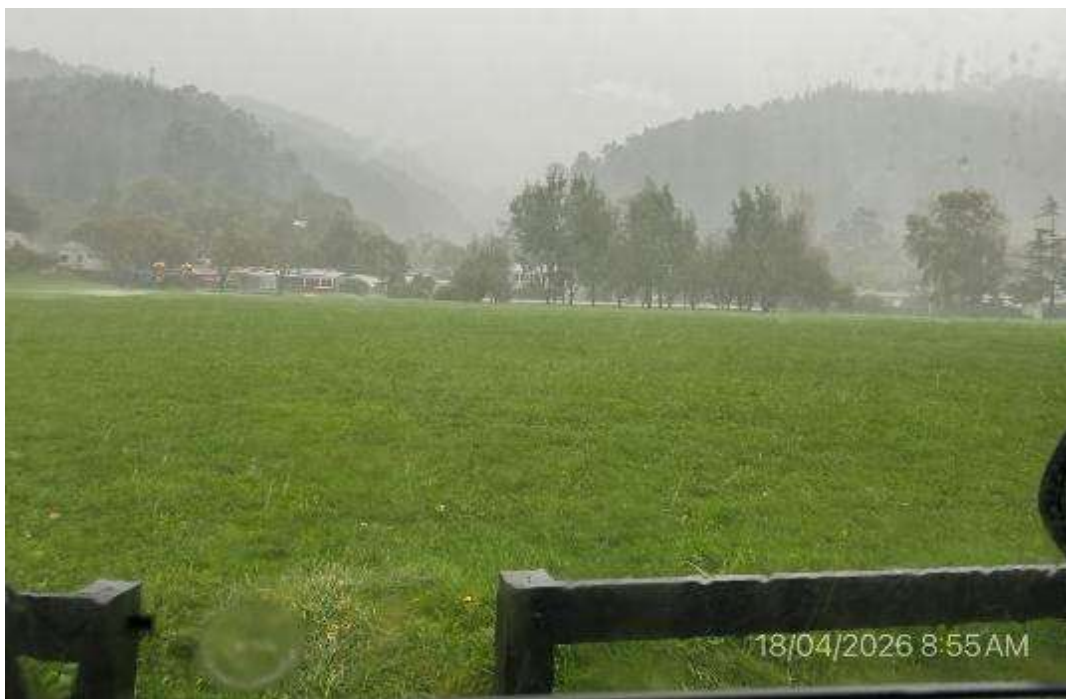
Figure 53 Pinehaven Reserve looking south 18 April 2026 at 8:55am - not flooded

Figures 52–58 above show photographs taken of Pinehaven Reserve during and shortly after the peak flow on 18 April. GWRC’s 1-in-10-year flood map shows Pinehaven Reserve totally flooded. But in three flood events all larger than 1-in-10-year events (8 December 2019, 16 February 2026 and 18 April 2026) Pinehaven Reserve did not flood. All three events demonstrate that the official flood maps grossly exaggerate flooding and are unreliable.

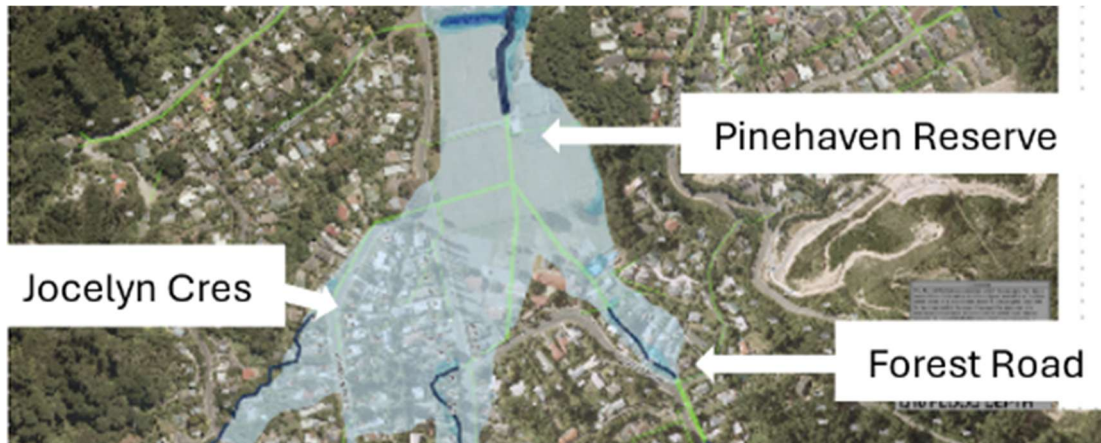
Figure 59 Close-up of GWRC 10-year flood map for Pinehaven Reserve / Jocelyn / Forest Road

In Figure 59 above, roughly 99% of the flooding shown in this part of GWRC’s 1-in-10-year flood map did not occur on 18 April 2026, estimated as larger than a 1-in-10-year event.

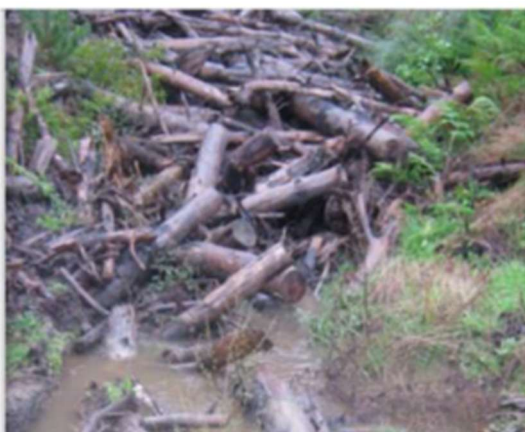
Figure 62 The future built into the baseline

- **Manning's n = 0.2** for the upper catchment, i.e. for the main stream and all stream branches that are upstream of Pinehaven Reserve;
- **Manning's n = 0.05** for the lower Pinehaven Stream reach from Pinehaven Reserve to Hulls Creek;
- **Manning's n = 0.035** for Hulls Creek; and
- **Manning's n = 0.015** for concrete piped sections.

The very high upper-catchment value of **n = 0.2** (a clogged channel) matters because a normal functioning channel conveys water downstream. A clogged or highly obstructed channel does not: it backs water up, pushes water out of the channel and makes flooding appear much worse.

Council modelled the streams totally clogged!

Figure 62 shows how the future has been built into the baseline flood model. SKM's Pinehaven flood model used a very high roughness value for all the upper catchment stream channels, effectively treating all the existing channels that are upstream of Pinehaven Reserve as if they are already severely obstructed or clogged.

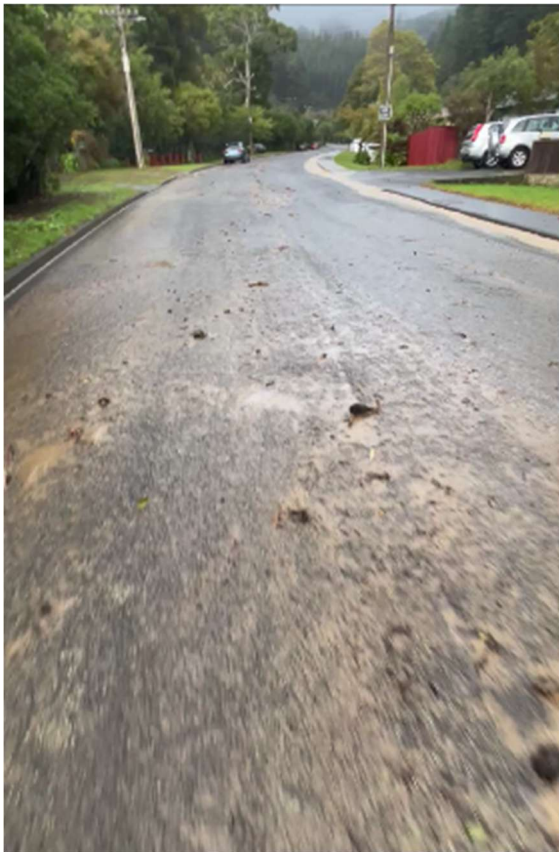
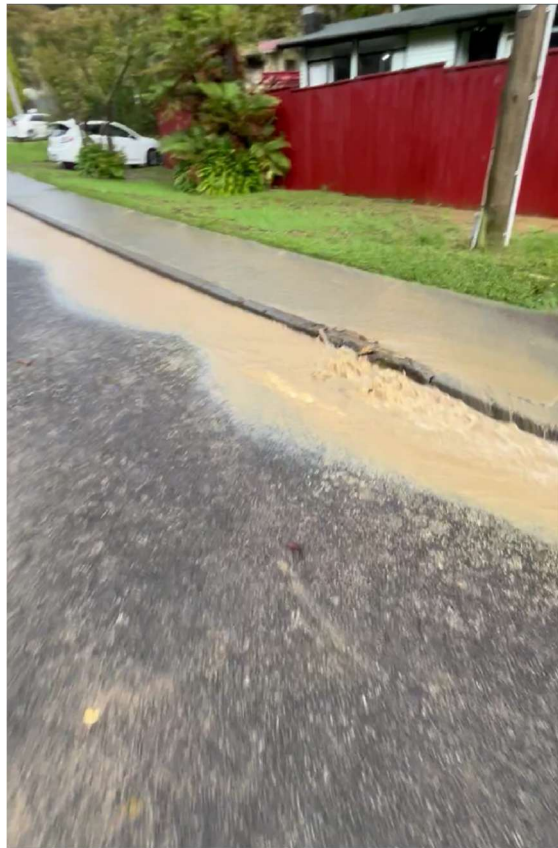
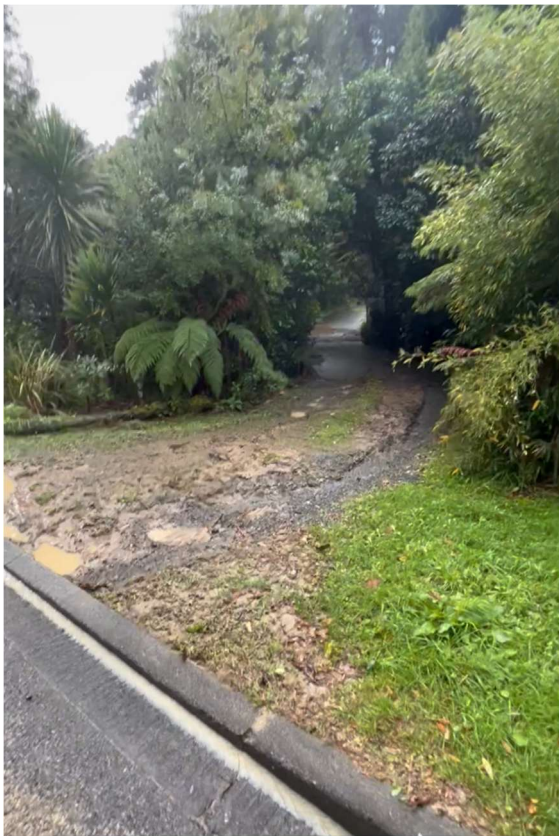
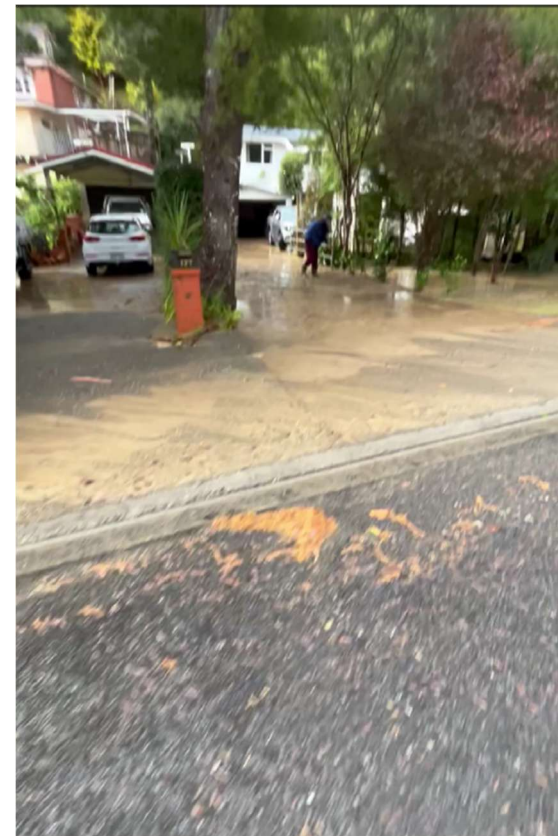
Some driveways and garages received significant flow that overtopped road gutters and berms.

Figure 65 18-4-26 9:58am View south up Pinehaven Rd – full carriageway and berms flooded

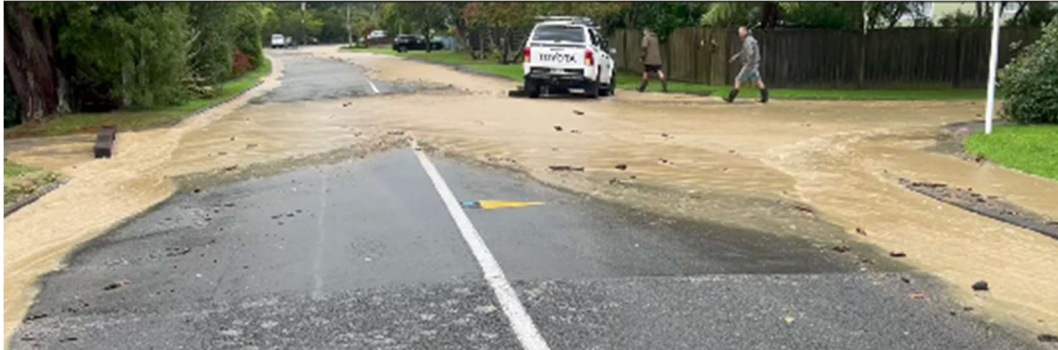
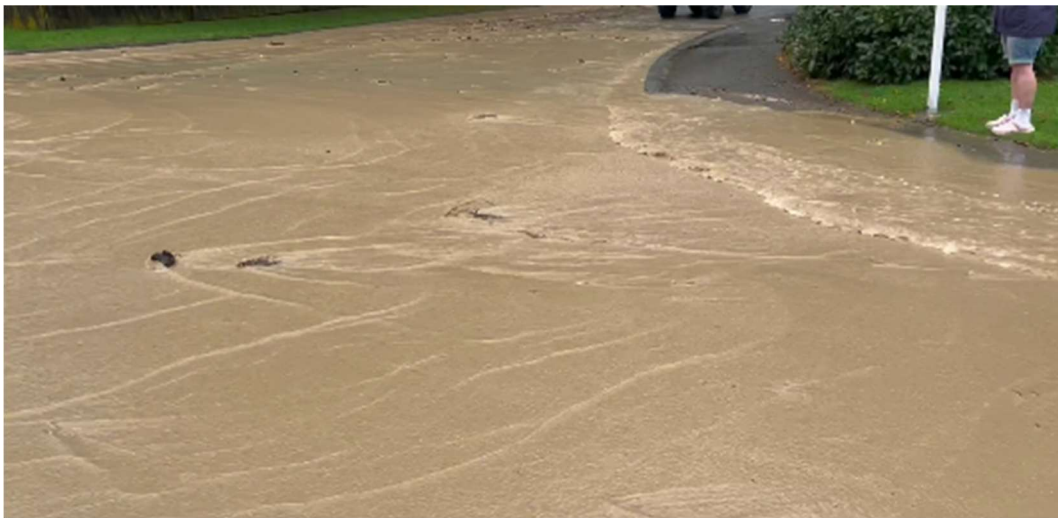
Water from the overtopped culvert at 122 Pinehaven Road (Figure 64) flooded the intersection at the southern end of Jocelyn Crescent on 18 April (Figure 67). A local resident on the scene said flooding down Pinehaven Road was worse than during the storm two months earlier (16 Feb).

Figure 67 18-4-26 9:44am Intersection of Pinehaven Road and Jocelyn Crescent (southern end)

This is a repeat of what happened during the storms on 8 December 2019 and 16 February 2026.

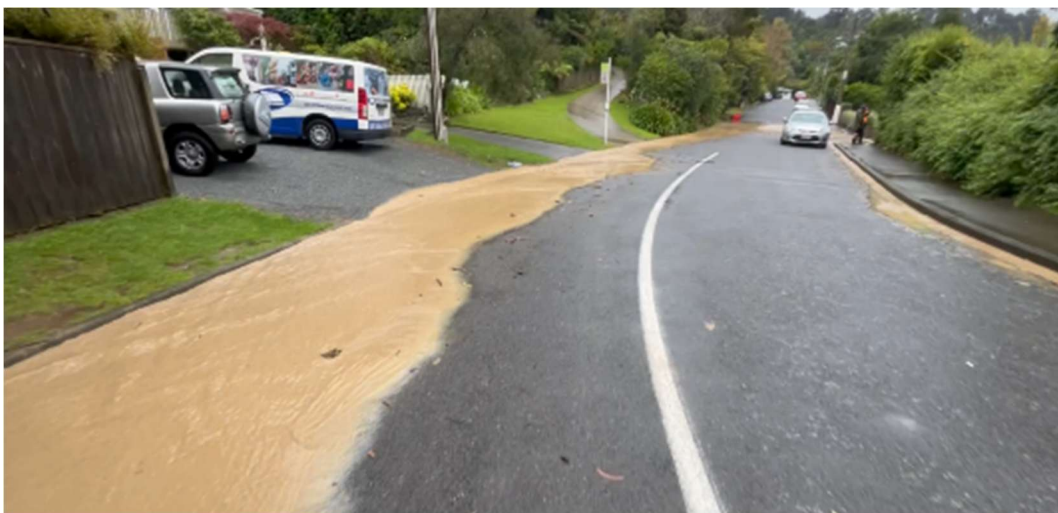
Figure 68 18-4-26 9:44am -Water flowing along Jocelyn Crescent from Pinehaven Road

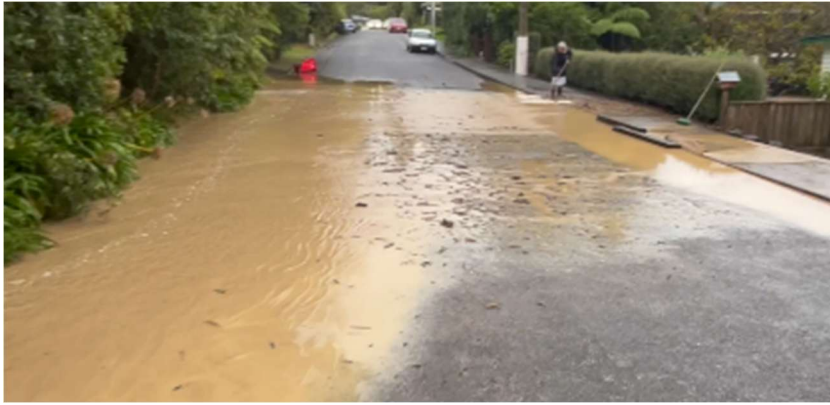
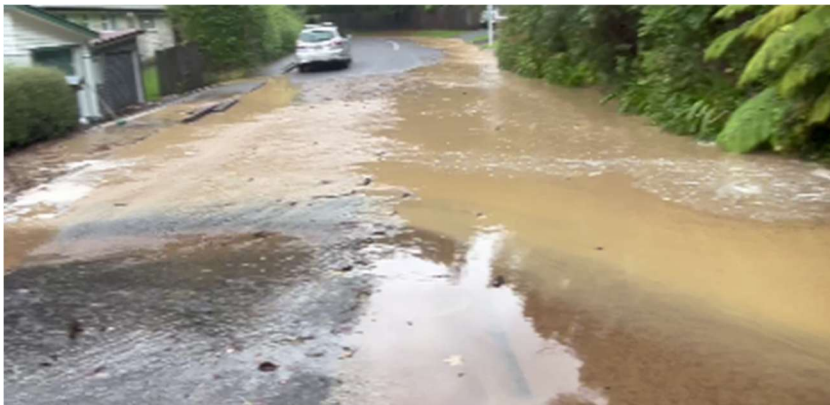
Figure 69 18-4-26 9:44am – Low point in road at 39 Jocelyn Crescent

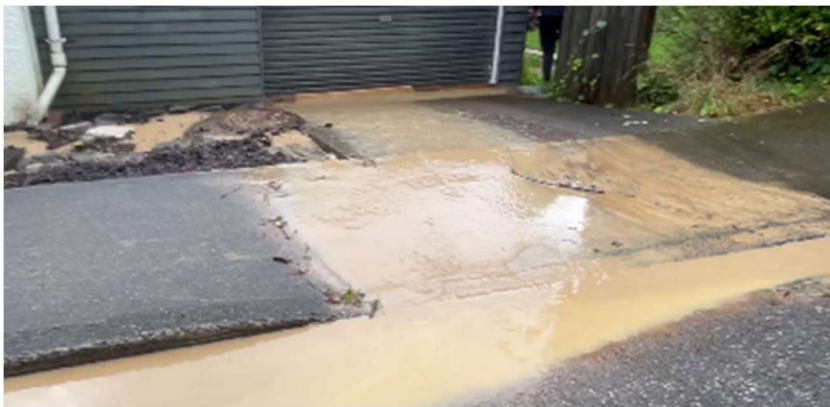
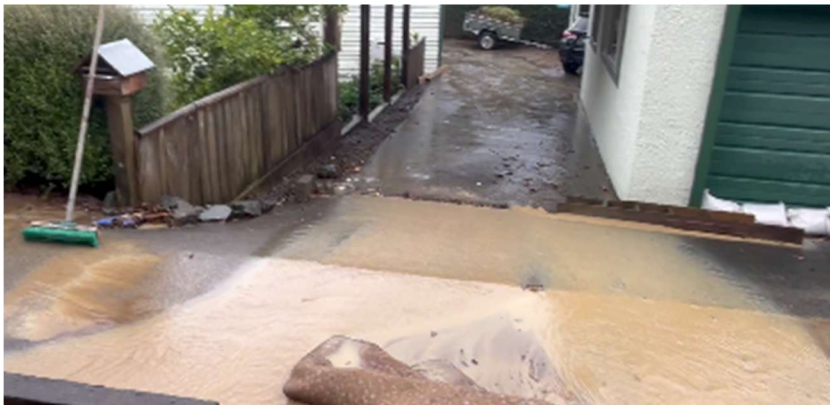
Figure 70 18-4-26 9:44am Water from 122 Pinehaven Road entered 39 Jocelyn Crescent

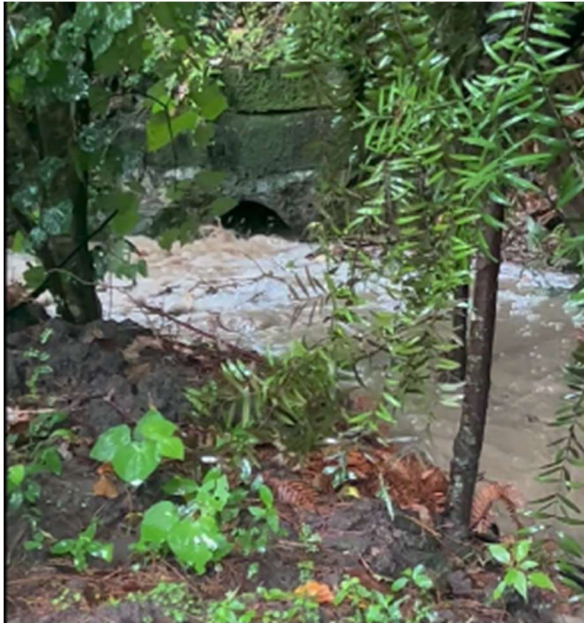
Figure 71 18-4-26 9:55am Public drain discharging into 37 Jocelyn Crescent

A public drain from under the road discharges into 37 Jocelyn Crescent (Figure 71) ...

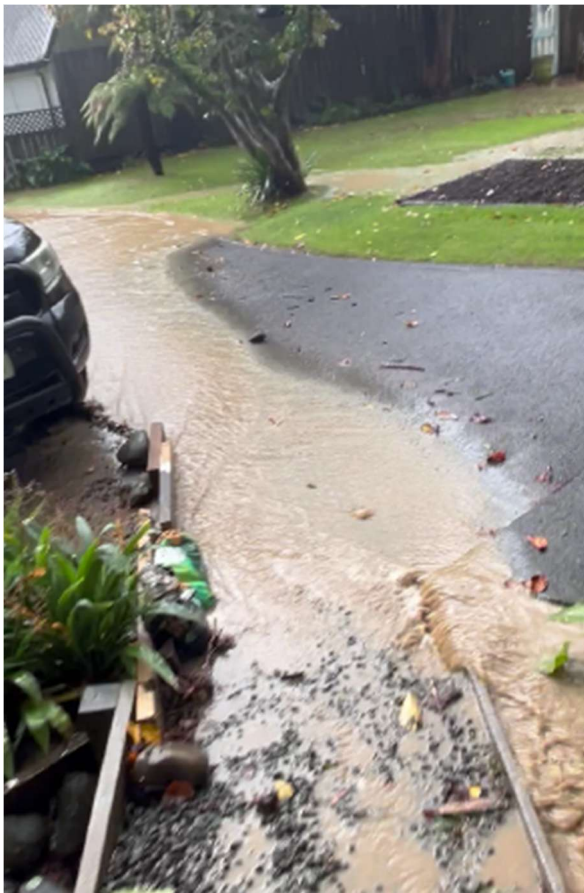
... causing flooding at 37 Jocelyn Crescent (Figure 72) ...

Figure 72 18-4-26 9:55am 37 Jocelyn Cres.

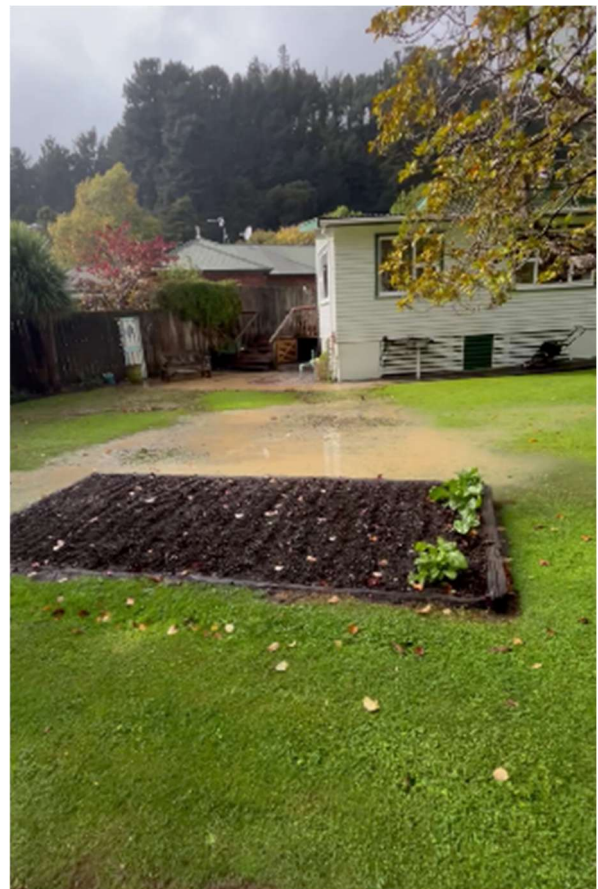
... and 39 Jocelyn Crescent (Figure 73).

Figure 73 18-4-26 9:55am 39 Jocelyn Cres.
