Warning Signs from the Hills

Forestry Runoff, Debris and Flood- Modelling Risk in Pinehaven and Silverstream

Report on the 18 April 2026 Storm

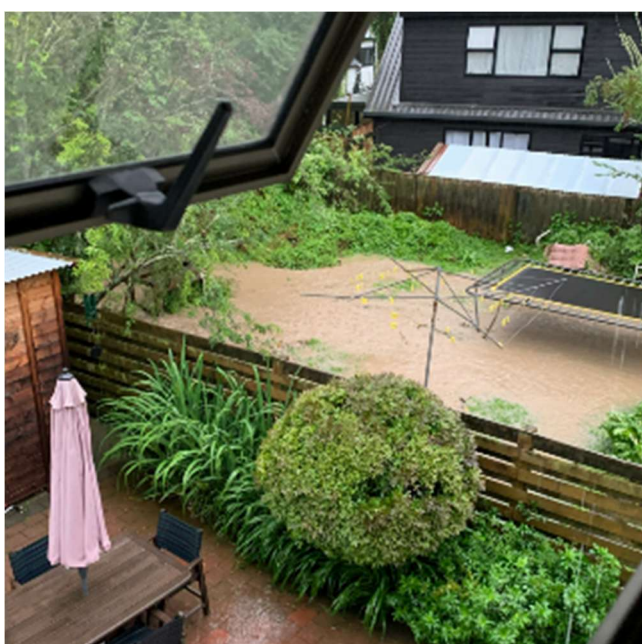
Water from the overtopped culvert near 108A Wyndham Road ran down Wyndham Road and into road sumps on each side of Jocelyn Crescent (Figure 75). These sumps are isolated from the public stormwater main drain which terminates a little further along Jocelyn Crescent. So these two isolated sumps discharge into an open channel on private property at 23 Jocelyn Crescent. After flowing through 23 Jocelyn Crescent, the open channel overtopped and flooded the back yard of 72 Pinehaven Road, similar to what happened on 8 December 2019 (Figure 76).

On 8 December 2019, flood water from the overtopped culvert by 108A Wyndham Road ended up flooding the back yard of 72 Pinehaven Road (Figure 75 and Figure 76). The resident owner of 72 Pinehaven Road said his back yard flooded again on 18 April 2026 (pers. com.).

Figure 76 Flooding on 8 Dec 2019 at 72 Pinehaven Rd (Photo: Murray Quinn)

This could be avoided if Council extended the existing stormwater drain in Jocelyn Crescent to connect to the two isolated road sumps instead of simply discharging them into the channel on the property at 23 Jocelyn Crescent.

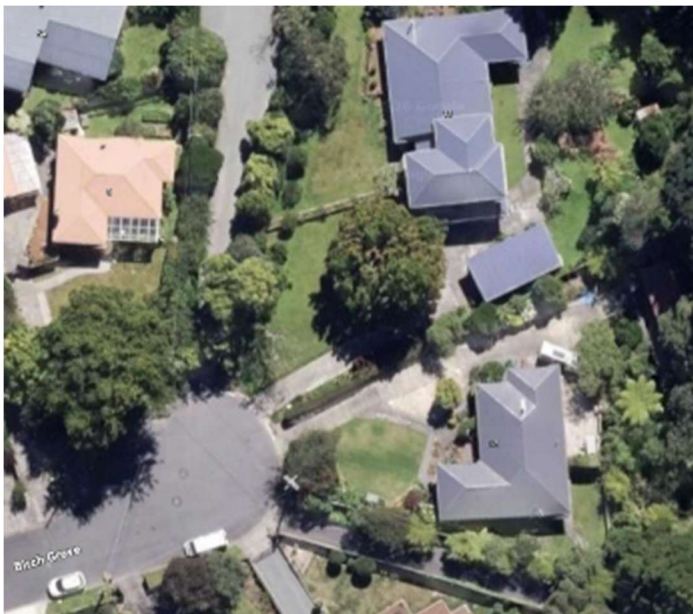
“During the storm on 18 April 2026, water came out of the stream channel behind the house at 12 Birch Grove and down its driveway into the Birch Grove cul-de-sac, then up into our driveway at 11 Birch Grove as far as the front of the garage and then receded again. It all happened very fast, within an hour. It was worse in April than it was in the previous storm in February.”

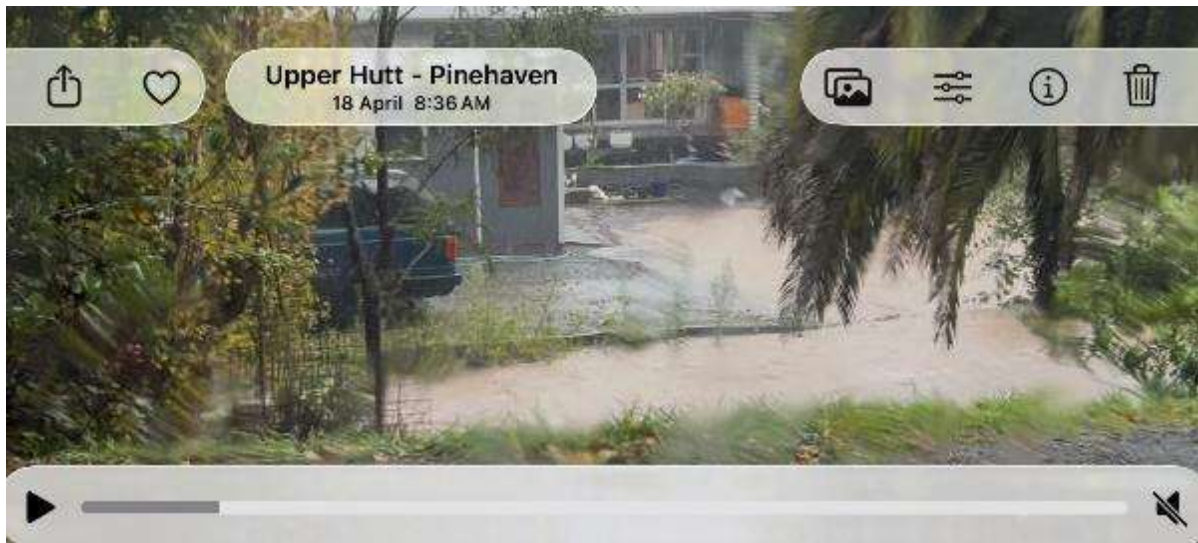
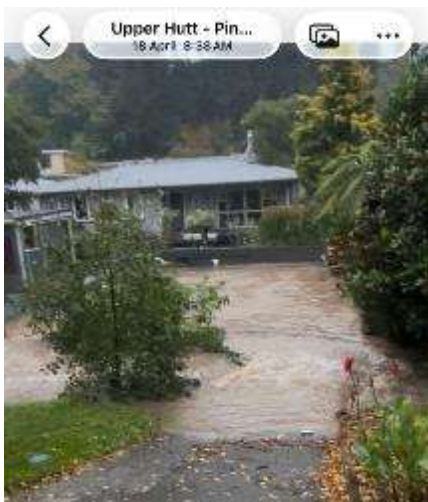
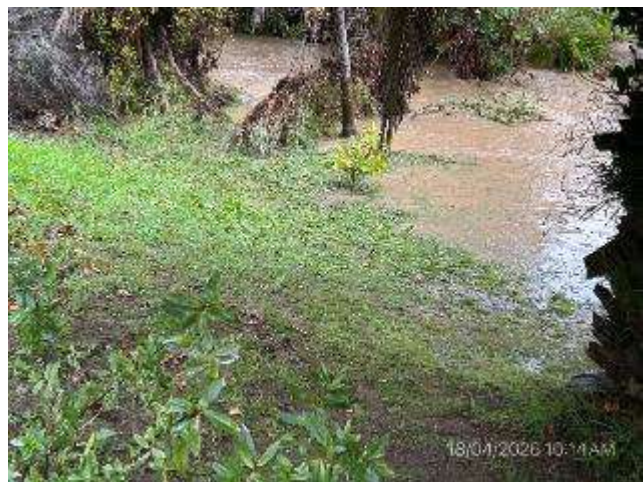
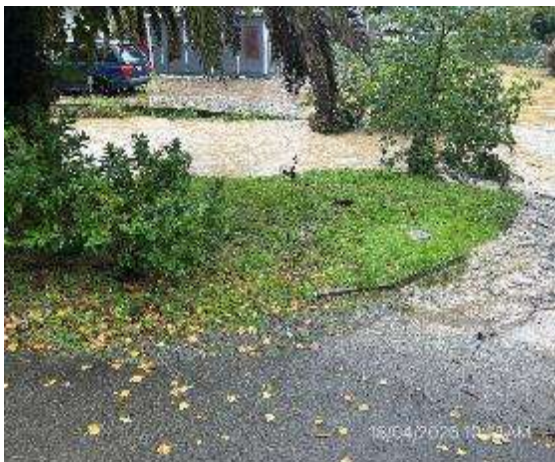
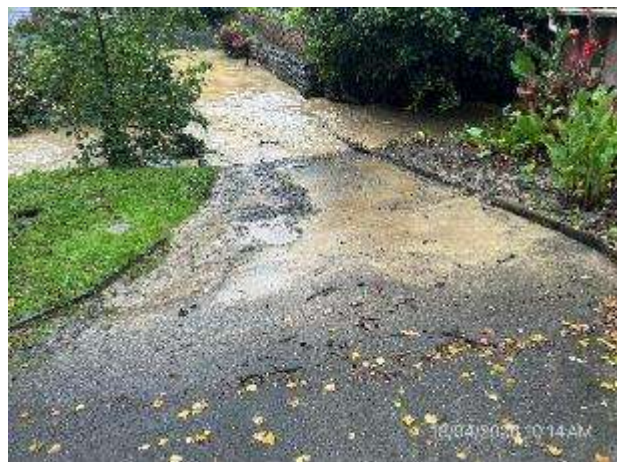
Flooding occurred on 18 April 2026 on the low lying land along Pinehaven Stream immediately downstream of the new Pinehaven Road culvert from 36 to 28 Blue Mountains Road.

Figure 80 18 April 2026 - 36 Blue Mountains Road, 8:36am rising and 10:14am receding

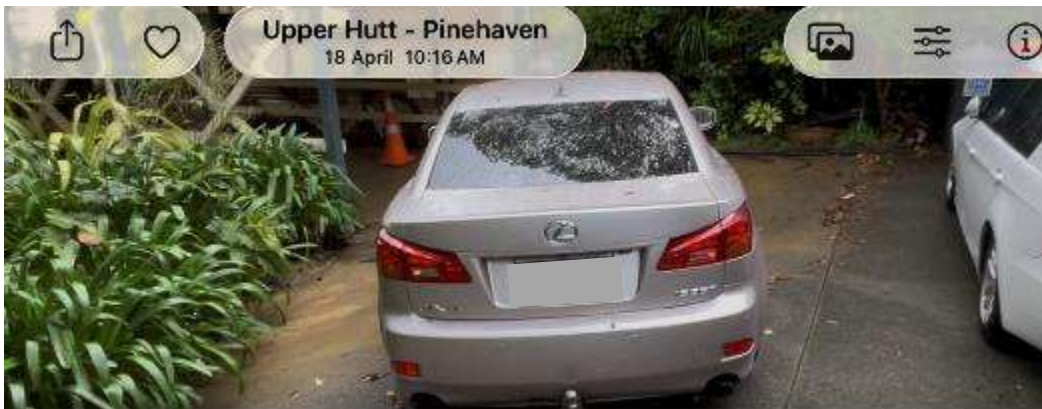
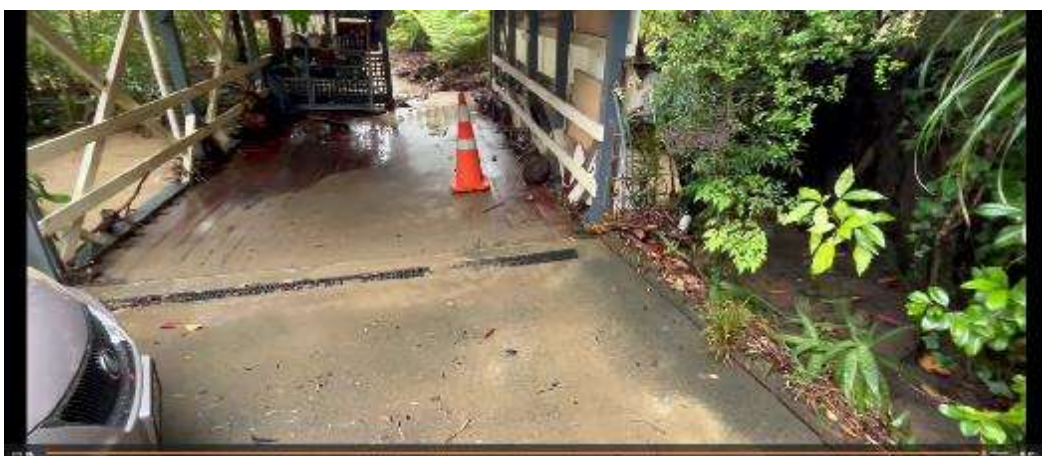
Figure 82 18 April 2026, 10:15am - 30 Blue Mountains Road – water has flooded the bridge

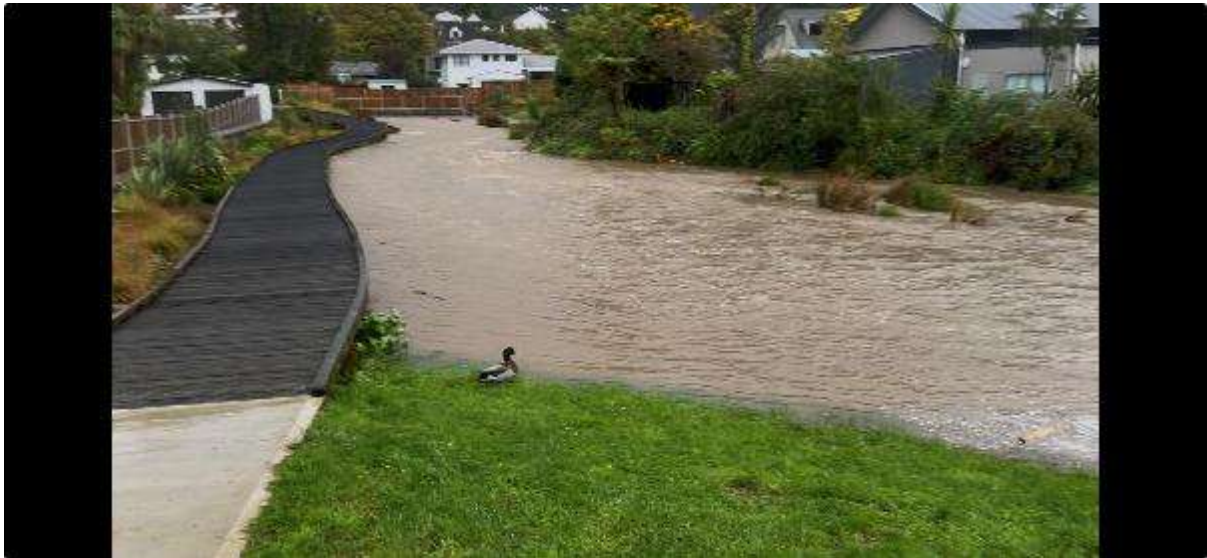
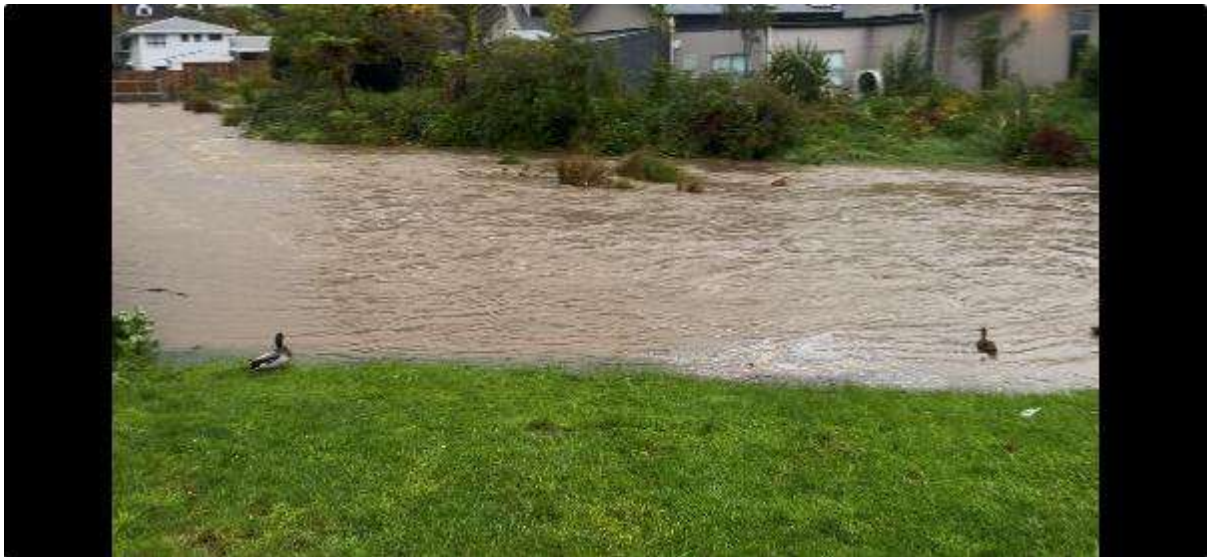
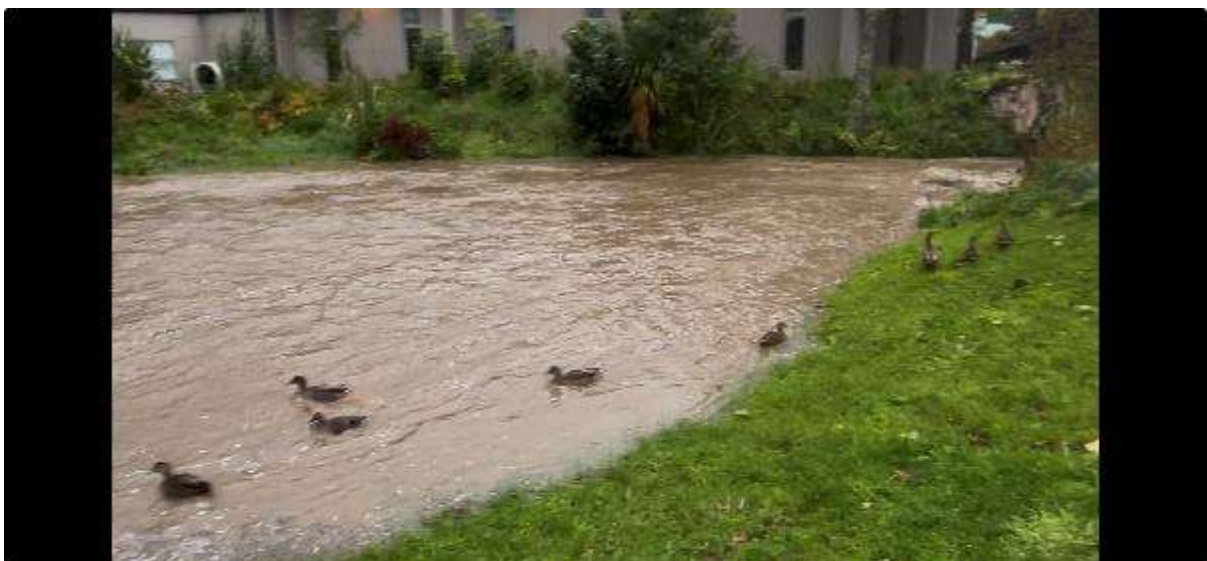
Figure 83 Willow Park - 18 April 2026 at 08:41am (before peak flow)

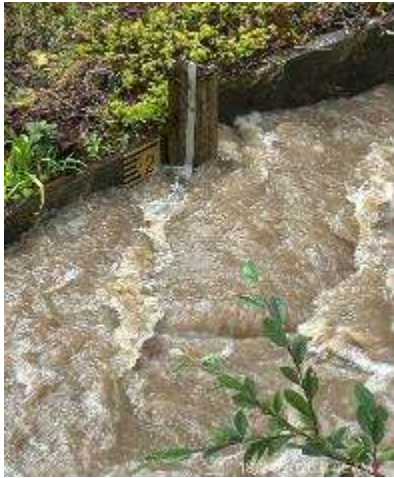
Figure 92 8:45am / water level 1.18m

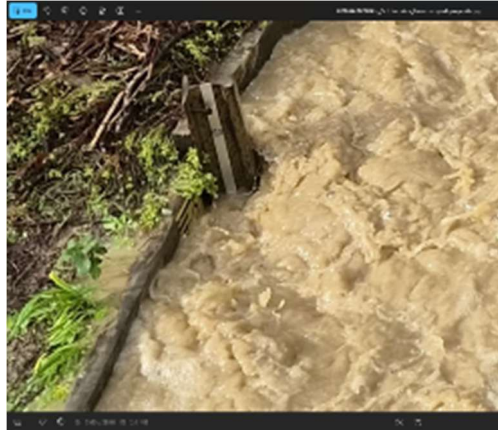
Figure 93 10:07am / water level 1.24m [Photo: C. Leenders]

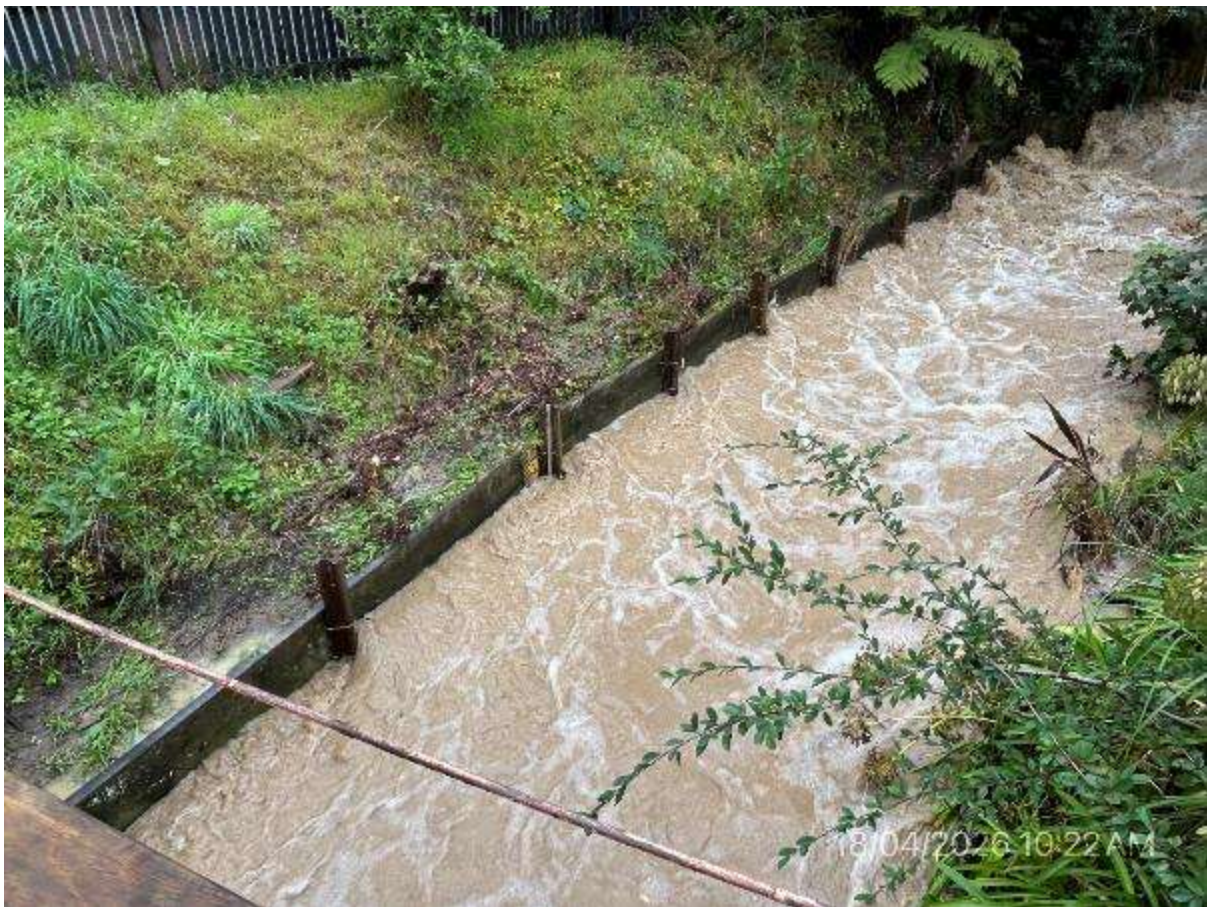
Figure 94 10:22am / water level 1.05m

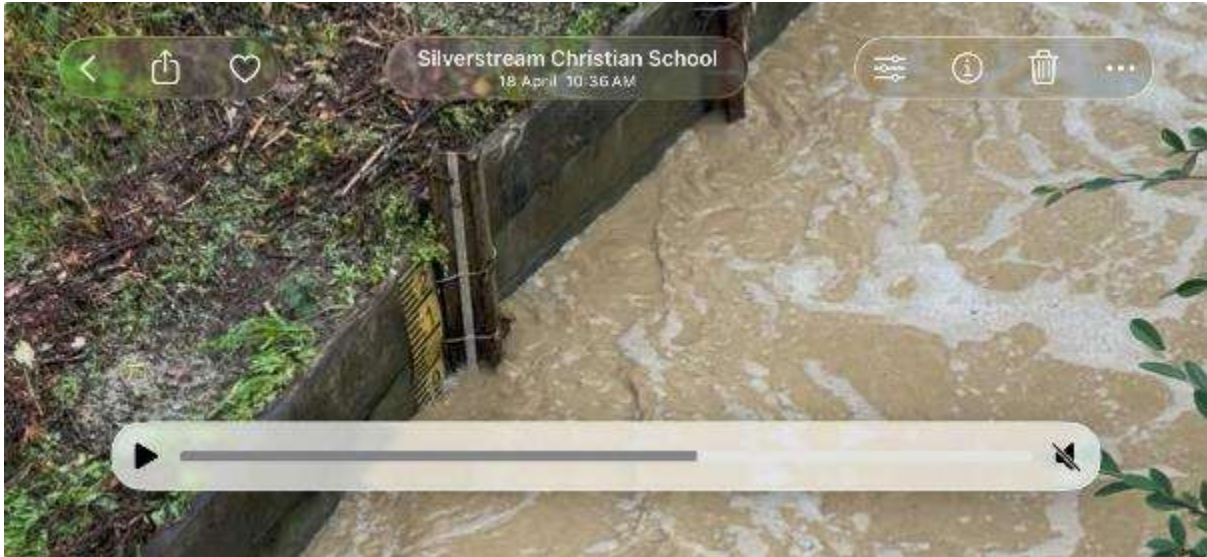
Figure 95 10:36am / water level 0.93m

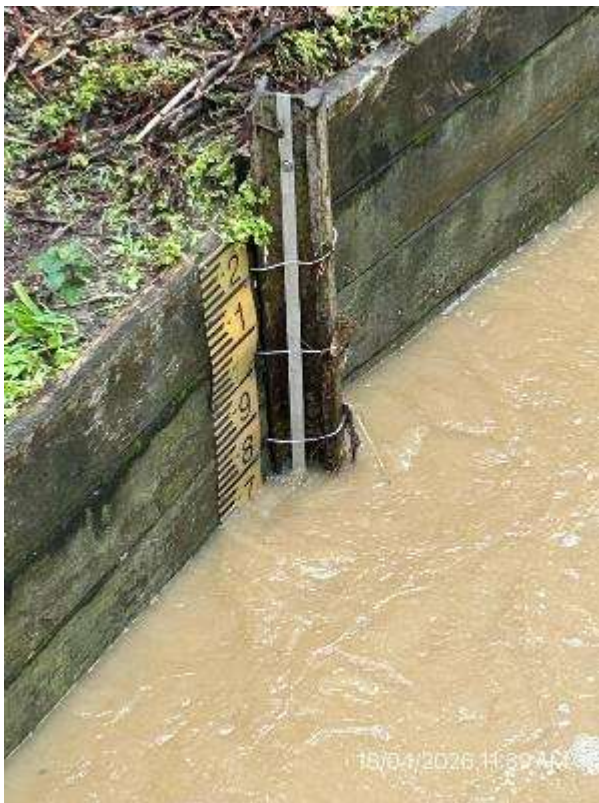
Figure 96 11:39am / water level 0.73m

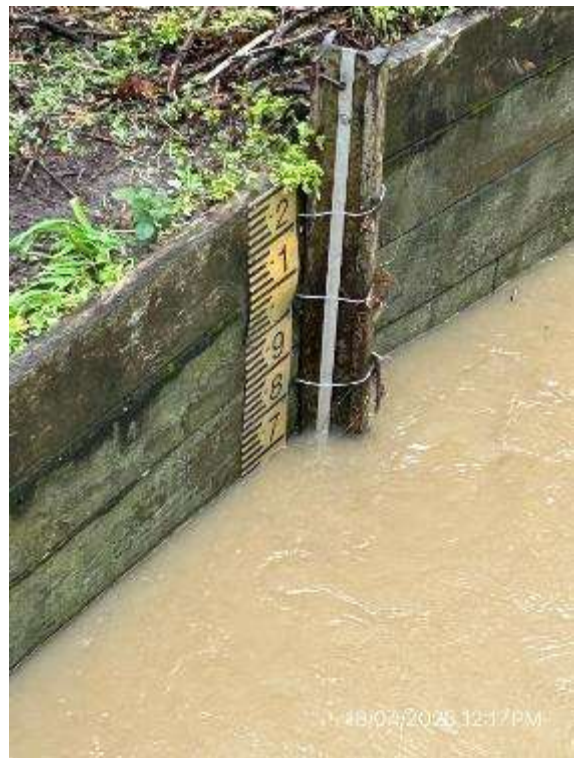
Figure 97 12:17pm / water level 0.67m

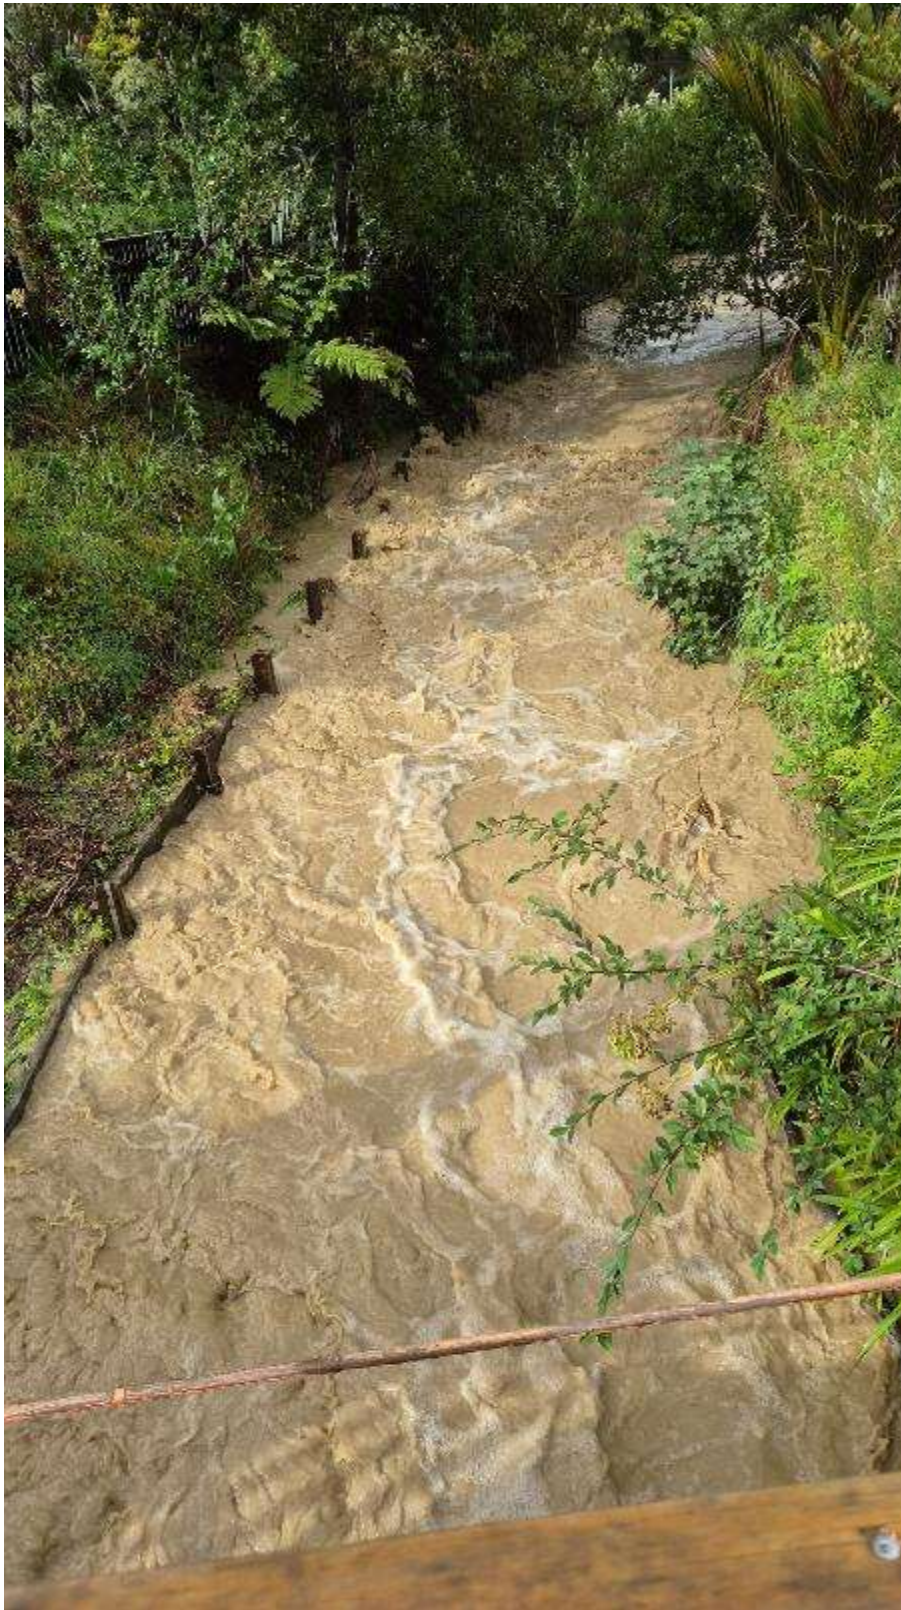
Figure 98 Pinehaven Stream (by Reformed Church) 10:07am, 18 April 2026 [Photo: C. Leenders]

This is based on the water level having not yet reached the peak at 8:45am (Figure 92) and having passed the peak by 10:07am (Figure 98 below).

The debris on the bank above the timber retaining wall on the left side of the stream in the photo above (Figure 98) shows that at peak flow the water overtopped the retaining wall (Figure 99). The height of the top of the timber retaining wall at the staff gauge is shown on the staff gauge as 1.31m. By measuring the level of the debris above the top of the retaining wall, we estimate that the water level peaked at about 150mm above the top of the retaining wall at the staff gauge.

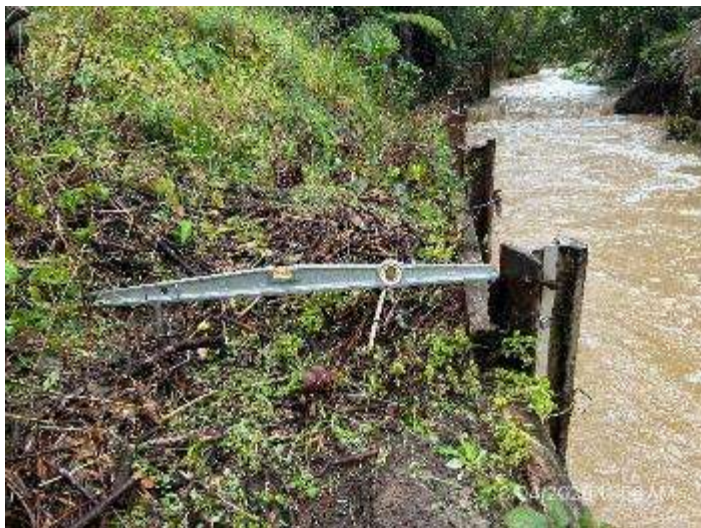
Figure 100 Measuring level of debris above retaining wall

The height of the debris above the retaining wall at the staff gauge is about 0.15m (150mm). We therefore estimate that the water level peaked at about $1.31 + 0.15 = 1.46\text{m}$.

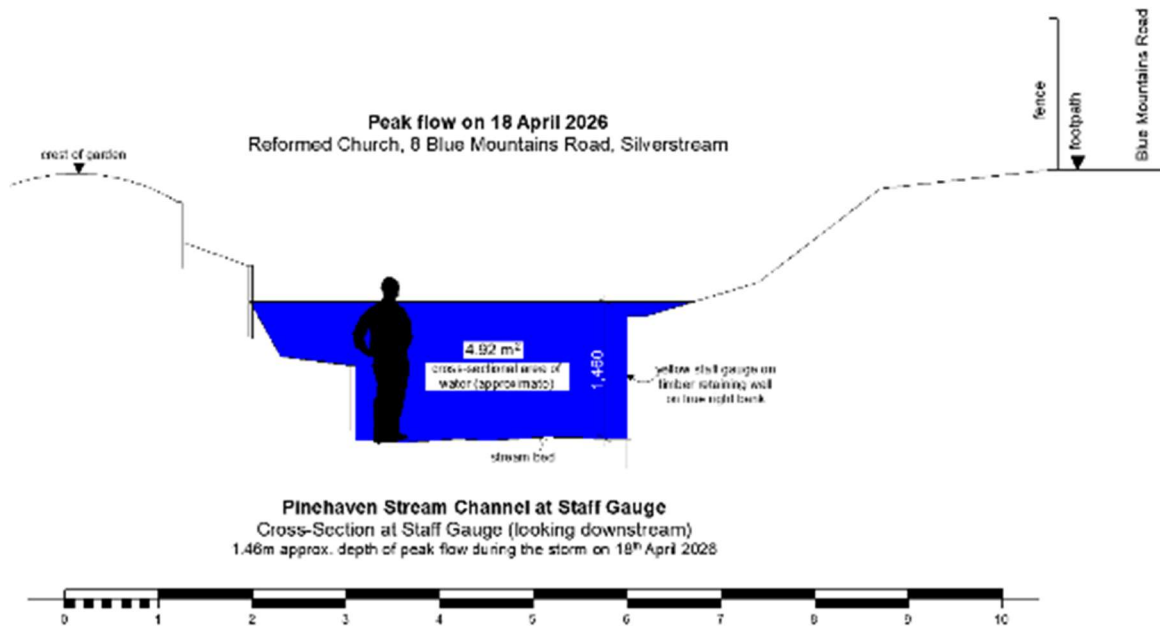
Figure 102 Cross-Section of Channel at Staff Gauge, 8 Blue Mountains Road

At 1.46m deep, the cross-sectional area of water is approximately 4.92m² (Figure 102). Assuming a velocity of about 2.2m/s suggests a peak flow at the staff gauge of about 10.8m³/s (Figure 105).

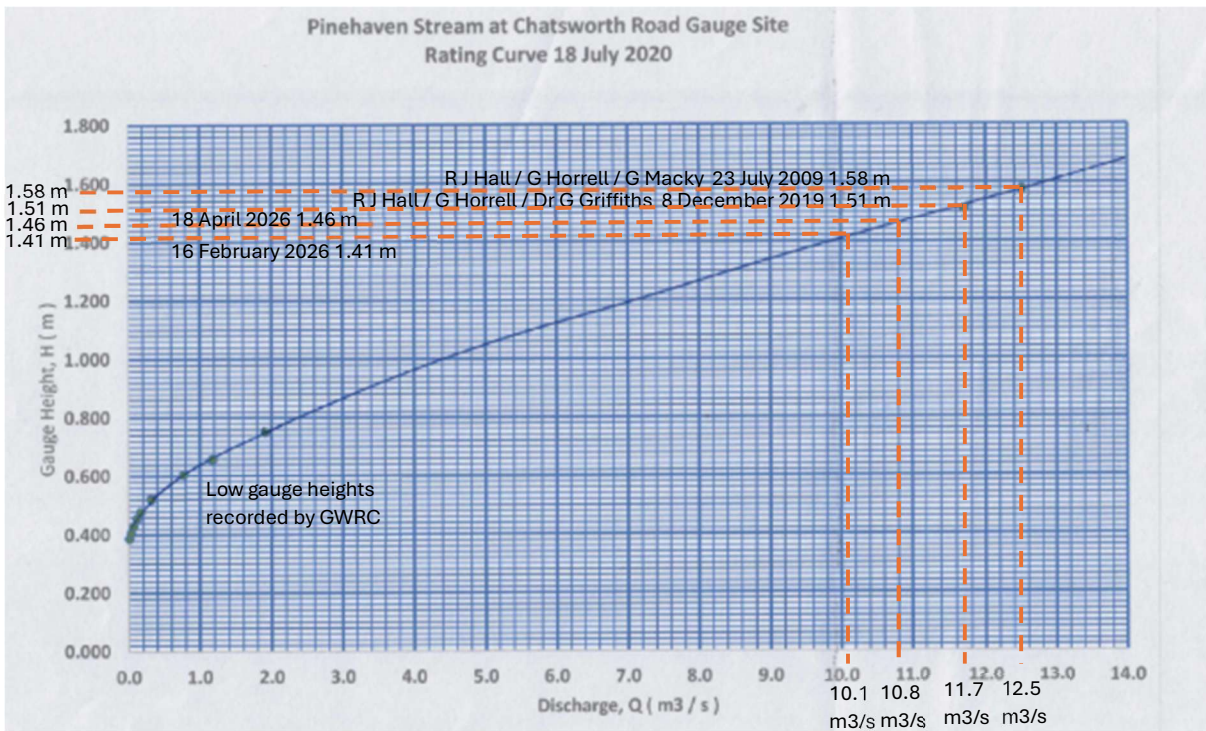
Figure 105 Rating Curve at Pinehaven Stream Staff Gauge Site (R J Hall & Associates Ltd)

The estimated peak water level at the staff gauge on 18 April 2026 was about 1.46m at around 9:30am. On the R J Hall & Assoc. Ltd rating curve 1.46m depth is about 10.8m³/s. On R J Hall & Assoc. Ltd Flood Frequency Curve, a flow of 10.8m³/s is between a 1-in-15 to 1-in-20-year flood.

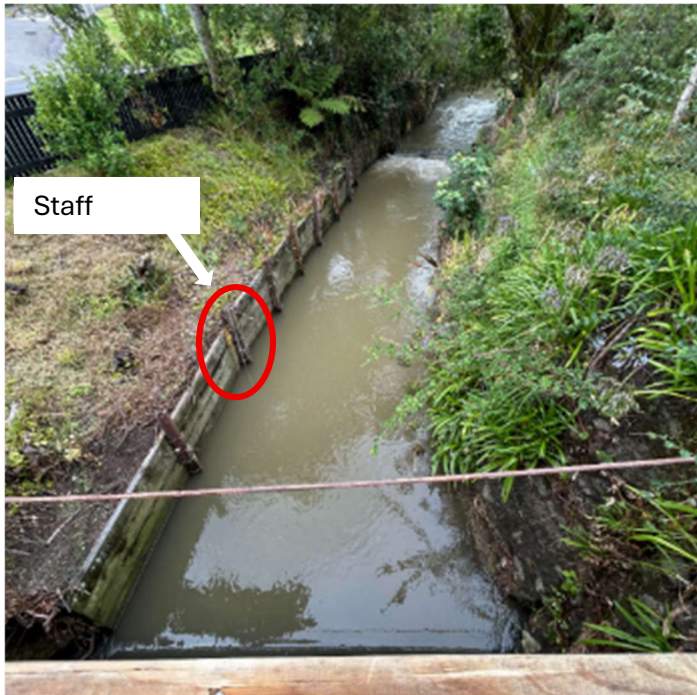
Figure 107 Location at 4-8 Blue Mountains Road (Reformed Church, Silverstream) of the original stream gauge in Pinehaven Stream

The original stream gauge was located at the second railway iron from the footbridge that supports the timber retaining wall on the true right bank of the stream channel. The gauge was located here from 2008 to 2013. This location allows stream flow depths of current events to be related to historical records for Pinehaven Stream at this location.

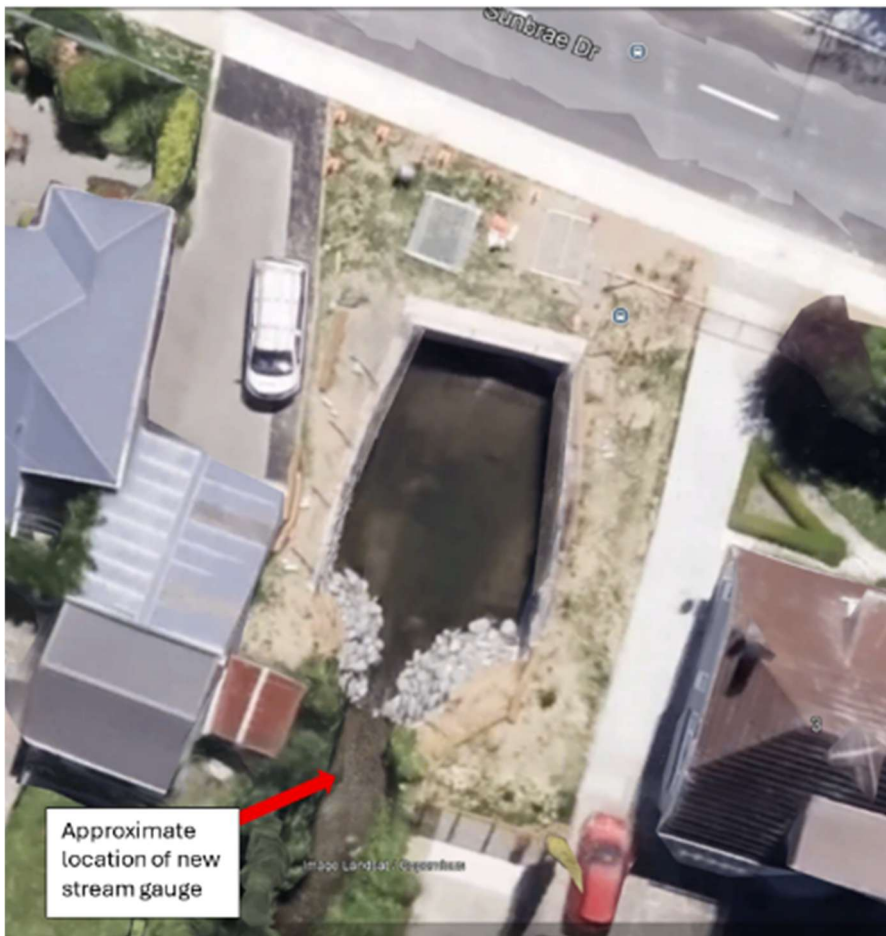
This aerial view (left) is of the new stream gauge site just upstream of the new Sunbrae Drive culvert. The new gauge site was set up by GWRC either late 2025 or early 2026.

This aerial view shows that just a couple of metres downstream of the new stream gauge are two rock piles, one at the true left bank and one at the true right bank. These rock piles have since swept away.

The disturbances to stream flow created by the rock piles being swept away in the 16 February and 18 April 2026 storm events may result in unreliable readings on the nearby stream gauge.

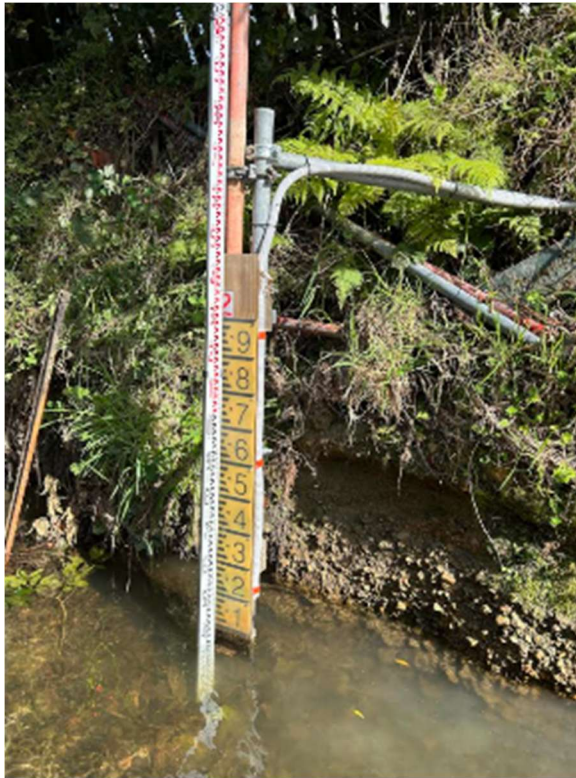
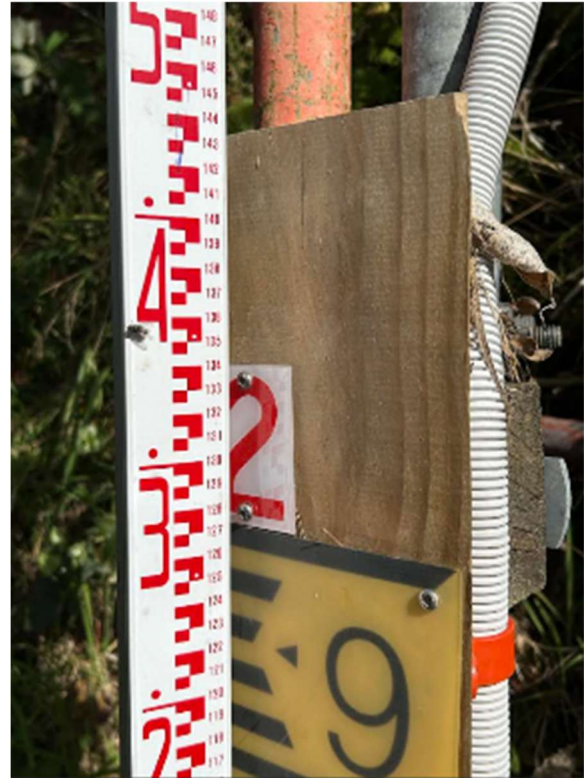
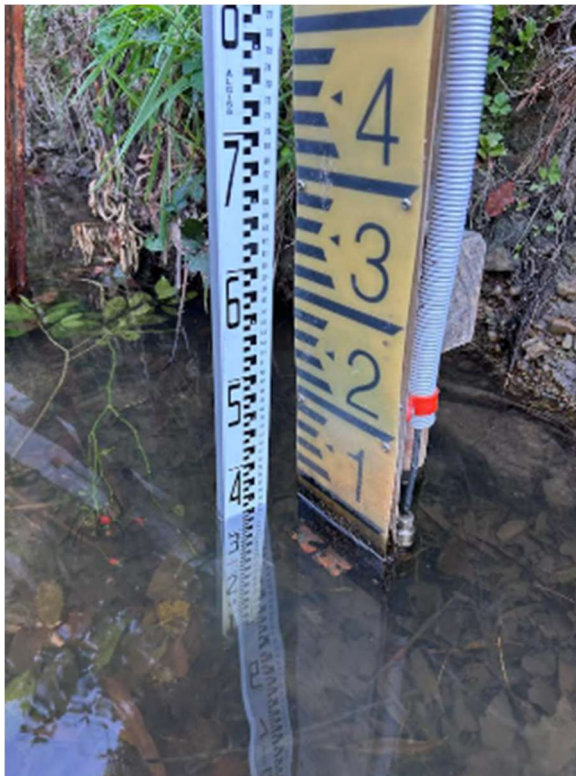
In addition to issues with unstable rock piles, the new stream gauge does not appear to be providing a reading of the depth of water from the bed of the stream channel but rather from a height of about 270mm above the bed of the channel.

Figure 111 Survey staff shows zero on stream gauge staff is 270mm above bed of the stream

The new stream gauge might not be providing reliable stream level data because the gauge is located about 270mm above the stream bed.
